## FULL SCALE STEEL PLATE SHEAR WALL: MCEER/NCREE PHASE II TESTS

### ABSTRACT

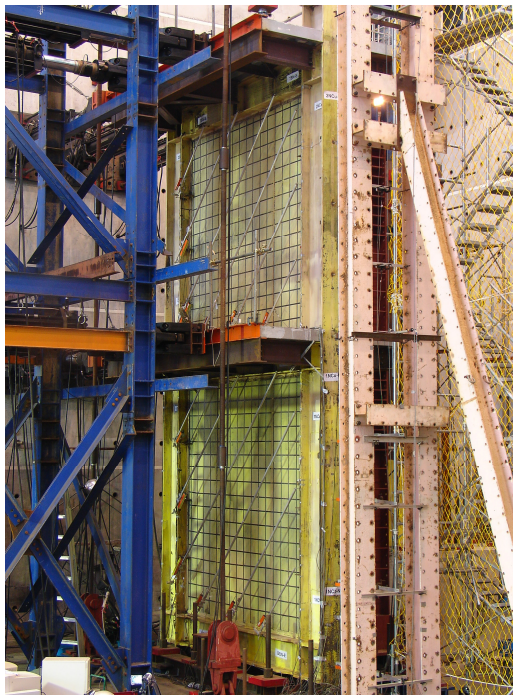
The SPSW specimen and hysteretic curves obtained from the Phase II pseudo-dynamic test, along with the counterpart results obtained from Phase I for the same level of excitation are shown in Figs.3 (a-b).

(a) Specimen prior to Phase II tests

(b) Hystereses of Phase I and II pseudo-dynamic tests

Figure 3. Specimen and hystereses.

Comparing the hysteretic curves from the Phase I and Phase II tests shown together in Fig. 3(b), the two specimens are found to behave similarly under the same strong ground motion except that the initial stiffness of the repaired specimen is higher than that of the original one. This is because the intermediate concrete slab suffered premature cracks and two anchor bolts fractured at the south column base at the time step of 9.5 sec and 24 sec of the first earthquake record in the Phase I tests respectively, as mentioned in the companion paper. The Phase I tests resumed after the specimen load transfer mechanisms were strengthened at those locations. The results shown in Fig. 3(b) for the specimen in Phase I are those obtained after the specimen was repaired due to the aforementioned failures. Therefore the infill panels had already experienced some inelastic deformation before these unexpected failures occurred.

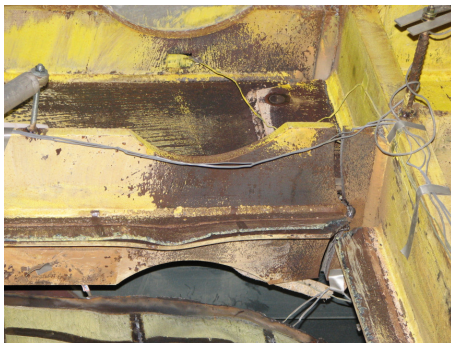
Figure 7. Ruptures at the north end of the intermediate beam.

Rupture of the shear tabs triggered fracture of the bottom flange at the north end of the intermediate beam. At drifts of 3.3% and 3.1% at the first and second story respectively in Cycle 9, the bottom flange at the north end of the intermediate beam fractured as shown in Fig.7. However, no fractures developed in the reduced beam flange regions of the intermediate beam. The welds connecting the infill panels to the fish plates around the north end of the intermediate beam also fractured over a substantial length to a more severe extent after the specimen experienced drifts of 5.2% and 5.0% at the first and second story respectively as shown in Fig.8. These events significantly changed the load path within the system. However, the SPSW specimen was still able to exhibit stable force-displacement behavior as evidenced by the hysteretic curves shown in Fig. 6, which demonstrates the redundancy of this kind of structural system. The cyclic test ended at drifts of 5.2% and 5.0% at the first and second story respectively, when sudden failure occurred in the load transfer mechanism, i.e. when a fatal longitudinal crack developed along the top concrete slab of the specimen as shown in Fig.9.

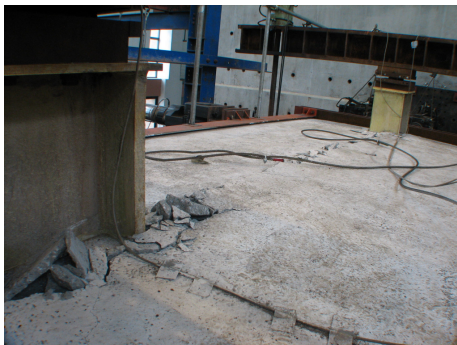
Figure 9. Crack at the top slab

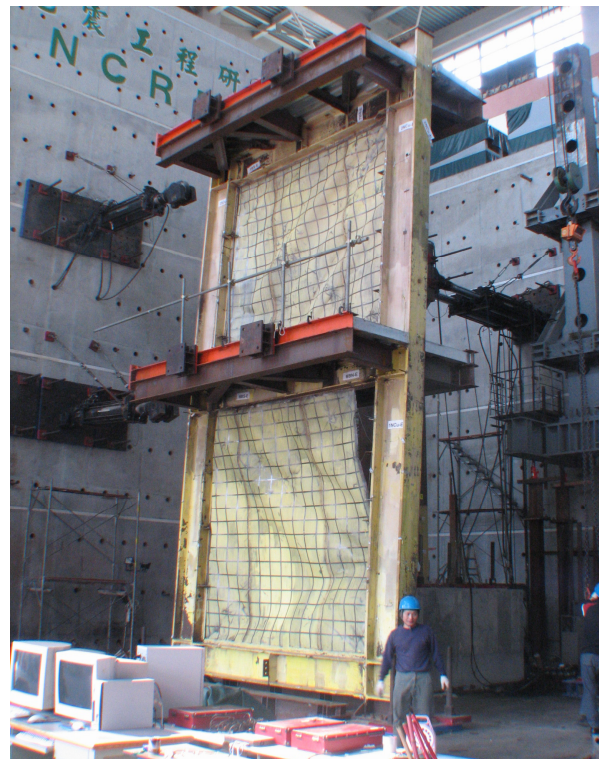
Figure 8. Fracture of the welds connecting the infill panels to fish plates.
