## STONE COLUMNS FOR SEISMIC GROUND IMPROVEMENT: A DESIGN AND CONSTRUCTION CASE HISTORY

**ABSTRACT:** A new development project in the Fraser Valley Regional District in British Columbia involved the construction of a new electrical substation. The substation is located on sloping terrain in a seismically active area. Ground conditions at the site consist of an upper layer of non-engineered soft fills extending to depths of 15 m in some areas, which are underlain by generally stiff low to medium plasticity silt with frequent interbedded lenses of low to non-plastic sandy silt/silty sand. Based on the results from the site investigations programs, these lenses were considered to be horizontally continuous throughout the site. Given the inferred relative density in the low to non-plastic sandy silt/silty sand lenses and considering the 2% in 50-year recurrence interval design seismic event, liquefaction triggering was anticipated in those lenses, which would result in large seismic and post-seismic movements and possibly lead to slope failures. Ground improvement using bottom feed vibro-replacement (stone columns) was adopted to reinforce the ground, therefore preventing slope failu

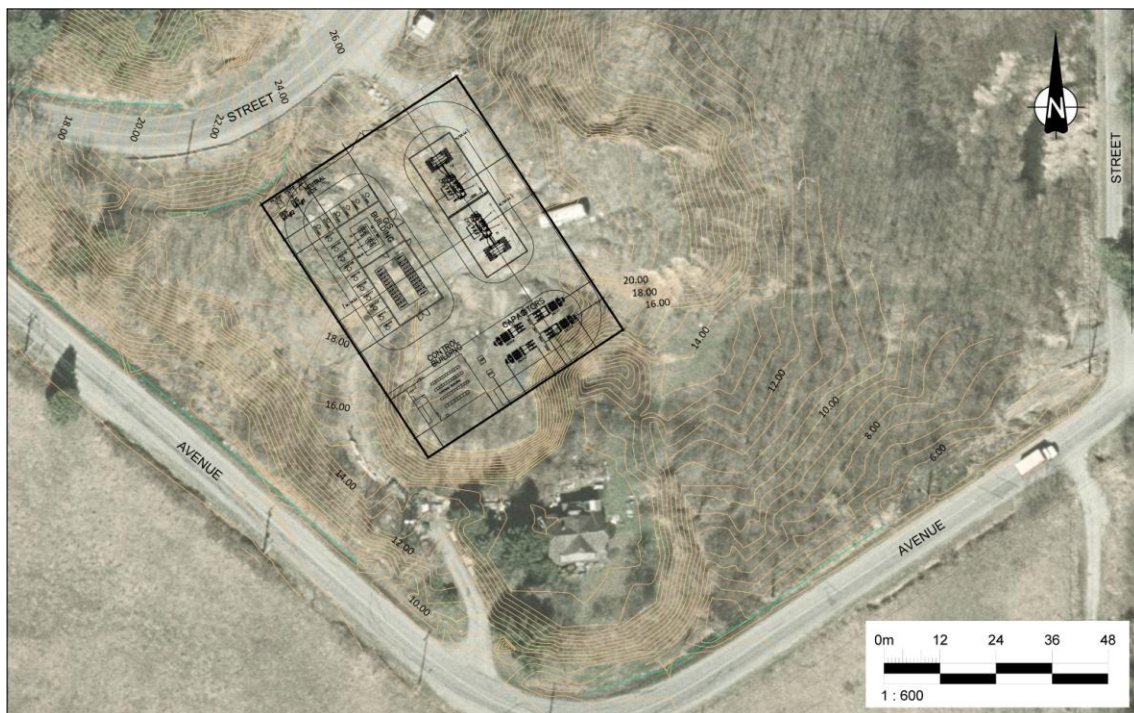
Fig. 1 – Substation Layout Plan

The new substation would consist primarily of two multi-level buildings and the general layout of the structures is shown on Fig. 1. It was decided that the substation would be placed at an elevation of about +18.5 m in order to try to optimize and balance excavation cut and fill volumes. The building and structure loads generally varied between 50 kPa to 100 kPa.

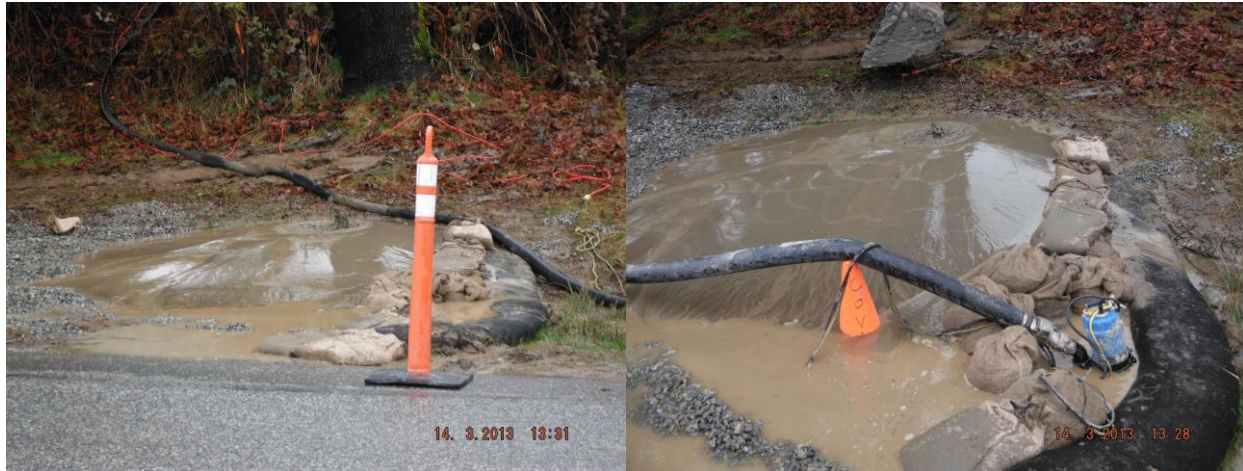
**Fig. 3 – Sand boil**

With the exception of sand boil #1, the diameter of the sand boils typically varied between 0.5 m and 1 m approximately. The diameter of sand boil #1 reached 3 m approximately, during the installation of a column that resulted in the ejected approximately 3 m<sup>3</sup> of sand and silt. Photos of a sand boil are shown on Fig. 3.

As a result of the stone column installations, several sand boils developed at the toe of the slope around the southern edge of the site (along the avenue). Consisting of discrete points where water and soil discharged from the ground during installation activities, sand boils first developed during installation of the test section and were subsequently noted during stone column production, in particular at locations close to the crest of an existing slope (sand boil #1). Sand boils are believed to be the result of the large air pressures used at the tip of the vibroflot during initial penetration as well as during construction of the stone columns, which were typically in the order of 600 kPa to 700 kPa. Such pressures are notably higher than the overburden soil pressures in the upper 25 m, thereby causing “fracturing” of the ground and resulting in such boils.

Up to approximately  $3 \text{ m}^3$  of sand and silt were ejected during the installation of any individual column, although the ejected volumes were typically less than  $0.5 \text{ m}^3$ . In general, ejection of sand and silt from sand boils exceeding  $0.1 \text{ m}^3$  per column occurred in about 16% of the stone columns only, with volumes exceeding  $0.5 \text{ m}^3$  occurring in less than 2% of the columns. Only three columns resulted in sand and silt volumes ejected from sand boils exceeding  $1 \text{ m}^3$ .

By the completion of stone column installation, 11 sand boil locations had developed, primarily aligned along the southwestern edge of the site.

It was noted by the design engineer's field monitors that column installation sequencing appeared to have the greatest effect on the magnitude of sand boil discharge. Through discussions with the general contractor and ground improvement contractor, an installation sequence that consisted of installing first the outermost two rows of stone columns closest to the slope was developed. This recommendation was followed on the southeastern side of the production area, and very limited sand boil activity occurred in that area once the recommendation was followed. However, the recommended sequence was not followed by the contractor on the southwestern edge of the production area, where the majority of the sand boils occurred.
