SEISMIC VULNERABILITY OF HISTORIC STONE MASONRY: A CRITICAL REVIEW

ABSTRACT: Historic structures are of great importance to current and future generations as they convey historical and cultural aspects of past civilizations. Many historic structures were built of stone masonry in the form of residential and religious buildings, bridges, and monuments. Some of those structures have survived earthquakes for centuries while others collapsed, revealing our lack of knowledge concerning the seismic behaviour of such structures. Historic structures are typically massive and stiff and can be vulnerable to seismic events - even ones of low to moderate severity. The seismic vulnerability of such structures arises possibly due to the attraction of high inertial forces, the lack of ductility to dissipate seismic energy and the deterioration and weakening of the material over time. Historic structures were typically built based on the builders' experience: seismic codes did not exist at the time. To conserve those structures, seismic resistance should be evaluated carefully, and an appropriate rehabilitation scheme used if necessary. The seismic vulnerability of a stone structure is a function

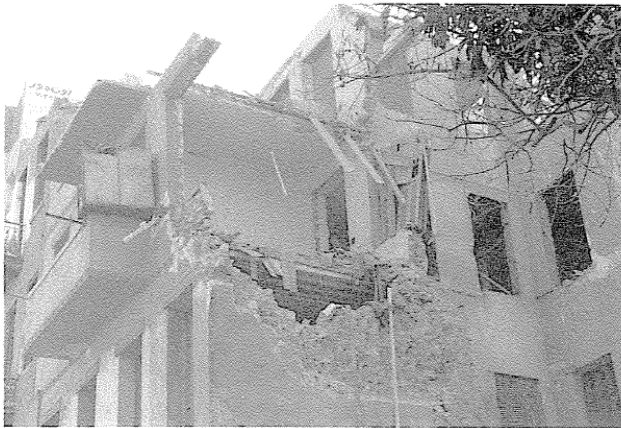
(a) Heavy damage to stone bearing wall buildings in Egypt (EERI, 1992).

Fig. 1 – Failure of Stone Masonry to Earthquakes (Permission to Reproduce is Granted by the Earthquake Engineering Research Institute)

Historic structures are tangible records of the history and culture of past civilizations, and how they could have influenced current generations. Thus, many societies see conservation of historic structures as important. Masonry units such as stone, bricks, and adobe are the fundamental components of many historic buildings since they were easy to extract or form from local resources. The mortar used with those masonry units was typically based from pozzolan, clay, or lime, or more recently Portland Cement, or lime/cement. Structures built solely on such masonry composition – i.e. units and mortar – are defined as unreinforced masonry (URM) structures. Stone masonry is a typical example of URM, in which the URM walls are the indispensable elements that resist an earthquake, in both the in- and out-of-plane directions. Seismic activities represent the most critical hazard that put heritage structures at risk of damage or collapse, since those structures were built using the builders' expertise, rule-of-thumb, with little/or no knowledge of how to resist seismic action at the time. In addition, historic structures may have very thick and massive walls, which can have catastrophic consequences if they fail, especially, in crowded urban areas. Some historic stone buildings have survived earthquakes for centuries, while others did not survive even the first ground shaking. However, just because a heritage stone structure is still standing does not confirm it has adequate seismic resistance because earthquakes, particularly ones of high severity, occur at a lower probability than other natural hazards. In general, failure of stone structures to earthquakes was manifested during past activities; e.g., as shown in Fig. 1 (e.g. ERRI, 1992; ERRI, 2005). The seismic

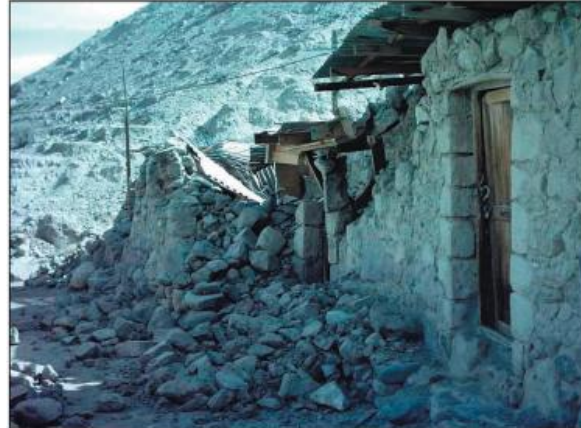
(b) Heavy damage to stone house in Chile (EERI, 2005).

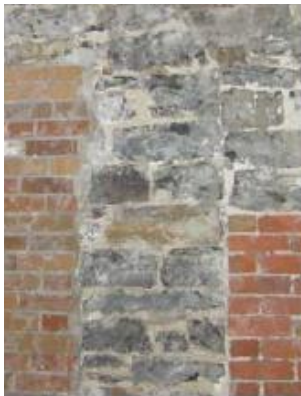
Mixed stone and brick masonry

Fig. 2 – Configuration of Stone Masonry Walls

Stone masonry used in heritage structures is site-dependent and may be coursed or uncoursed. The former can be solely stone units or stone units combined with other URM masonry (e.g. bricks), and the latter can be randomly placed (rubble), or a combination thereof, as shown in Fig. 2. Multi-wythe walls often have more than one stone wythe and a rubble material, with or without mortar, between them. Such walls are common in historic structures and can be more vulnerable than single wythe walls.

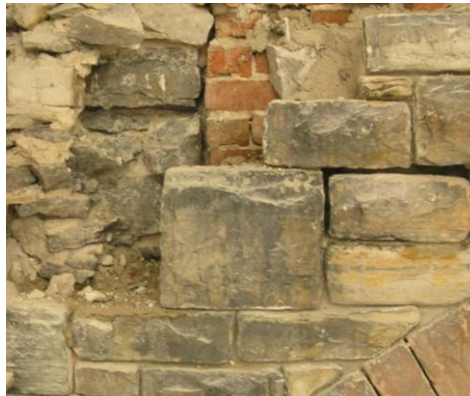
Coursed and uncoursed stone with different masonry in a wall.

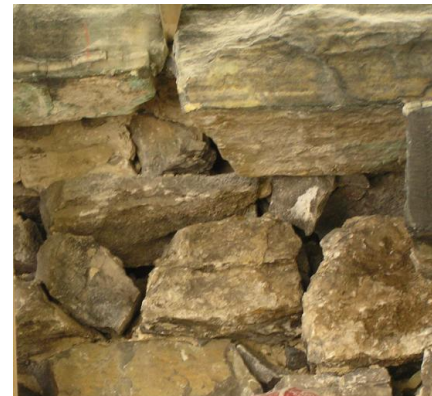
Rubble stone

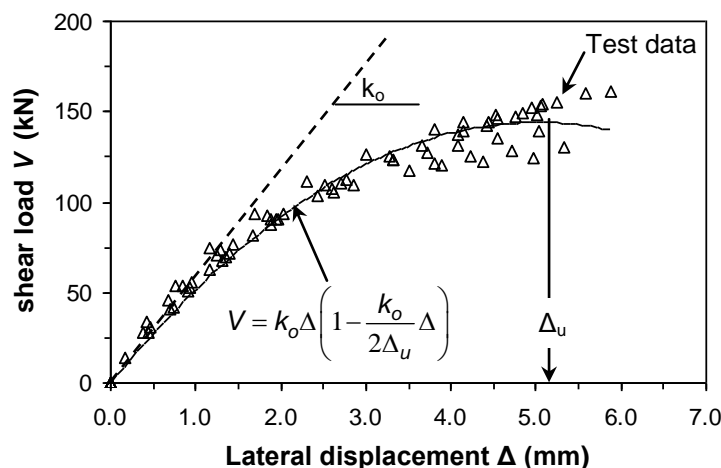
Fig. 3 – Experimental Lateral Shear Load and Displacement of Stone Walls (Elmenshawi et al., 2010a)

Experimental data concerning the relationship between the in-plane shear strength and deformation of stone masonry walls show nonlinearity. For example, Elmenshawi et al. (2010a) tested multi-wythe stone walls (one external wythe of sandstone and the other of limestone, with a rubble core between) and obtained the relationship shown in Fig. 3. They observed that the nonlinearity between the lateral shear load, V , and corresponding displacement, Δ , commenced at an early stage. The nonlinear relationship was modeled with an equivalent bi-linear format, as shown in Fig. 4, such that the areas under the experimental and bi-linear curves were equal. The bi-linear relationship was used to define an associated equivalent ductility, the term of *equivalent ductility* being used instead of *ductility* to emphasize that the inelastic behaviour being defined was not due to the yielding of mild steel, as in reinforced concrete, reinforced masonry or steel structures.

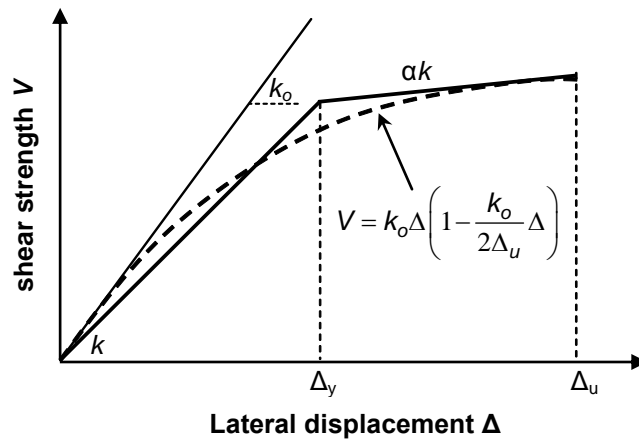
Fig. 4 – Idealization of Nonlinear Behaviour of Stone Walls (Elmenschawi et al., 2010a)

The equivalent ductility is the ratio of the displacement at ultimate strength to the displacement at a yield point as shown in Fig. 4. The bi-linear relationship could be even further simplified to an elasto-plastic model ($\alpha = 0$ in Fig. 4) because the variation in α did not significantly affect the equivalent ductility values. In contrast, the ratio of effective stiffness k to the initial stiffness k_o did have a profound effect. The equivalent ductility, μ_{eq} , was therefore consequently computed as in Eq. 1 (Elmenschawi et al., 2010a).

$$\mu_{eq} = \frac{\Delta_u}{\Delta_y} = \frac{k}{k_o} \left[1.5 + 1.23 \sqrt{1.5 - \frac{k_o}{k}} \right] \quad : \frac{k}{k_o} \geq \frac{2}{3} \quad (1)$$

The term of k/k_o in Eq. 1 indicates the stiffness degradation of the stone walls in the elastic stage. Theoretically, if there is no stiffness degradation ($k = k_o$) before virtual yielding, i.e. no tensile cracks develop, the equivalent ductility can reach 2.4. However, it is prudent to consider a practical limit to the ratio k/k_o , e.g. 0.8. In this case, the equivalent ductility has a maximum of 1.7. Elmenschawi et al. (2010a) found further that the ratio k/k_o was correlated to the lateral drift, Δ/h , of the wall as shown in Fig. 5. In fact, Fig. 4 and Fig. 5 reveal that continuing maintenance of masonry is necessary to minimize degradation of k/k_o over time, in order to keep the equivalent ductility as high as possible and the wall's lateral drift as low as possible. The post-peak behaviour of the walls was not monitored in Elmenschawi et al. (2010a), so the equivalent ductility factor obtained is deemed to be a lower-bound of the actual ability of the walls to deform inelastically.

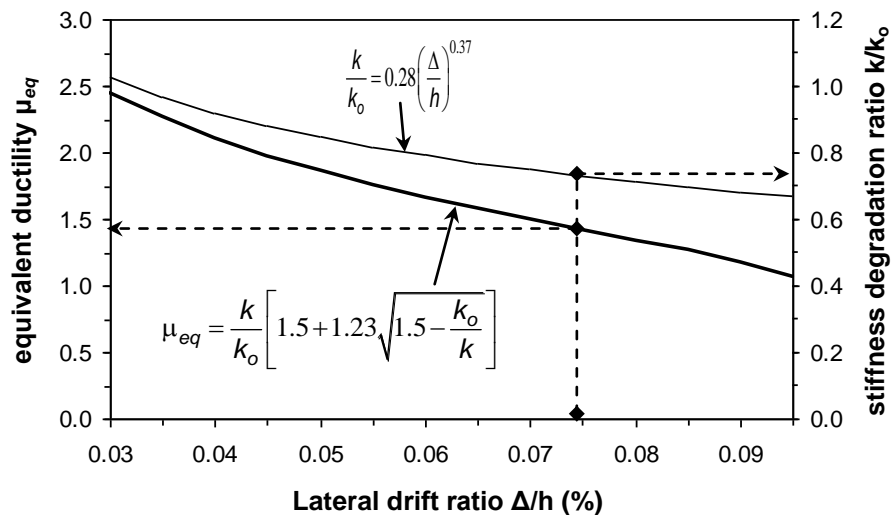
Fig. 5 – Trinity of Drift, Ductility, and Stiffness of Stone Walls (Elmenschawi et al., 2010a)

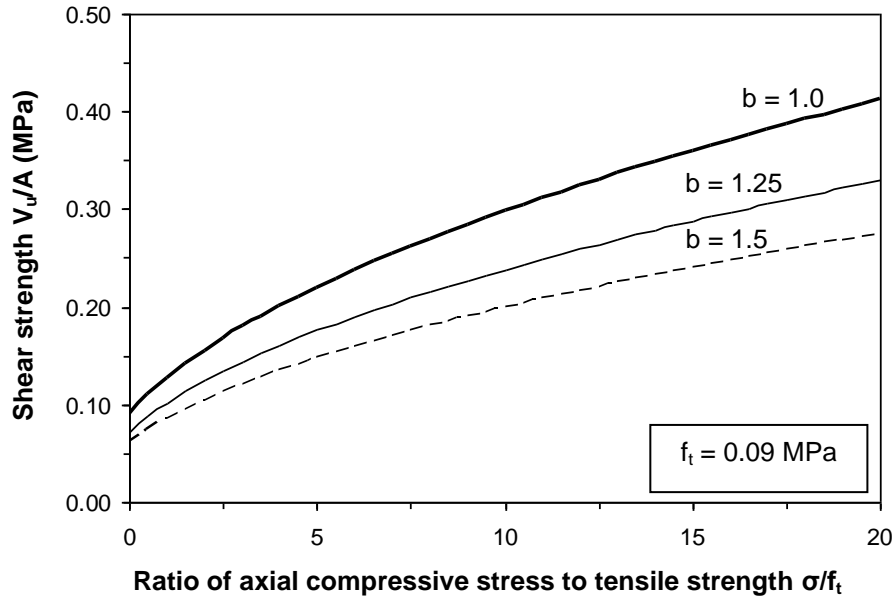
Fig. 6 – Factors Affecting Shear Strength of Stone Walls (Fixed-End Conditions)

obtained (Tomažević, 2009; Turnšek and Čačovič, 1970); for mixed stone-brick masonry, an $f_t = 0.08$ MPa was determined (Sheppard, 1985); and for three-wythe stone walls, an $f_t = 0.09$ MPa was obtained (Elmenschawi and Shrive, 2015). Thus, it is clear that the referential tensile strength of stone masonry is lower than that of other URM. It is worth stating that FEMA 356 (2000) suggests that as an approximation, the referential tensile strength f_t can be replaced by the bed-joint shear strength for URM other than stone. The effect of variation of the terms in Eq. 2 is shown in Fig. 6 for the value of $f_t = 0.09$ MPa, through the aspect ratio (b -variable), and the ratio of σ/f_t . These both influence the shear strength V_u . For heritage structures, however, the ratio σ/f_t is expected to be between 2.0 to 5.0; therefore, one can anticipate that the shear strength of a wall would vary between 0.1 and 0.22 MPa regardless of the b -value, for the fixed-fixed boundary condition.
