## SEISMIC RETROFIT OF THE GRANVILLE STREET BRIDGE TRUSS SPANS

**Shane Cook, M.A.Sc., P.Eng.**

**Don Kennedy, M.A.Sc., P.Eng.**

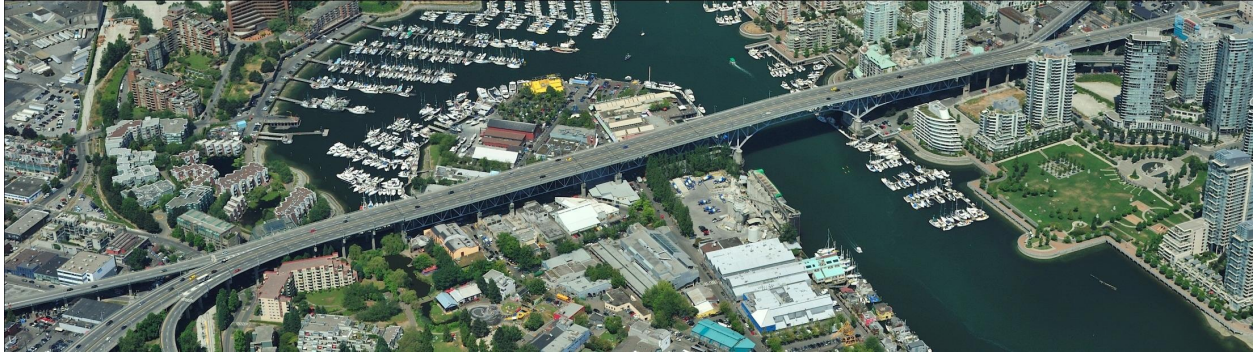
**Fig. 1 – Aerial View of Granville Street Bridge (Looking West)**

The Granville Street Bridge was built in the 1950's. The main bridge across False Creek comprises seven steel deck truss spans, with a total length of 538 m, with an 8 lane concrete deck, supported on concrete piers. Figures 1 and 2 demonstrate the configuration of the truss spans. The south and north approach spans and ramps comprise multiple spans of cast-in-place concrete girder spans. The entire bridge had been previously retrofitted in the early 1990's. The primary requirement of our project was to remediate the existing bearings for PCB oils used to lubricate the roller bearings. PCB is classified as hazardous materials, and need to be removed to comply with Federal and Provincial legislation. There were originally 14 roller bearings and 6 fixed bearings supporting the steel truss. The City of Vancouver originally let the project with the scope to remediate the PCB's in the existing bearings without considering seismic upgrades. This approach was predicated on the bridge having been previously retrofitted. Through the course of the project development it became apparent that an opportunity existed to greatly enhance the seismic performance of the major structure as part of the bearing remediation project through the implementation of a seismic isolation retrofit. This retrofit would address the PCB issue by removing the existing roller bearings as well as enhance the seismic performance.

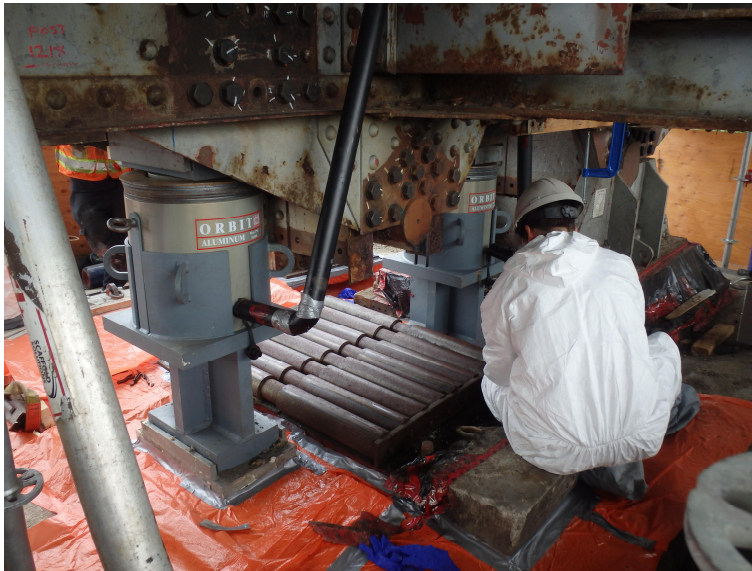
**Fig. 7 – Preparing PCB Contaminated Rollers for Removal**

The presence of the PCB's was a continuous challenge for the contractor. Components that were PCB contaminated had to be handled with care, removed, bagged, and transported off site for full cleaning. This process was complicated by the size of the elements to be handled and the space allowed for removal. One complicating property of PCB's are that when burned the fumes released are extremely hazardous. This meant that the contractor could not torch cut existing elements that may be PCB contaminated.

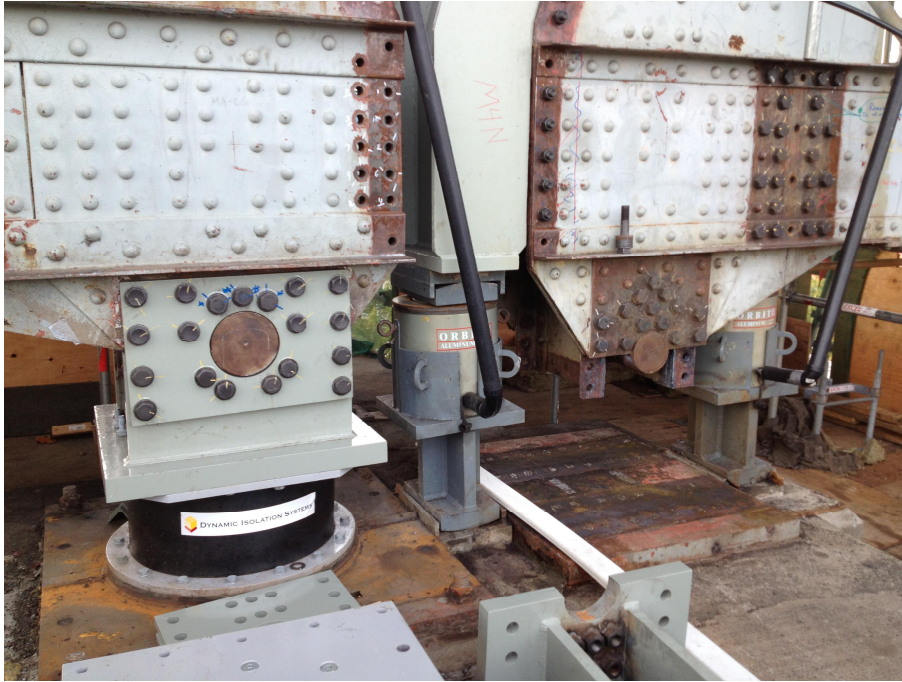
**Fig. 8 – Completed Bearing Adjacent to Removed Bearing**

The space constraint on the bridge piers was probably the biggest factor affecting the contractor's methods. Tolerances for installing bearings, placing equipment and materials, and locating jacks were severely restricted. Existing components were generally removed as soon as they were freed from the existing structure. New components were delivered only when ready for installation and slid immediately into place. Final tolerances for installation of the bearings were less than 15 mm.
