SEISMIC UPGRADING OF HERITAGE BUILDINGS ON THE DOWNTOWN EASTSIDE OF VANCOUVER

Andy Metten, P.Eng., Struct.Eng.

Partner, Bush, Bohlman & Partners LLP, Canada
ametten@bushbohlman.com

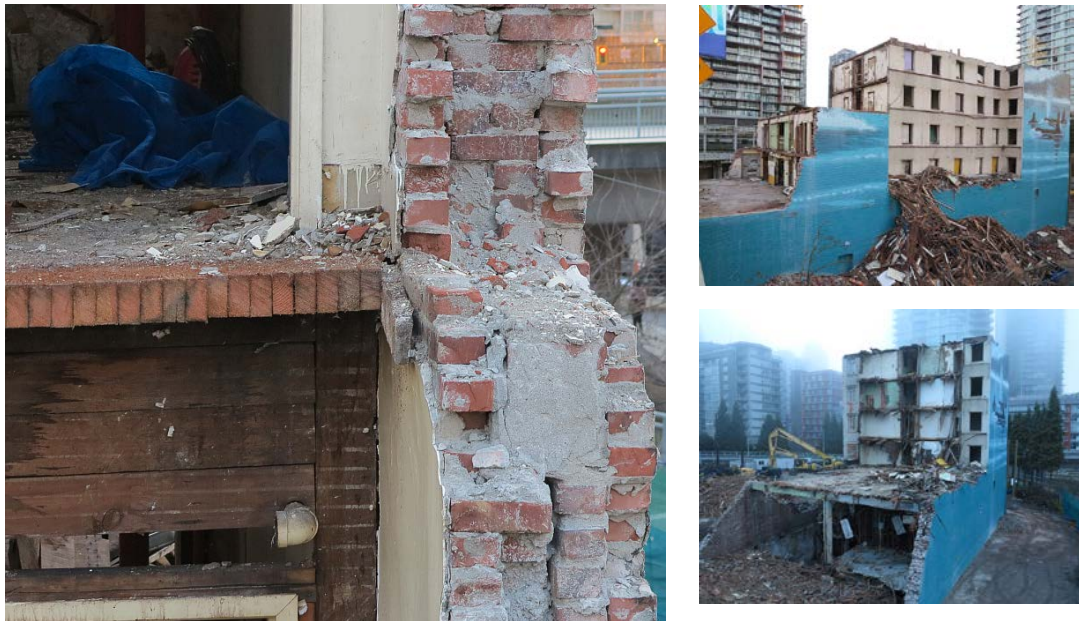
Fig. 1 – Typical SRO Brick and Wood Construction and seismic issues

During the early part of 2015 a 2012 vintage hotel building on Granville Street in Vancouver was demolished, while this building was not part of the SRO renewal initiative its demolition was done in way that provides a cross section featuring the seismic issues of the of the five buildings that we will discuss. Figure 1 shows the Wyland building (former Old Continental Hotel at 1390 Granville St.) during its demolition and the issues that must be addressed in the seismic upgrading of similar buildings. The Old Continental Hotel was built in 1911-1912 the same period as the five hotels discussed in this paper.

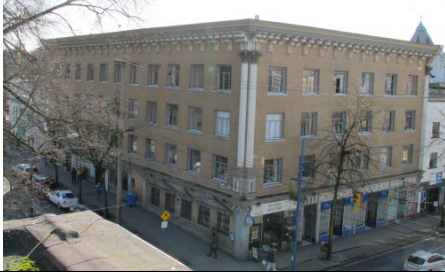
Concrete walls & new concrete spread footings. Diaphragm upgrades with plywood and steel straps. Steel connectors between walls and diaphragms, Connect brick veneer to mass brick.

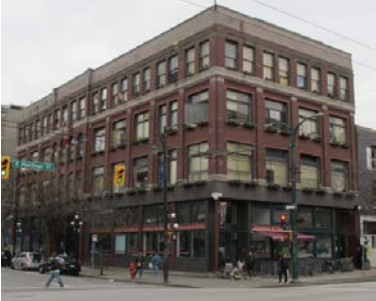
Sunrise Hotel (101 East Hastings St.) (Built 1906)	4	All buildings had fundamental weakness and a Code force compliance in the range of 5%.

Plywood walls in upper floors, diaphragm upgrades with plywood, connecting walls to diaphragm, steel frames in ground floor & concrete walls and footings in basement.
Rice Block (404 Hawks Ave.) (Built 1912)	4	All buildings had a weak and soft story.

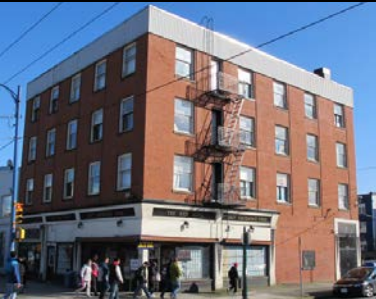
Plywood walls in upper floors, diaphragm upgrades with plywood, connecting walls to diaphragm, steel frames in ground floor & concrete walls and footings in basement.

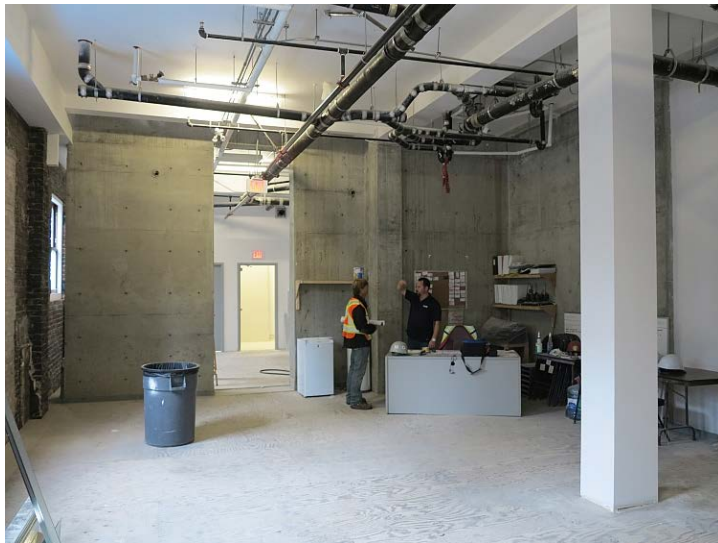
Fig. 2a (Left): Completed Concrete walls in the ground level of Marble Arch Hotel

The added seismic system must address both the need for strength and stiffness. While the use of plywood on the walls of the SRO rooms was advocated as a seismic upgrade method this had significant structural issues due to the difficulty in providing sufficient drift control with plywood walls and the desire to keep the ground floor reasonably free of obstructions for use as retail space. The Marble Arch, Tamura House and the Hazelwood Hotel used concrete walls throughout their full height. The Rice Block and the Sunrise Hotel had a seismic system consisting of plywood walls in the upper floors and steel bracing added in the main floor with concrete walls and foundations below the braces in the basement level. Use of plywood walls in seismic upgrading a heavy brick building requires covering almost all walls above the main floor in plywood and extensive work is necessary to at the main floor ceiling level to transfer both the overturning forces from the plywood walls and transfer the shear forces from the terminated plywood walls to the braces below. Providing a seismic system using concrete walls throughout proved to be most cost effective solution. In doing the concrete walls some of the buildings used one-sided forms with gunnite concrete walls while others used traditional two sided concrete forms. Sometimes wood-slat formworks was used to match the heritage look of the building.

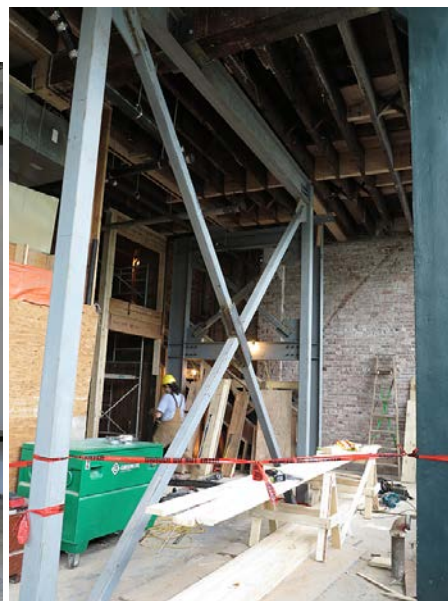
Fig. 2b (Right): Steel brace bay / moment frame frames in the ground level of the Sunrise Hotel

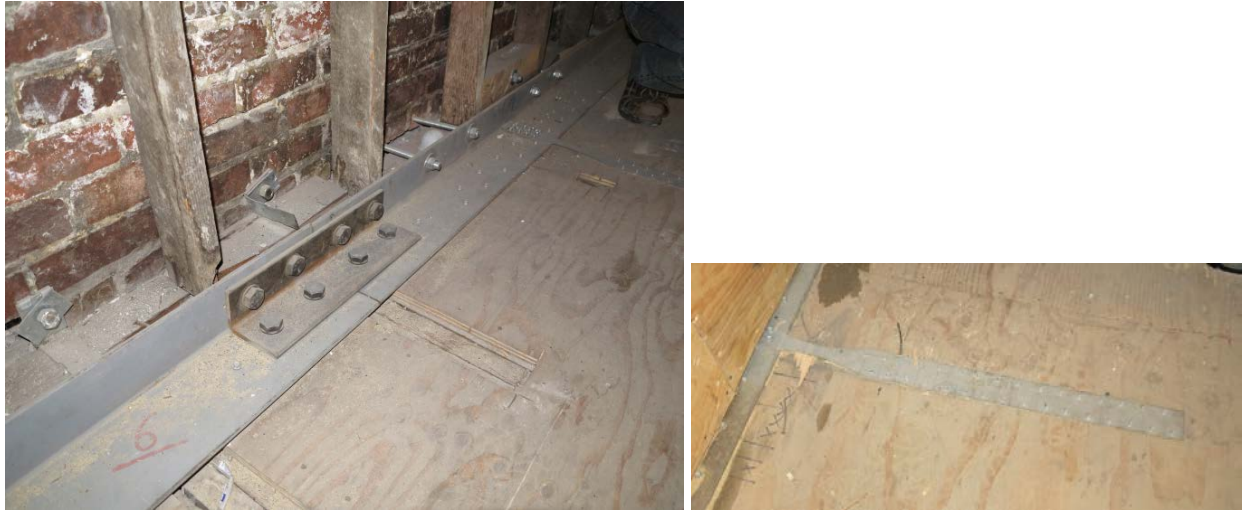
Fig. 3: Diaphragm Upgrading with the addition of Plywood, angles for diaphragm chords and Steel Straps. The steel straps have a potential yielding region to reduce the amount of connection required at the diaphragm side.

A second significant requirement of seismically upgrading the buildings is providing a diaphragm that can transfer the forces from the walls to the seismic resisting elements. The five buildings in this paper all had wood diaphragms that had significant issues with carrying the seismic loads. Improvements in diaphragm shear capacity was achieved by adding plywood to the floors, steel strapping for drag struts and angles for diaphragm chords. The heavy brick walls that were only loosely connected to the diaphragm were tied firmly to the floor by adding connectors to the diaphragm attached to the brick through with threaded rods in cored holes fastened with epoxy. Only coring was used on the brick to prevent the disruption of the century old mortar with hammer drilling. The straps to the diaphragm were designed using a yielding neck that provided a ductile fuse and helped reduce the number of screws required to the diaphragm.

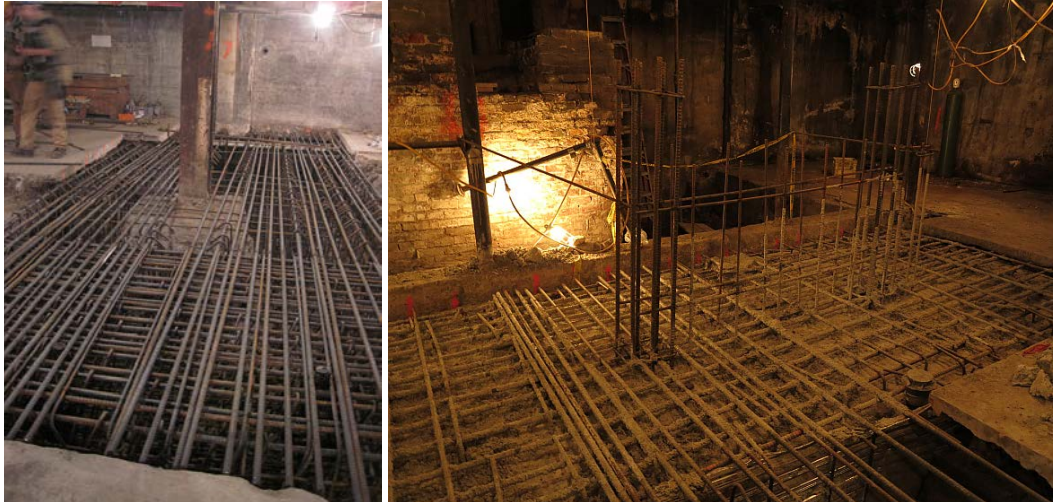
Fig. 4a & 4b: Footing construction in the Marble Arch (Left) and the Hazelwood (Right) .

The new seismic system requires footings to transfer the loads to the foundation. Concrete footings were added to carry the seismic loads. Footings for the Marble Arch used tie-down anchors to carry some of the overturning moment and reduce the size of the footing for other buildings the footing size was increased to pick up dead load of the structure and resist overturning moments. With the exception of Tamura House all the buildings in this study had a basement and the top of the footings became the new basement floor. Excavation for the footings was carried out with a mix of small excavating equipment and by hand. Footings for existing columns were incorporated in the new footings. All the sites were located on firm ground, classified as Site Class C and bearing under ultimate loads ranged up to 450 kPa. Under some circumstances, the footings were constructed in segments to assist with underpinning existing walls, in these cases couplers were used to connect the reinforcing steel from one section to the next.

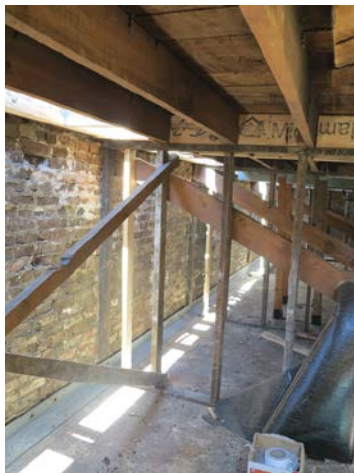
Fig. 5a (left) – Upgrading of Front Parapet on Marble Arch Hotel the angle to connect the brick to the diaphragm at the bottom of the parapet can be seen, plywood and connection at the top of parapet has not been performed at the time of the photograph.

All of the buildings in this study are immediately adjacent to sidewalks, streets, and alleys on at least two sides of the building and objects falling from the building present a risk to those outside. To mitigate this it is necessary to fasten potentially falling objects to the building in a way that provides a load-path for these objects. Of particular concern are cornices, parapets, brick chimneys and signage. While the brick chimneys were removed this was not possible with heritage items such as the parapets and cornices. The parapets are of particular concern as they are of brick construction and may be quite tall to accommodate roof slopes. Structural steel frames provided the mitigation of falling of parapets particularly for those portions of the parapet that extend above the top diaphragm. In some cases plywood diaphragms were added both at the top of the roof level and the ceiling level. Figure 2 shows the upgrading of the parapet in the Marble Arch hotel where plywood is added at both the roof and ceiling level and steel supports are added to the tall parapet.

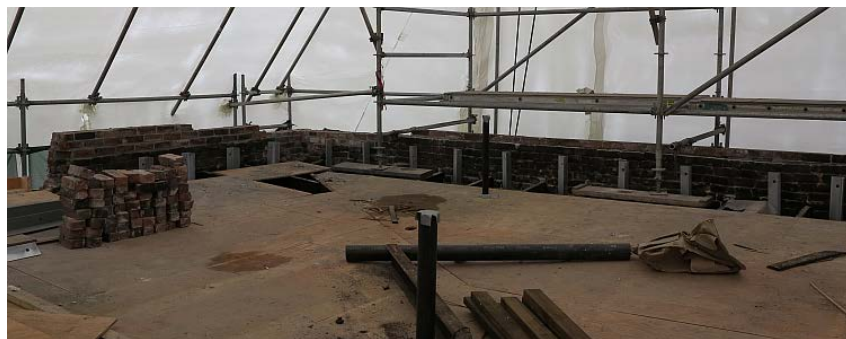
Fig. 5b(Right) – Installing angle bracket support and reworking brick where the mortar had turned to sand on the Sunrise Hotel

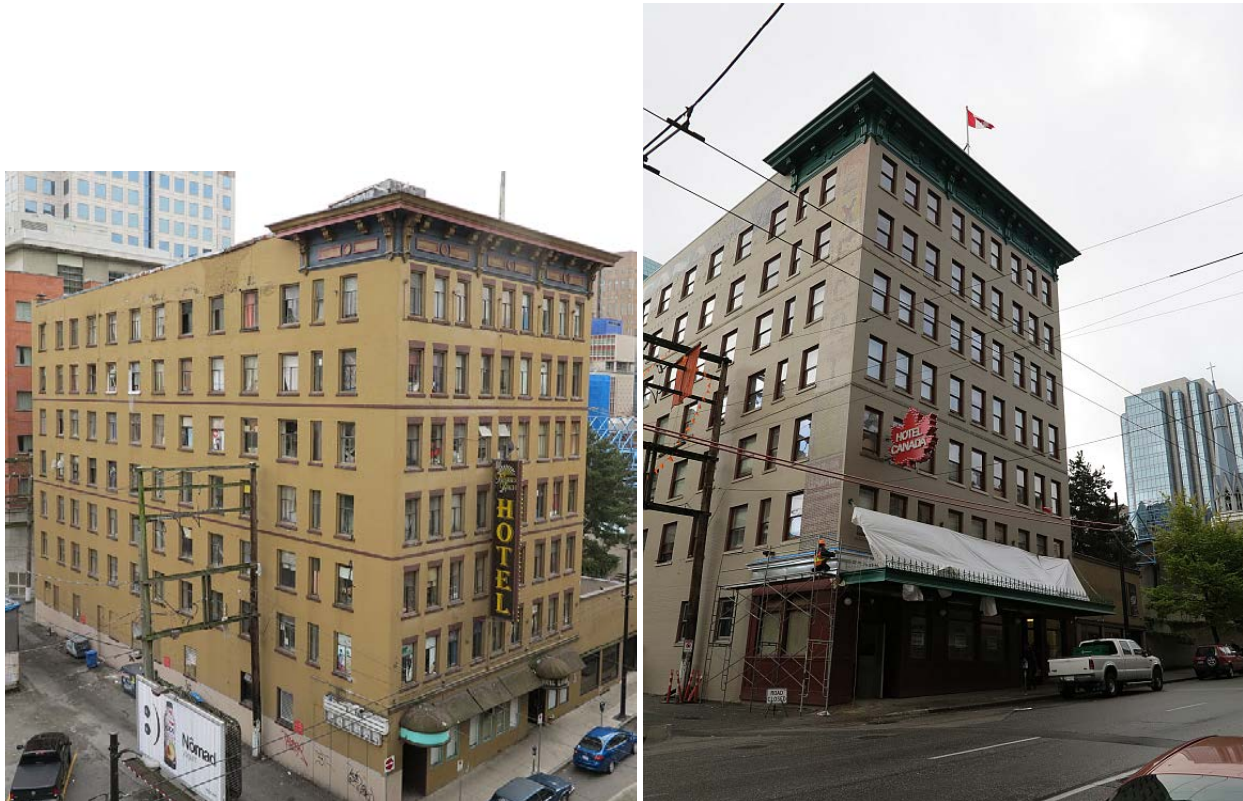
Fig. 6a and 6b: Pre-Renovation Marble Arch Hotel and Completed Canada Hotel.
