## SEISMIC RESISTANCE OF CIRCULAR GLASS FIBER REINFORCED POLYMER CONFINED CONCRETE COLUMNS

**ABSTRACT:** GFRP is slowly gaining acceptability as a replacement of steel to address the issue of steel corrosion in concrete structures. To evaluate the feasibility of using GFRP spirals as internal reinforcement in columns, an extensive research program is underway at the University of Toronto. Sixteen 356 mm diameter concrete columns were tested under simulated earthquake forces, which included constant axial load and cyclic lateral displacement excursions. Each column contained six longitudinal steel bars. Lateral steel consisted of spirals in eight columns while the other eight columns had lateral GFRP spirals. This paper presents responses of selected specimens in the form of moment vs. curvature response, shear vs. deflection behaviour, and discusses ductility parameters related to curvature, displacement, and energy dissipation to evaluate the performance of columns. Columns reinforced with longitudinal steel and lateral GFRP spirals demonstrated excellent post elastic stable response accompanying large shear and moment capacities. Strength and ductility results of these specimens

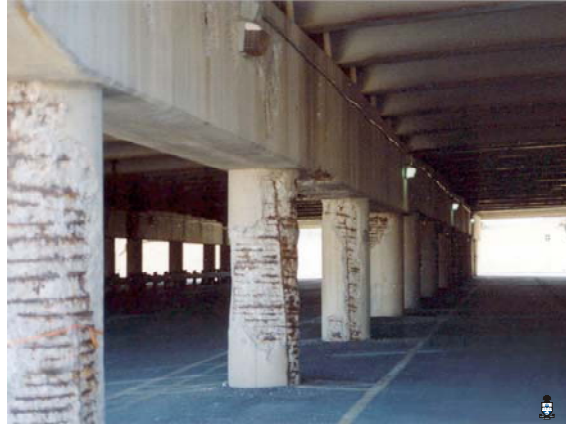
**Fig. 1 – Corrosion of spirals in columns**

Recent estimates indicate that the annual cost of corrosion from all sectors worldwide in 2010 was about USD 2.2 trillion, which represents about 3% of the world's GDP of \$73.33 trillion (Hays, 2010). About 16.4% of the total corrosion cost is from the infrastructure sector. Typically, corrosion happens in bridge decks, beams and columns. This has led to a \$13.6 billion annual direct corrosion cost for highway bridges in the United States (NACE, 2013). In concrete columns, steel spirals are the first element to corrode since the concrete cover protecting these bars is typically not adequate to protect steel. As the steel continues to corrode, the buildup of rusts puts pressure on the surrounding concrete, causing cracking around the steel. Eventually, the concrete cover spalls off due to the expansion (See Fig. 1).

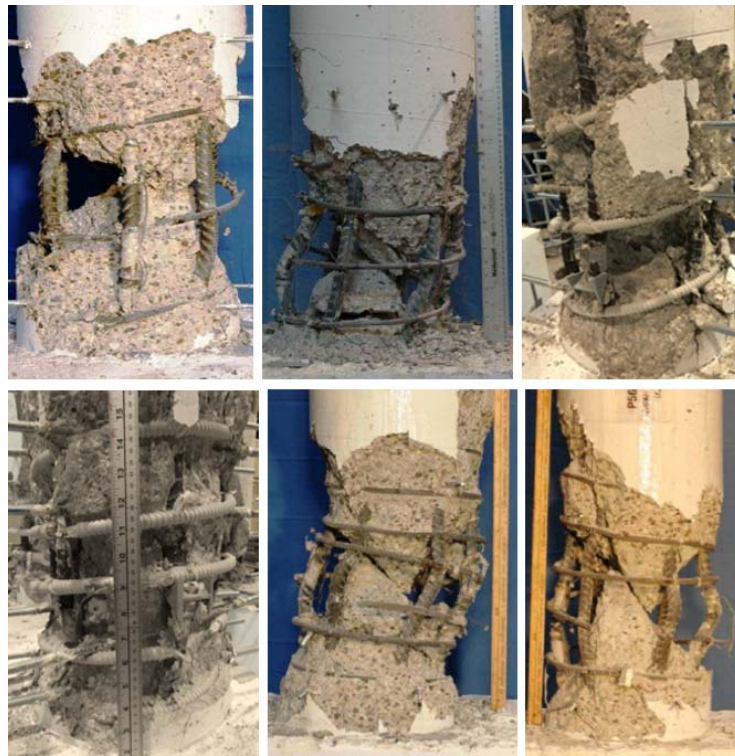
Fig. 7 shows the most damaged regions after failure of the six specimens discussed here. The shifting-away of the most damaged section from the maximum moment section at the column-stub interface is due to the additional confining effect by the heavily reinforced concrete stub.

**Fig. 7 – Columns after testing (in clockwise direction, starting from top left): P27-NF-1, P27-NF-2, P28-LS-12-160, P56-NF-11, P56-NF-12, and P55-LS-12-90**

In group 2 specimens, concrete cracks and spalling occurred at levels of displacement excursion similar to those observed for group 1 specimens. Longitudinal steel bars buckled prior to rupture of GFRP spirals in columns with spiral pitch of 160 mm. In the specimen with spiral pitch of 90 mm, longitudinal bars showed some sign of buckling during a cycle prior to rupture of spirals.

The confinement provided to the core concrete and the support provided to the longitudinal bars vanished as soon as the GFRP spiral ruptured. A combination of buckling of the longitudinal bars in compression accompanied by the crushing of the concrete core in the most damaged zone led to termination of the test.

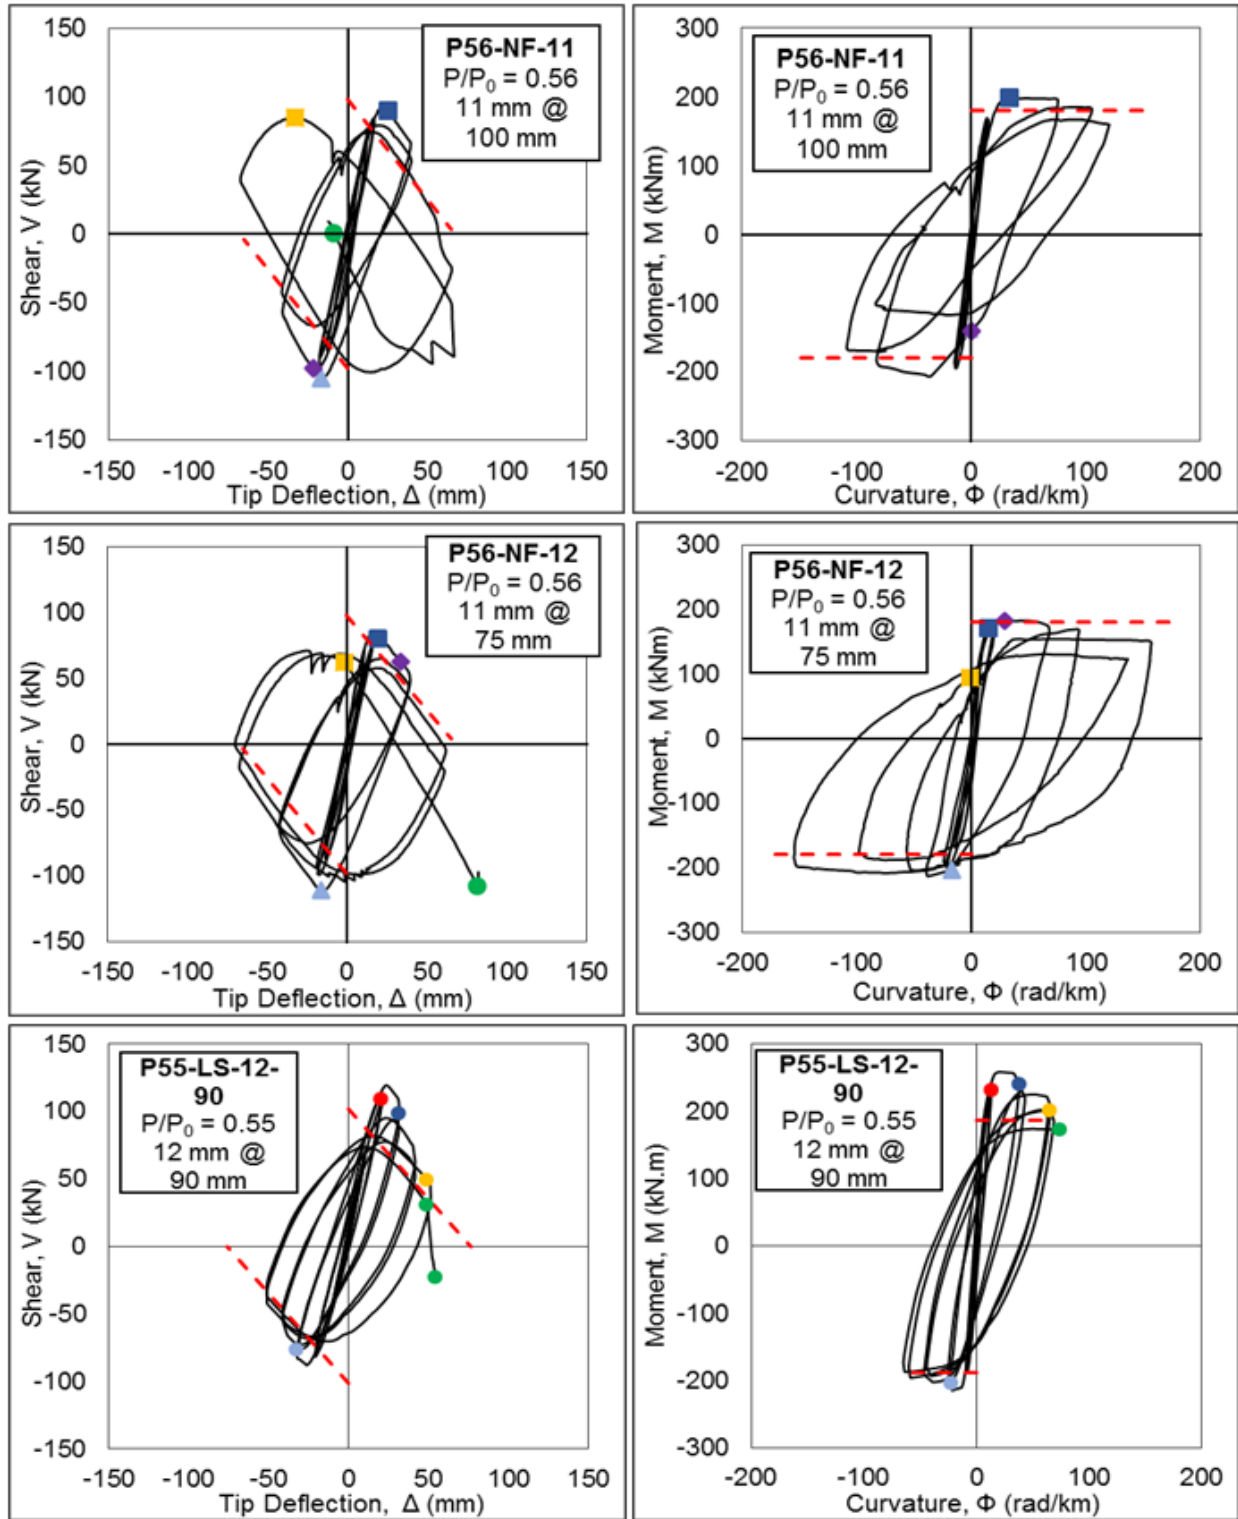
The second set in Table 1 contains three specimens under approximately 2550 kN of axial load. Fig. 9 and Fig. 10 show  $V - \Delta$  and  $M - \Phi$  hysteresis relations and envelope curves for these three columns, respectively.

Fig. 9 – Shear vs. deflection and moment vs. curvature hysteresis ( $P/P_0 \sim 0.55$ )
