SEISMIC REHABILITATION OF RIVIÈRE-DU-LOUP HOSPITAL USING FRICTION DAMPERS

Martel, Jean-François

Structural Engineer, CIMA+, Canada
jean-francois.martel@cima.ca

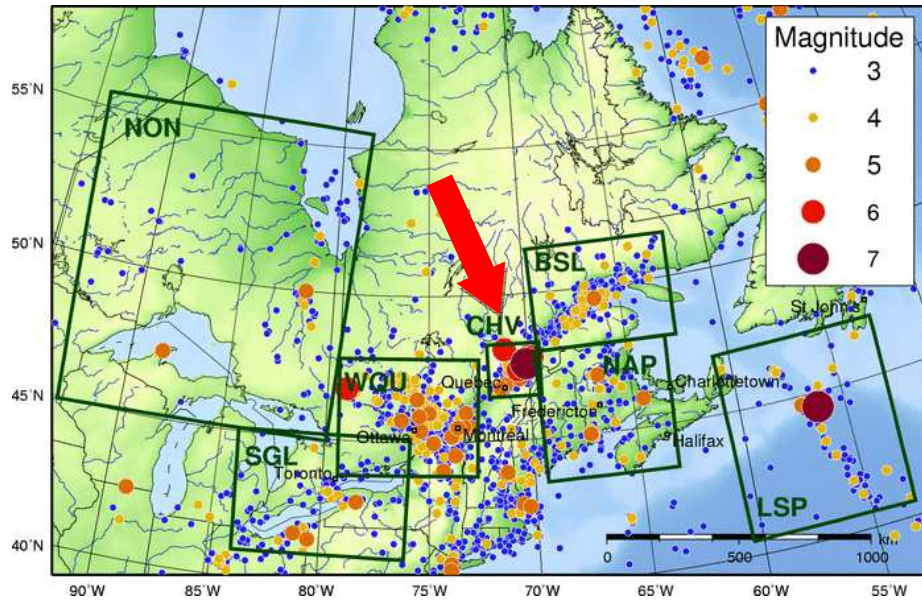
Figure 1 - Charlevoix seismic zone (CHV)

Then, on March 6th of 2005, a magnitude 5.4 earthquake occurred in Rivière-du-Loup, which is located inside the Charlevoix seismic zone. It was strongly felt in the city. Those two earthquakes, and the release of a new seismic hazard map prescribed by NBCC 2005, brought the authorities to request proposals for the seismic retrofit of wings A and B. The non-structural components were excluded from the proposals: only the building's structure had to be studied and retrofitted.

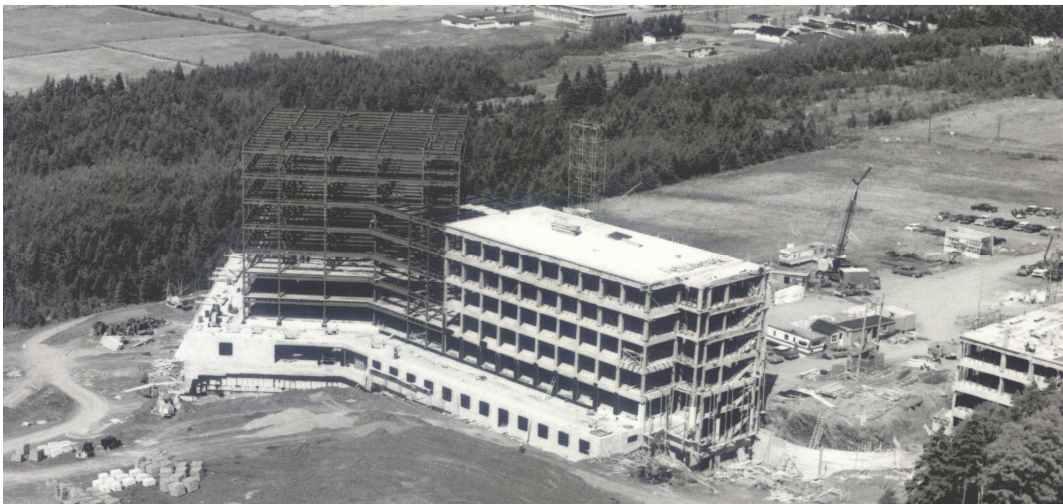
Figure 2 – Aerial view of wings A and B under construction (1968)

Wings A and B of the Rivière-du-Loup hospital were built in 1968. Wing A is made of a 7-stories steel tower built on a 3-level concrete podium (including one level below the soil grade line). Wing B is composed of a 5-stories concrete structure built on a 2-levels concrete podium, including one level below the soil grade line. Also, wing A's steel tower is oriented with a 45 degrees angle from wing B, as shown on Figure 2.

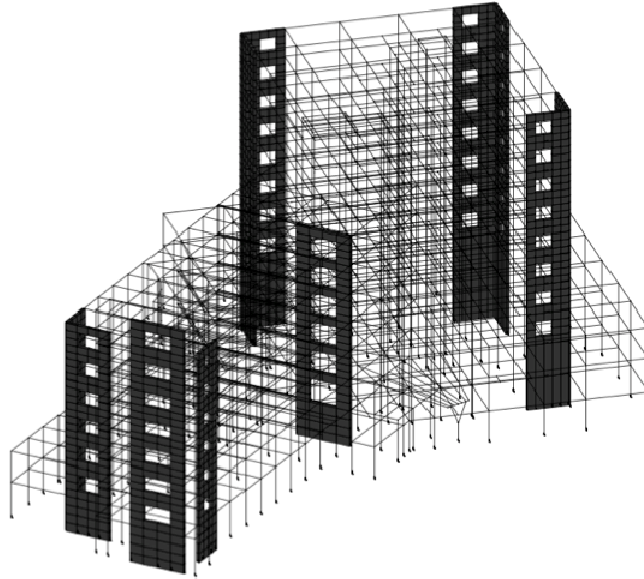
Figure 3 – Seismic retrofit scheme using concrete shear walls

Several seismic retrofit schemes were considered in order to meet the above-mentioned requirements. A solution with concrete shear walls (figure 3) offered a good performance, despite not providing the most damping, but had unacceptable impacts on the hospital operations, both after and during the construction work. The seismic retrofit using concrete shear walls also caused stresses concentrations in the floor diaphragms, which would have required parts of the diaphragms to be strengthened.

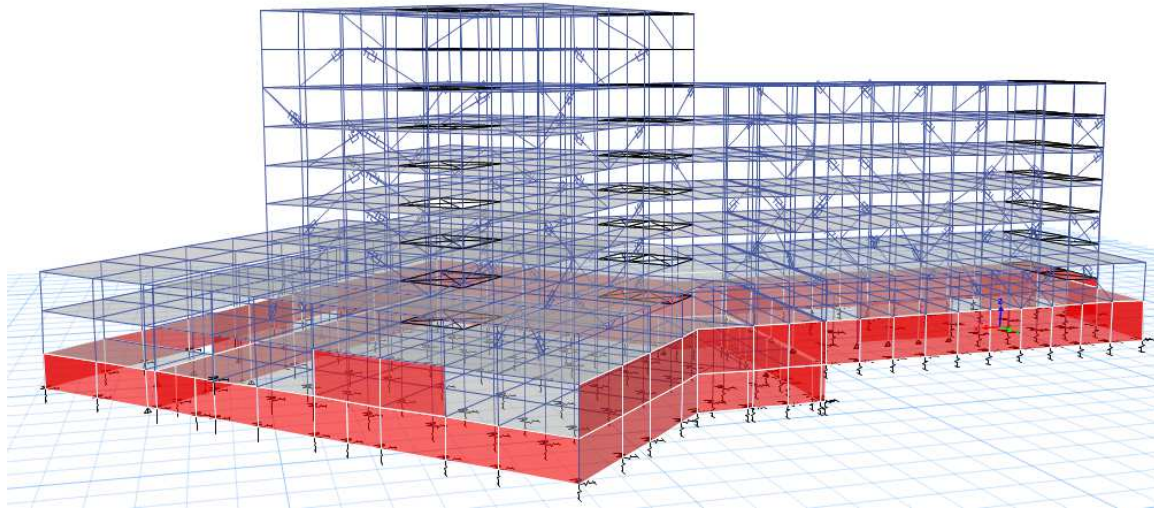
Figure 4 – Numerical model of the structure (Etabs nonlinear)

The slippage mechanism of the friction damper mounted on an elastic brace constitutes nonlinearity. In order to quantify the amount of energy dissipated by this mechanism, which is a function of the displacement, nonlinear response history analysis were conducted on a 3D numerical model in ETABS (figure 4) with friction dampers modeled as a yield force. The numerical modeling of braces equipped with friction dampers is simple: since the hysteretic loop of the damper corresponds to the rectangular loop of an ideal elasto-plastic material, the slip load of the damper can be modeled as a fictitious yield force, using, in this case, a *Plastic(Wen)* type of nonlinear link.

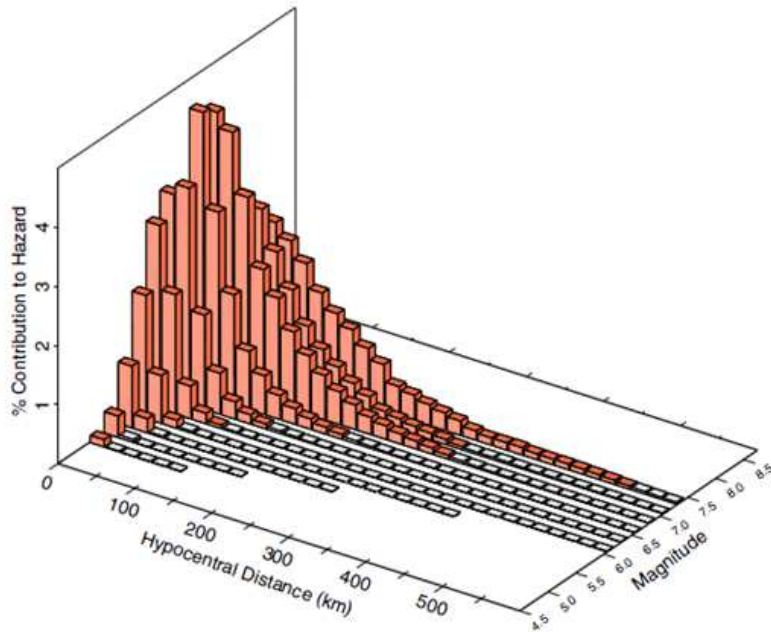
Figure 5 – Deaggregation of the seismic hazard (Regional model, Sa(2.0))

To adequately capture the non-linear dynamic response of the structure retrofitted with friction dampers, nine (9) pairs of orthogonal ground motions were used for the nonlinear time history analysis. In order to properly select the ground motions, the design team requested the deaggregation of the seismic hazard at the hospital site (figure 5). This was performed by the Geological Survey of Canada for a probability of exceedance of 2% in 50 years. The assessment of the contribution to the seismic hazard of both the Historical model and Regional model for each of the spectral ordinates ($S_a(0.2)$, $S_a(0.5)$, $S_a(1.0)$, $S_a(2.0)$) revealed a strong contribution from the Historical model. The choice of earthquake scenarios (magnitude-distance, M-R) was therefore based primarily on the deaggregation of the Historical model, but M-R scenarios from the Regional model were also considered to incorporate the potential adverse effects produced by the differences in the duration and frequency of the dominant seismic motions. The M-R scenarios retained for the ground motions selection were : M6.5-7.0 for $R = 10-80$ km, and M7.0-7.5 for $R = 20-100$ km.

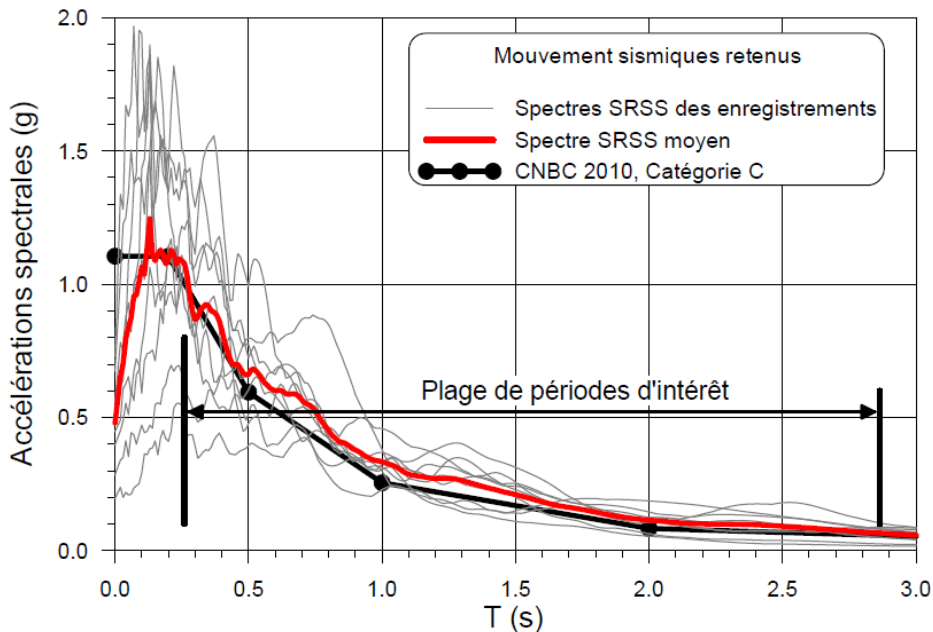
Figure 6 – Response spectrums of the ground motions used for the analyses

The use of 9 pairs of motions was deemed appropriate considering the mass contribution that was found in several vibration modes to the dynamic response of the structure. The ground motions were spectrally matched to the 2010 NBCC, 1:2475 years response spectrum (figure 6). The motion histories were selected and adjusted following the 2010 NBCC provisions, completed with the ASCE 7-10 and ASCE 41 provisions. Those references also served as guidelines for the nonlinear time history analyses.

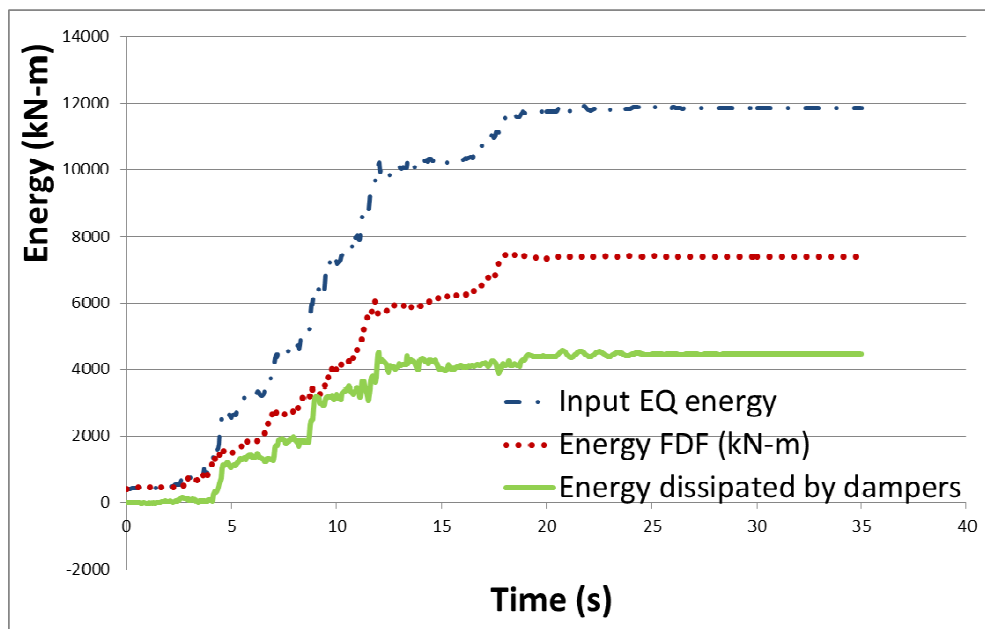
Figure 7 – Time histories of earthquake energy (input and dissipated) for one given ground motion

The nonlinear time history analyses allowed for a comprehensive study of several key features of the implemented retrofit scheme, starting with quantifying the amount of dissipated energy (figure 7). For example, figure 8 shows the hysteresis loop of a 400 kN friction damper under one given earthquake motion. The area of this loop represents the amount of energy dissipated in one full cycle of movement. Nonlinear time history analyses also allowed for the assessment of the floor accelerations at different levels, and the global behavior of the retrofit scheme with respect to the ability of the existing moment frames to provide sufficient centering capacity for various dampers slip load values. In order to study the latter, the displacement history of joints located at various levels were drawn to make sure their permanent offset was reasonable (figure 9).

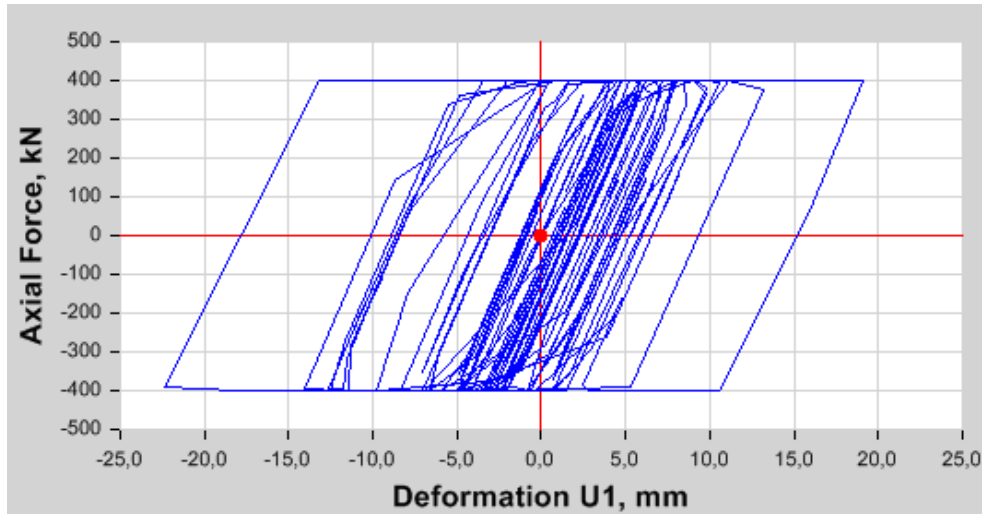
Figure 8 – Hysteresis loop of a 400 kN friction damper under one selected ground motion

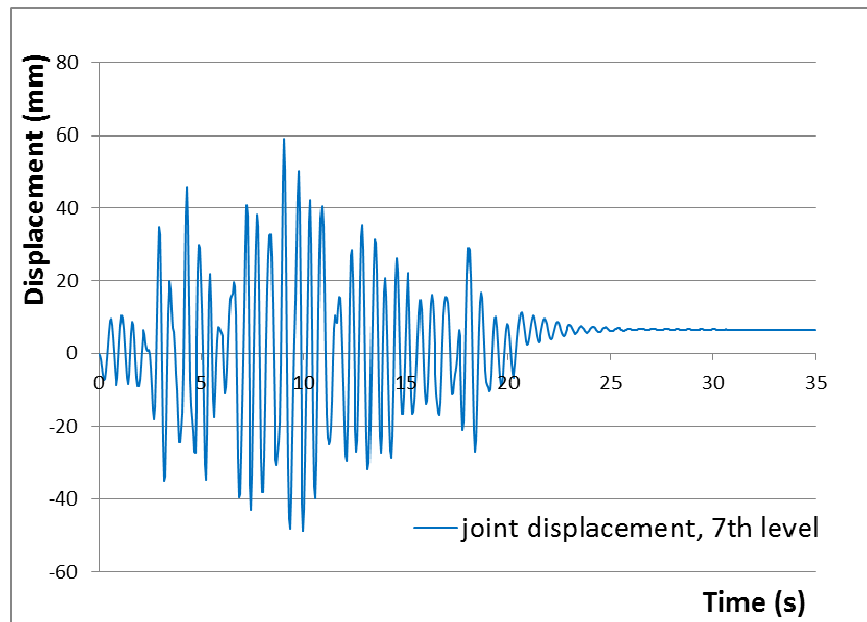
Figure 9 – Time histories of displacement at 7th level of the steel tower

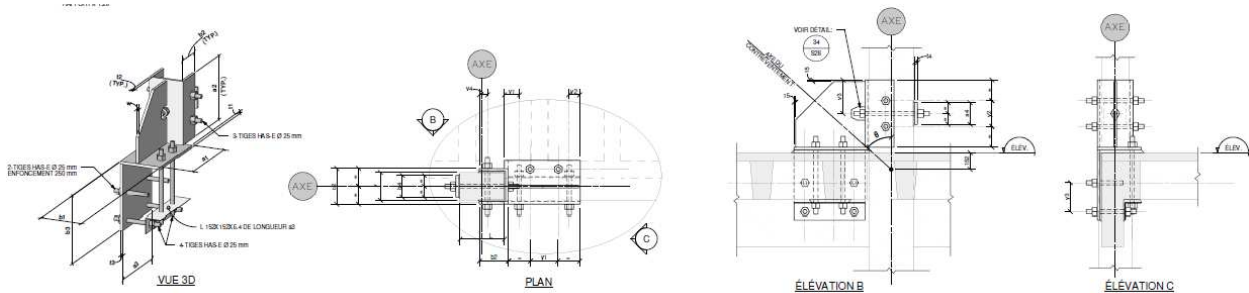
Figure 10 – One of 27 types of brace connection

The construction schedule would not allow for the design of the connections to be made by the contractor, as it would usually be the case. Because of that, and because the concrete frame had many specificities to take into account, the structural engineer designed and modeled all the 27 needed types of connections (figure 10).

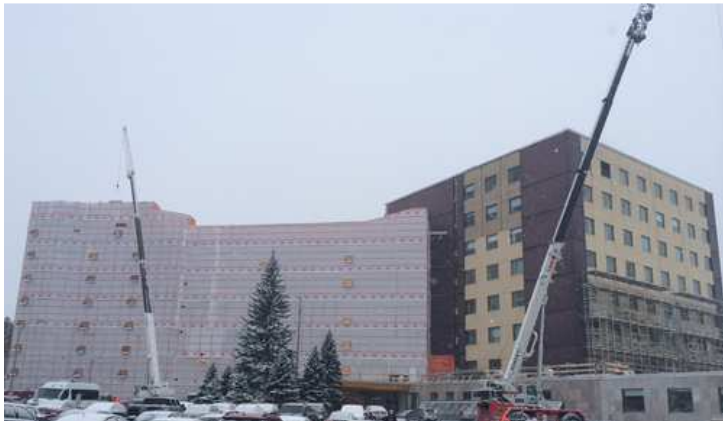
Figure 11 – East side of wing B under retrofit work

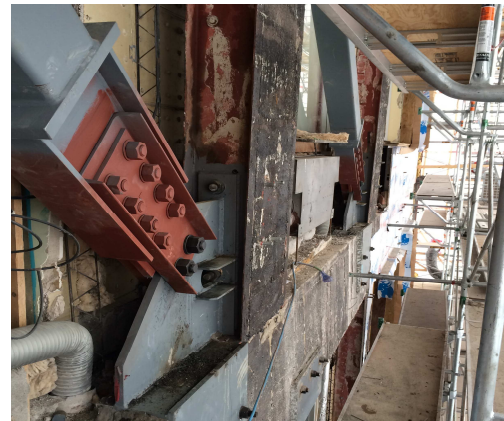
Figure 12 – Installed friction damper
