## OUT-OF-PLANE SHAKE TABLE TESTING OF RETROFITTED URM PARTITION WALLS

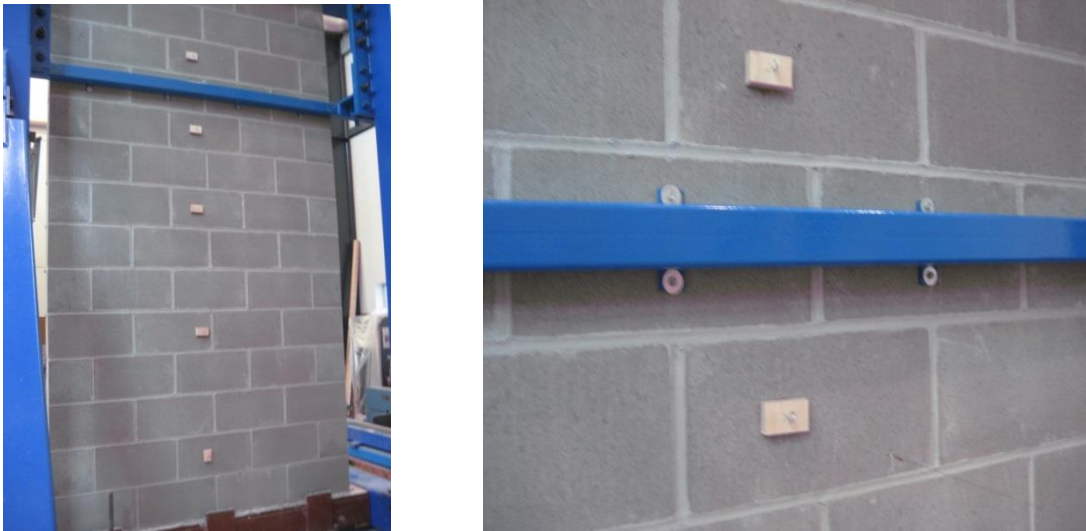
**Fig. 8 – Horizontal Restraint Retrofit**

For the horizontal beam retrofit, the intent of the specimen design was to use the smallest beam possible since the span was very short compared to what would be done in practice. Ultimately a 64x64x4.8 HSS

was placed at the 2/3 height horizontally across the wall, shown in Figure 8. The beam was attached to the wall using eight masonry screws with a diameter of 1/4" and total length of 1-3/4". One design consideration is the placement of the screws, either in the web or the flange of the block. While the flange is more convenient due to the availability of a larger area, it was found that when using a hammer drill a wedge of concrete is broken off inside the core, reducing the total depth of penetration for the masonry screw. It is useful to note that despite this, it did not seem to affect the performance and in fact after significant shaking it was found that the screws were still held tight; this is an issue that merits further investigation.

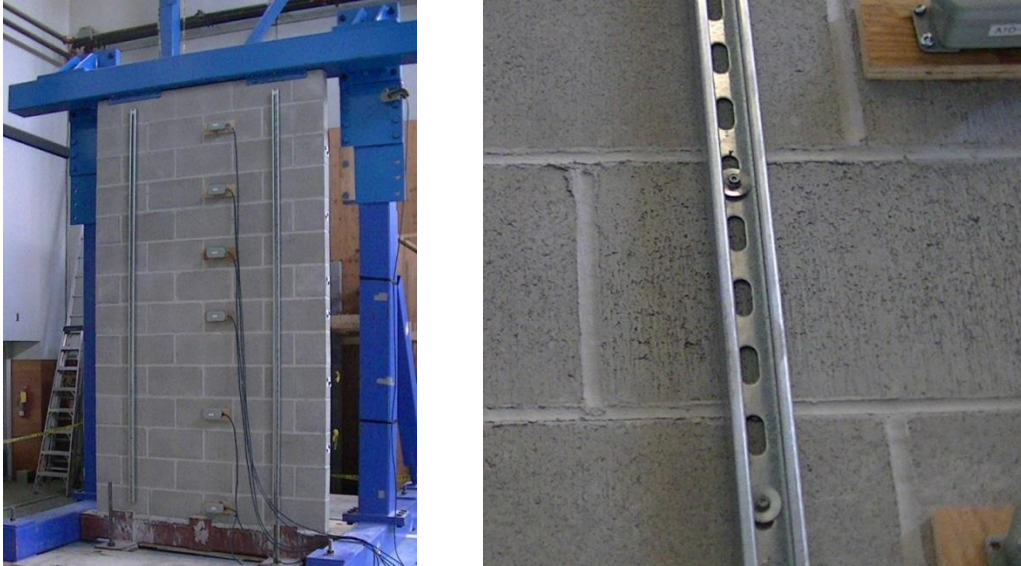
**Fig. 9 – U-Channel Retrofit**

For the U-channel retrofit, a pair of Unistrut™ P1000T sections were used. They were installed with a 1000 mm spacing and attached using masonry fasteners spaced vertically at 300 mm. The U-channels were cut shorter than the full length of the wall, both at the top and bottom to eliminate any restraint effect at the ends of the channel in contact with the top or bottom. The initial design proposed the proprietary end connectors which attach to the floors above and below. Instead it was chosen to cut them short to create a pin effect and have the channel only restrain the wall on its face.

An out-of-plane test rig was used to support the walls at the top; a separate, detachable top beam was fabricated to serve as the top restraint and act as the upper floor. This was a 203 x 203 HSS beam, which allowed for the width of the wall and two 50mm angles to be attached (one on either side). The frame and top angles can be seen in Figure 9.

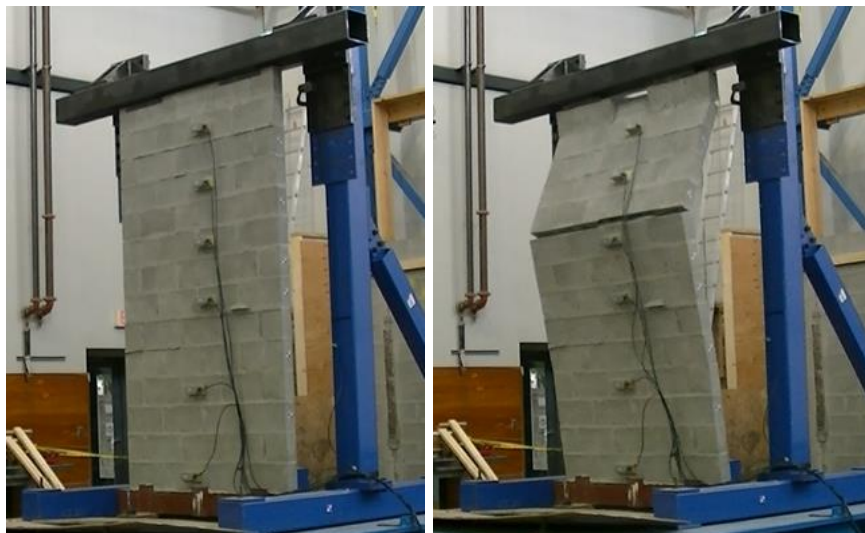
Fig. 1 – Failure Location for Bare Wall

Three tests were done on bare specimens, which were supported at the top using the two angles on either side of the wall and had no additional reinforcement. The behaviour of these walls was all very similar; at the lower intensity tests, the wall cracked near the top third of wall. After this initial cracking the wall begins to move in a pin-pin rocking mode that was restrained at the top by the steel angles. The rocking continues until it reaches a critical displacement after which the wall collapses. It was seen that the bare wall could survive up to 100% of the design level in this rocking mode; collapse occurred at 135% of the design level in the extreme case but this number was not consistent and could not be relied upon. Figure 10 shows the behaviour during the tests, with the crack appearing above mid-height and the pin-pin mechanism. The right side photo is shown just before collapse. In that case a second crack had opened in the top course due to the angle restraint.

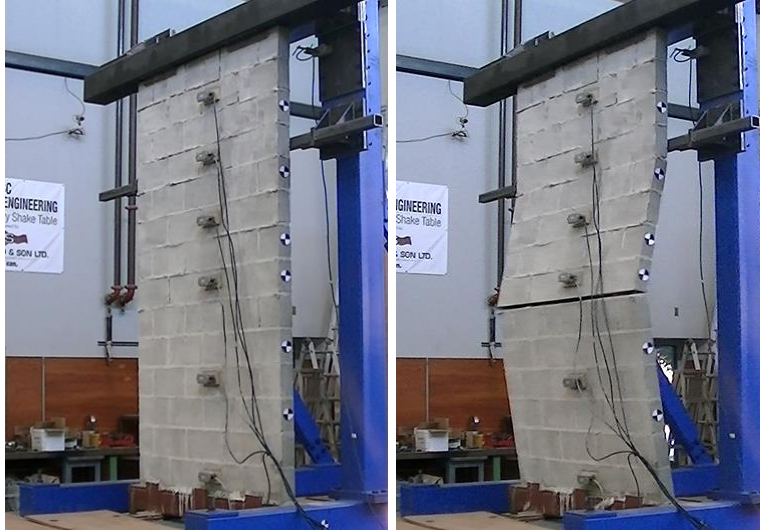
**Fig. 2 - Failure Locations of Horizontal Restraint Wall**

Two tests were done on horizontal restraint specimens. For both tests, the behaviour was the same. The course attached to the beam and those above were undamaged after all runs; the courses below the beam crack about halfway between the basebeam and the HSS beam and fails. It was found that the lower wall failed at 120% of the design level. The performance of the lower section was seen to be worse than the fully unreinforced wall. This is likely due to the fact that the wall is shorter, and is more susceptible to the higher frequencies of the chosen record. The smaller height may also have an impact on the critical displacement of failure. Figure 11 shows the failure mode.

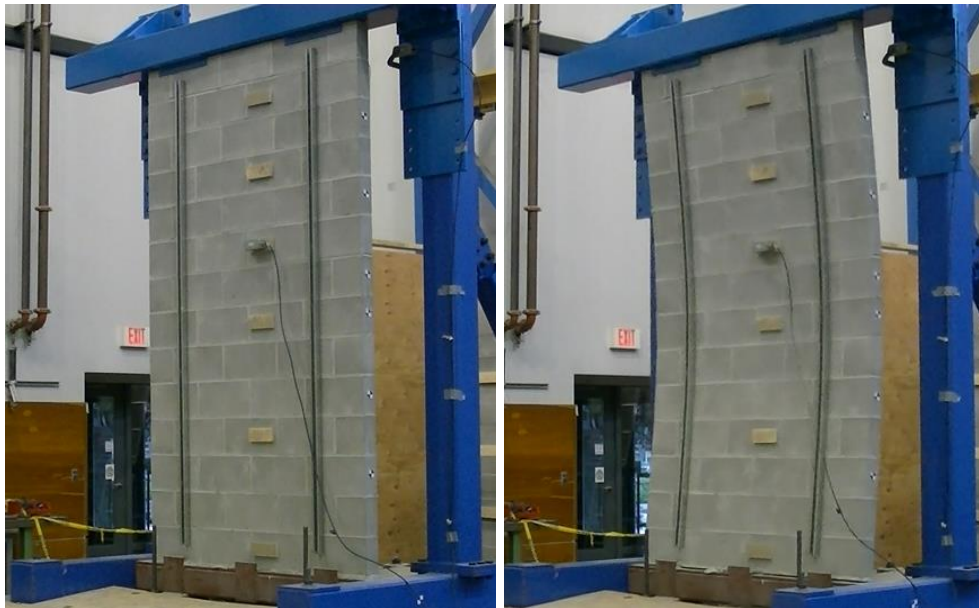
**Fig. 3 – Deformed Shape of U-Channel Retrofitted Wall**

Three tests were performed on the U-Channel retrofit, although in three different ways. The main test was the first one, which used two U-Channels spaced 1000mm apart. The wall survived up to 150% of the design level, with significant displacements at mid-height (up to 110mm). After the final test, each of the masonry screws were checked and all of them were found to be tight.

Two other tests were performed, one on a previously damaged wall and another with only a single U-Channel in the middle of the face of the wall. In the first case, several of the masonry screws were loosened early in the application of the test program, and the wall failed at a lower level (120%). For the second case, the wall failed very early (60%) due to masonry screws failing at the top, and then quickly came apart. Figure 12 shows the behaviour of the system during the tests.

Table 2 presents a comparison of the performance of three of the test specimens. The bare wall is shown to have a significant rocking displacement failure before failure, and therefore a higher test level. The performance is however dependent on the location of the initial crack, which makes it an unreliable mechanism. It is also worth noting that the highest acceleration was relatively low compared to the other two retrofits. Peak displacements were taken from the last cycle before failure, at the midheight of the wall. The acceleration time histories were filtered between 0.1 and 25Hz.
