## SEISMIC EVALUATION AND RETROFIT OF REINFORCED CONCRETE BUILDINGS

Some aspects of the ASCE 41-13 evaluation and retrofit guidelines are discussed. Experimental studies on thin walls containing lap splices at their bases are summarized, emphasizing the poor seismic performance of this type of construction. The effects of wall thickness and reinforcement detailing of deficient reinforced concrete walls are also presented. The improved performance of deficient shear walls due to different retrofit techniques are illustrated. The results of an experimental study indicate that the concrete may crush in thin walls at low values of uniform compression strain, and unlike a tied column, a thin concrete wall may suddenly lose the complete axial load-carrying capacity. Experimental results are presented, demonstrating the effectiveness of transverse prestressing applied to poorly detailed columns. The response of poorly detailed concrete frames, retrofitted by different types of lateral bracing is presented. The results of the seismic evaluation of a 12-storey concrete building that was damaged in the 2010 Haiti earthquake are described.

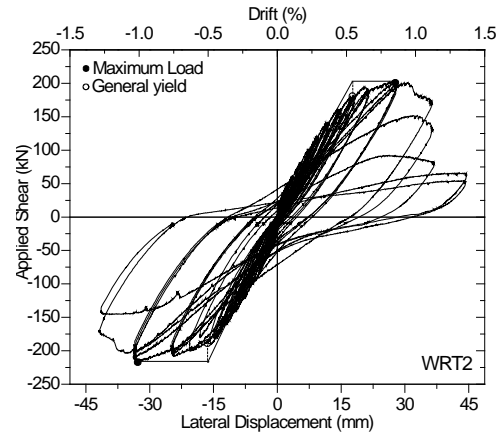
(b) Response with CFRP retrofit

**Retrofit with carbon-fibre wrap (CFRP)** – CFRP wrap was applied with epoxy over a height of 1.5 times the length of the wall region from the base of the wall to provide some confinement to the lap splice region (Fig. 3(a)). Above this region, CFRP strips were epoxied to the wall to provide additional shear reinforcement. The applied lateral load versus tip deflection response of retrofitted Wall WRT2 is shown in Fig. 3(b). The CFRP retrofit improved the splice strength, enabling the development of yielding such that a displacement ductility of 2.0 was achieved. This retrofit technique provides some improvement and minimizes the disturbance to the operations of the structure during retrofit.

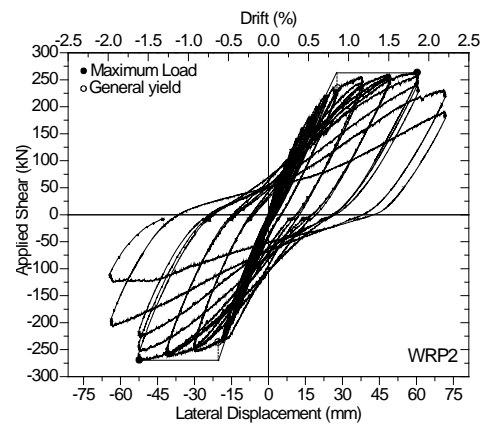
(d) Response with FRSCC splice retrofit plus CFRP wall retrofit

**Retrofit with fibre-reinforced self-consolidating concrete (FRSCC) and CFRP** – FRSCC sleeving was used over the height of the lap splices as shown in Fig. 3(c). Additional vertical bars were drilled into the foundation block and anchored with epoxy. The other ends of these bars were anchored with headed bars. The FRSCC contained additional confinement reinforcement and was attached to the existing wall by threaded bars passing through the wall. The CFRP strips outside of the lap splice region provided additional shear reinforcement. The flexural reinforcement exhibited yielding and the confined lap splice performed well. A more ductile response was achieved than with the CFRP retrofit. This retrofit resulted in improved response and the reinforced concrete sleeving was achieved by replacing some concrete at the wall ends so that the length of the wall was not increased.

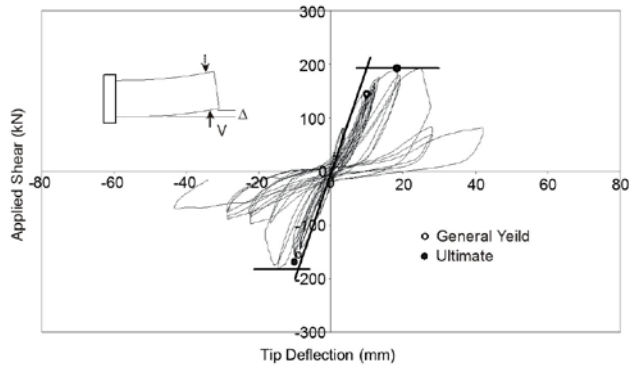
(c) Shear-deflection response

Figure 4 shows the details of a wall that was tested to investigate a proposed retrofit of an existing building, built in the 1960's, in Berkeley, California (Mar et al. 2000). Wall specimen W1 was 300 mm thick and contained lap splices at the base of the wall (see Fig. 4(a)). The concentrated reinforcement at the ends of the wall consisted of 2-25M bars with a 900 mm (36d<sub>b</sub>) lap splice at the base of the wall. The 10M transverse reinforcing bars had a spacing of 350 mm and were anchored by 90° hooks (see Fig. 4(b)). The concrete compressive strength was 25.9 MPa and the yield strengths of the 25M and 15M bars were 423 and 453 MPa, respectively. The wall was tested under reversed cyclic loading (Paterson and Mitchell 2003). Wall W1 achieved a displacement ductility of 1.5 and the shear versus displacement response was pinched (see Fig. 4(c)). Although yielding of the reinforcement occurred, the yielding was concentrated in the dowel bars at the base of the wall resulting in a very short plastic hinge length. The failure that limited the ductility was due to bond splitting along the lap splices and some significant shear cracking was also observed. Tests were also carried out with the lap splices located above the base to simulate the situation where a lap splice is present at the second or third floor level of the building. These specimens behaved much better with a displacement ductility of 4.0 and with little signs of pinching in the response.

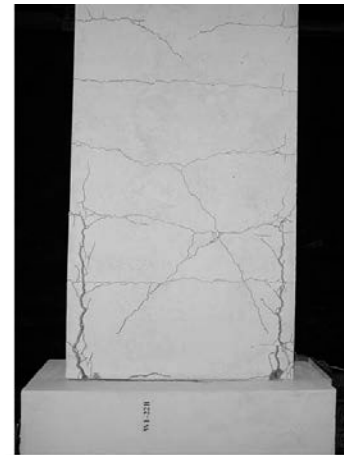
(d) Splice distress and shear cracks

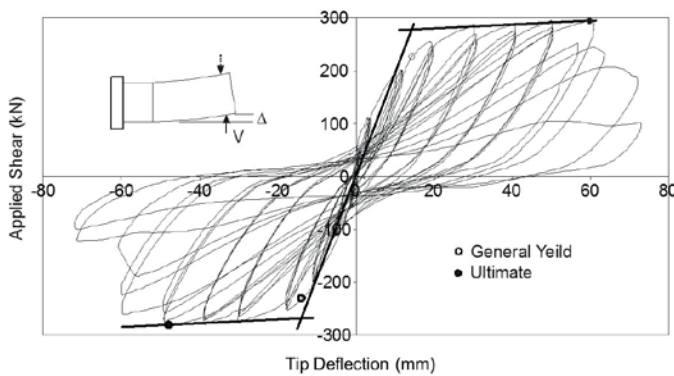
(c) Shear-deflection response

For the retrofit, a reinforced collar was constructed on the sides of the wall over the full length of the lap splice (see Fig. 5(a)). Headed reinforcing bars were used to provide adequate anchorage of the added longitudinal and transverse reinforcement bars in the limited space (see Fig. 5(b)). Headed bars were also installed through the thickness to ensure composite action between the new and existing reinforced concrete. Headed reinforcing pins were grouted into the ends of the wall to improve the confinement of the 90° hooks which anchored the transverse reinforcement (see Fig. 5(a) and (b)). The use of the pins at the ends of the wall enabled additional confinement without the need to increase the length of the wall. Strips of carbon fibre wrap were epoxied to the wall and anchored with headed bars drilled through the wall thickness to increase the shear strength.

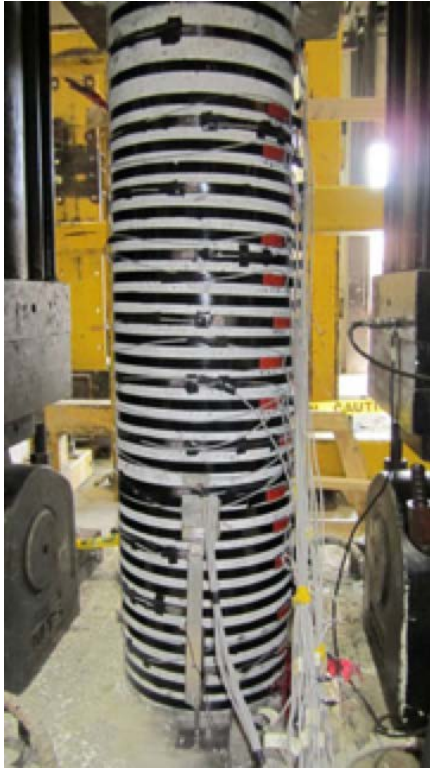
(a) Typical retrofitted column

A new seismic retrofit methodology was developed to improve the lack of concrete confinement and shear resistance in older building and bridge columns through transverse prestressing and the associated active lateral pressure. Full-size column specimens with circular, square and rectangular cross-sections were tested under simulated seismic loading. The transverse prestressing improved the confinement pressure, which improved column deformability while also improving shear resistance provided by concrete and transverse steel. Active lateral pressure delayed the formation of diagonal tension cracks significantly, potentially eliminating the need for post-earthquake repair work (Saatcioglu and Yalcin 2003). The same technique was extended to include columns reinforced externally by high-strength packaging straps, with some prestressing. This method proved to be less labor intensive especially for smaller size columns, where the straps can be placed with smaller bend diameters. Fig. 8 illustrates the performance of a test column (Sabri 2013).

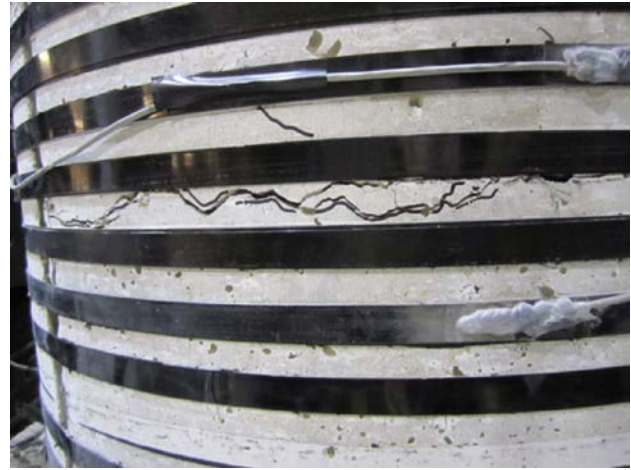
(b) Critical region at 6% lateral drift

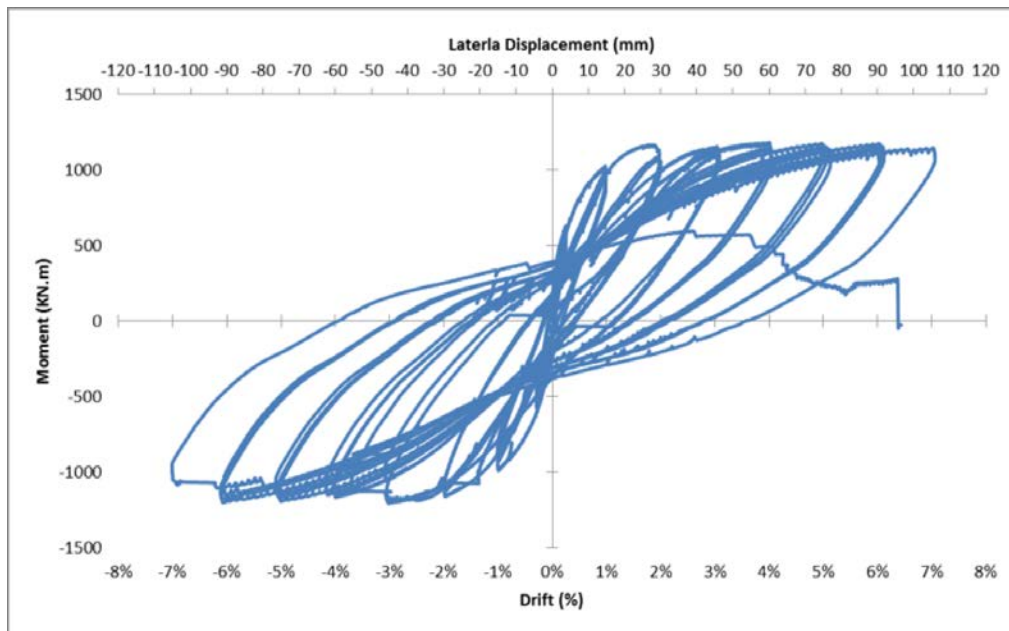
(c) Hysteretic response

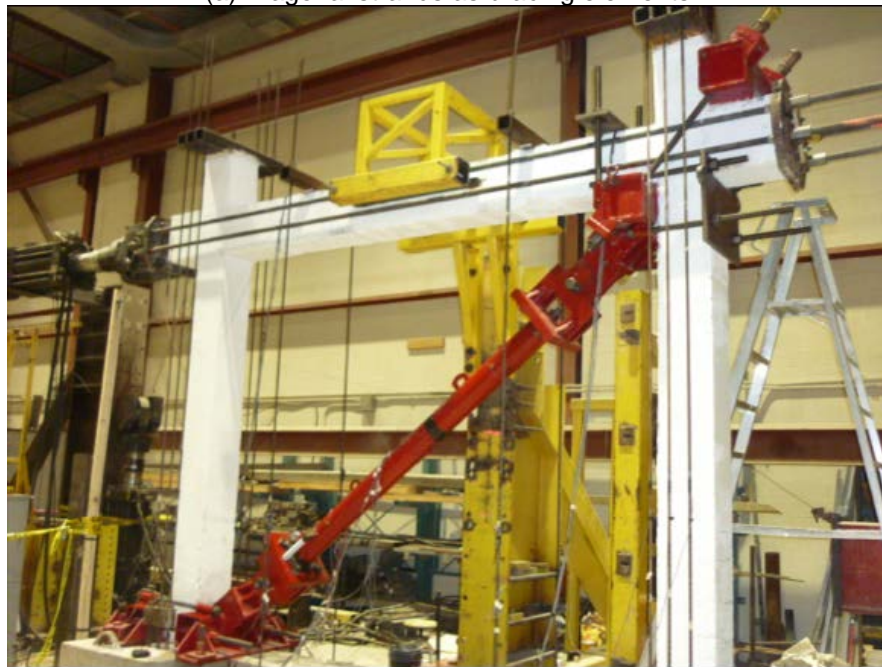
(b) Buckling restrained brace

The second retrofit system is a new buckling restrained brace (BRB) with a circular core and specially designed end attachments that allow inelastic deformations while continuously supporting the bar against buckling (see Fig. 9(b)). The new BRB was found to offset lack of sufficient seismic force resistance in older concrete frame buildings, with significant drift control to protect non-ductile frames. Different types of steel cores have been tested with different steel grades and elongation capacities. It was found that stainless steel core with higher strength and 40% elongation capacity provided the best alternative for both strength enhancement and lateral drift control while dissipating seismic induced energy (Al-Sadoon, 2015).

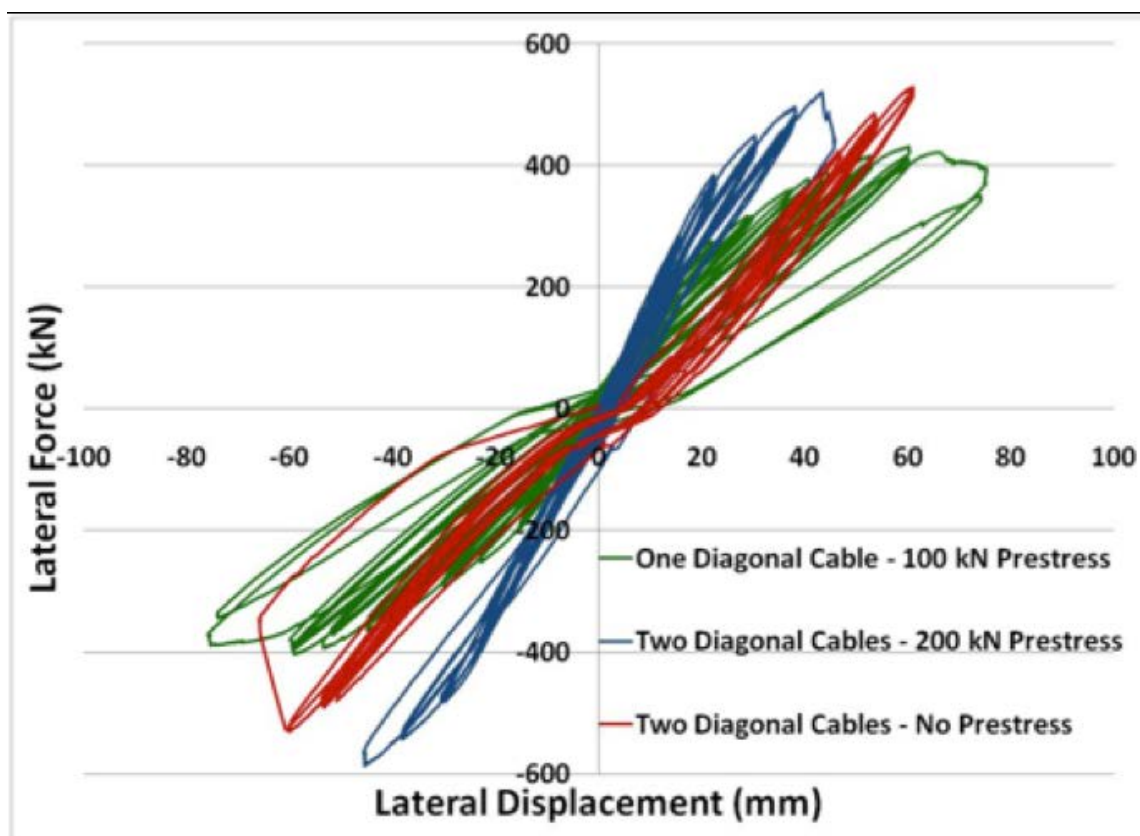
**Fig. 10 - Hysteretic response of reinforced concrete frames with steel strands as tension braces.**

Both systems provided significant strength enhancement and drift control. In the case of bracing with strands, the required amount of steel strands depended on the seismicity of the region and the level of drift control required. Yielding of the strands resulted in energy dissipation, but increased pinching of the hysteresis loops upon load reversals, until the deformation in the opposite direction increased to offset the plastic deformation experienced in the strands. Increased area of steel resulted in increased lateral strength, and prestressing the strands generated increased rigidity and more effective drift control. Fig 10 shows the comparison of hysteretic relationships of three frames with different number of strands and level of prestressing (Molaei, A. 2013).

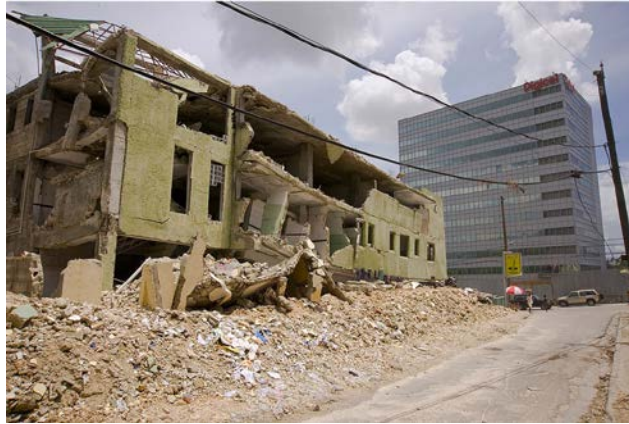
**Fig. 11 - The Digicel Building in the background and the damaged “Hopital de Turgeau” in the foreground (both buildings completed just prior to the earthquake).**

The 2010 Haiti earthquake caused massive damage to buildings that left the capital city Port-au-Prince in a state of emergency resulting in an estimated death toll of more than 300 000. The 12-storey reinforced-concrete Digicel building, located in a neighbourhood that was almost completely destroyed, suffered repairable damage in the main building (see Fig. 11). This good behavior could be explained by the use

of numerous shear walls as seismic force resisting system. However, on close inspection, it was found that beams and columns suffered significant damage only in the upper 6 storeys.

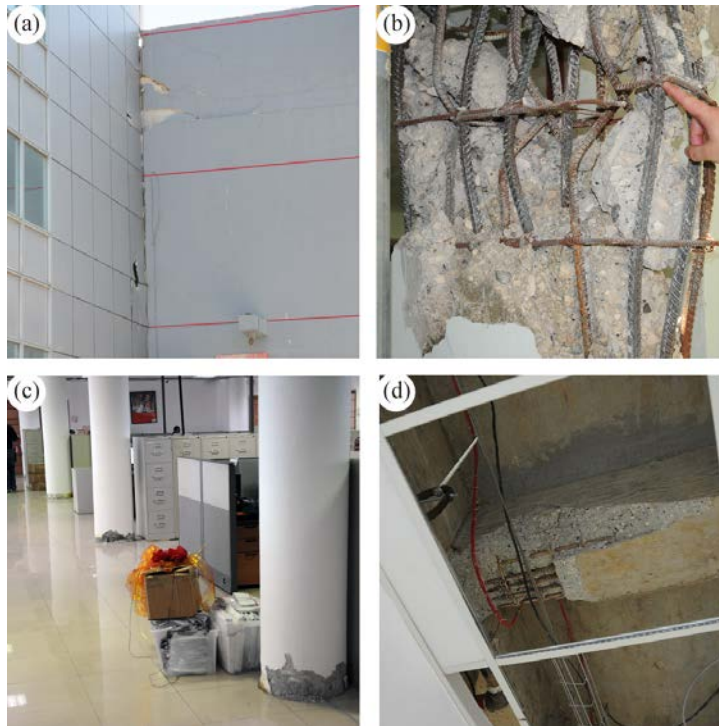
**Fig. 14 - a) Evidence of pounding between the high-rise and low-rise parts; b) Damaged parking-structure column; c) 10<sup>th</sup>-storey columns on axis 5; d) Damaged beam attached to a wall.**

Flexural damage to beams and columns was observed in the top storeys in the longitudinal direction. From the 7th storey up, most columns exhibited apparent concrete crushing (Fig. 14) due to large member rotation demands. Light concrete crushing, bond splitting, and even rebar buckling were observed in many beams directly connected to shear walls. The most damaged beams were those connecting to the east U-shaped wall on axes 5 and 6 in the top four storeys.
