SEISMIC EVALUATION AND RETROFIT OF MASONRY BUILDINGS

ABSTRACT: A review of seismic evaluation procedure outlined in ASCE41-13 is presented with emphasis on masonry buildings. Research projects conducted on seismic performance and retrofit of masonry walls are summarized. Retrofit techniques developed for masonry load bearing walls, consisting on surface-mounted carbon fibre reinforced polymer (CFRP) sheets, with CFRP anchors, as well as with stainless steel sheet anchors are presented. It is illustrated that the use of CFRP sheets is an effective retrofit technique to suppress shear distress in masonry walls. The use of appropriate anchors, providing tension ties to adjoining members can improve flexural wall resistance significantly. These techniques are able to improve both strength and deformation capacities to levels that can meet the required performance objectives outlined in ASCE41-13. The retrofit of unreinforced masonry (URM) infill panels with CFRP diagonal elements, properly anchored to the enclosing frame members can result in strength and stiffness enhancements in seismically deficient non-ductile reinforced concrete frames. The out-of-plane performance of URM walls a

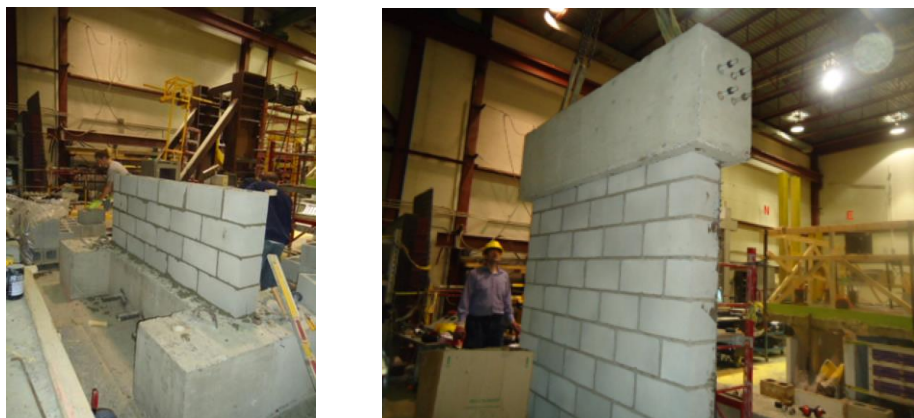
Fig. 3 – Masonry walls during construction

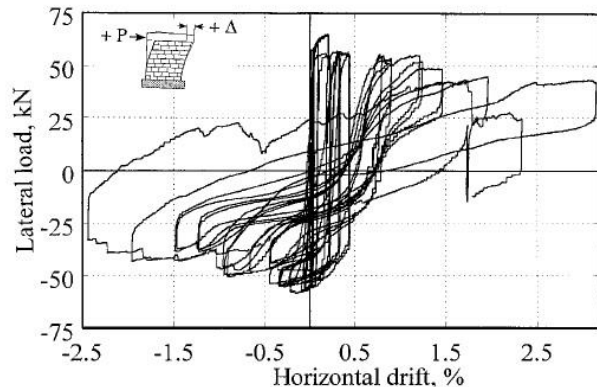
Fig. 6 – Hysteretic relationship of URM Wall

The URM wall behaved in a combination of rocking and sliding mode. The sliding developed in one direction during the push cycles at an ultimate force of 65 kN. Rigid body rocking was observed with slight sliding when the wall was subjected to pull cycles at an ultimate force of -59 kN. The wall exhibited relatively large deformations with minor strength decay before failure. Rocking and sliding was observed to occur along the bed joint above the second course of blocks. Figure 5 illustrates the observed rocking and sliding behaviour schematically. Rocking started at about 0.8% lateral drift cycles. The hysteretic behaviour is shown in Fig 6, indicating limited strength and deformability.

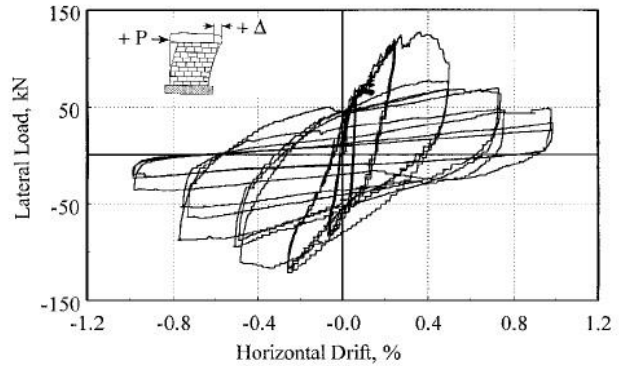
Fig. 8 – Hysteretic Relationship for PRM Wall

The second wall in the pair was unreinforced partially reinforced masonry (PRM) wall. It had the same geometry as the URM wall, details of which are shown in Fig. 4(a). The reinforcement details of the wall are given in Fig. 7. The PRM wall was tested by following the same loading protocol under incrementally increasing lateral deformations under a constant axial compression of 100 kN. The hysteretic relationship shown in Fig. 8 indicates symmetric and relatively fat hysteresis loops. The wall developed higher strength than the companion URM wall, but suffered from shear failure. Diagonal compression struts resulted in progressive crushing of masonry units, leading to early strength decay. The deformation capacity, prior to developing significant strength decay was approximately 0.4%. During testing, cracks appeared along vertical and horizontal mortar joints, between the diagonal corners, forming a stair-step pattern at about 50% of the wall capacity. The vertical reinforcement did not yield and the wall could not develop its flexural capacity due to the crushing of diagonal compression struts. The wall in-plane capacity was limited to approximately 120 kN, after which gradual crushing of the masonry was observed.

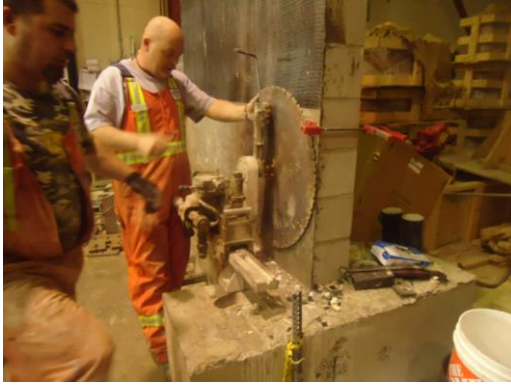
a) Cutting of the foundation concrete

Fig. 11 Implementation of Ductile Stainless Steel Sheet Anchors

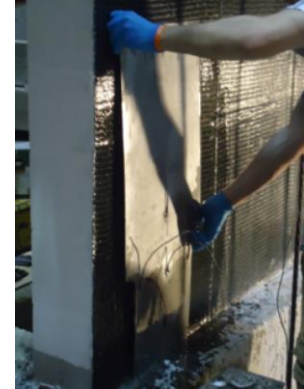
c) Anchor Placement

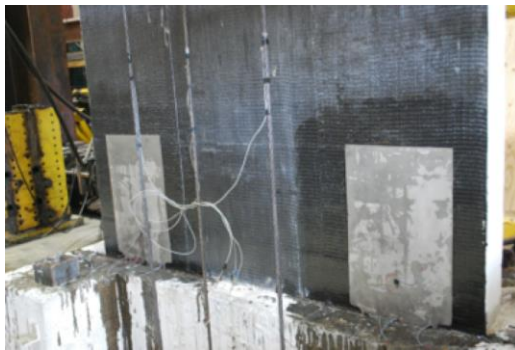
d) Anchors on the Wall Surface

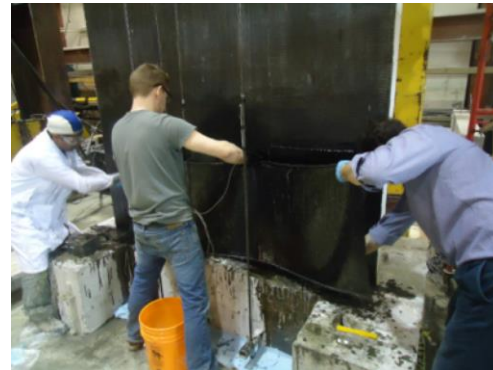
e) Anchors covered by a Layer of CFRP

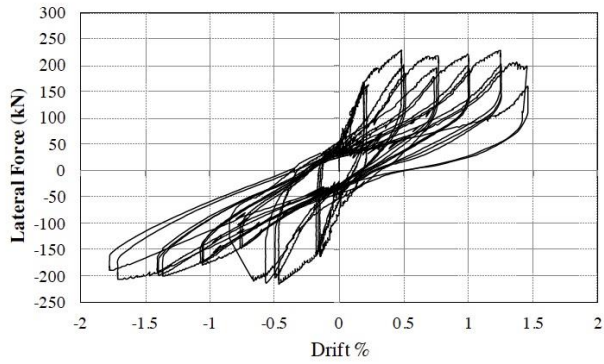
a) Hysteretic Force-Deformation Relationship

Fig. 12. – Recorded Hysteretic relationships for Retrofitted URM Wall

The application of CFRP sheets completely eliminated diagonal tension cracks and prevented shear failure. The application of the steel sheet anchors provided the required tension reinforcement between the foundation and the wall panel, and transferred tensile forces from the foundation to the vertical carbon fibres in CFRP. This resulted in substantial flexural capacity. The wall behaved in a ductile flexural mode. The steel sheet anchored yielded and developed very high elongations without experiencing tension rupturing. However, load reversals caused local buckling of the anchor sheets in compression. This resulted in pinching of hysteresis loops. The hysteretic relationship recorded during the test is shown in Fig. 12(a). As can be seen, relative to the unreinforced URM wall, there was a four-fold increase in lateral load capacity, with increased ductility. The test was stopped because the actuator stroke capacity was exceeded in the push side. It was then decided to continue the test with the application of pull cycles only up to 4.2% lateral drift ratio, as shown in Fig. 12(b), at which level the stroke capacity of the actuator was exceeded in the pull direction as well. There was no strength degradation observed during the test.

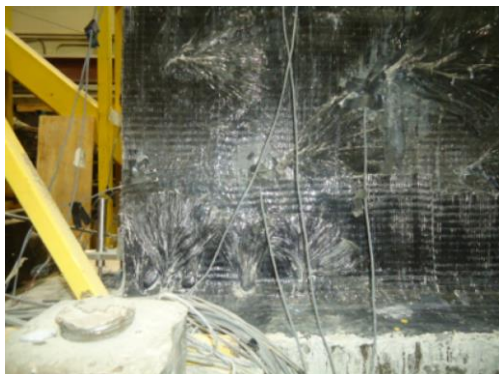
d) Close up View of Installed CFRP Anchors

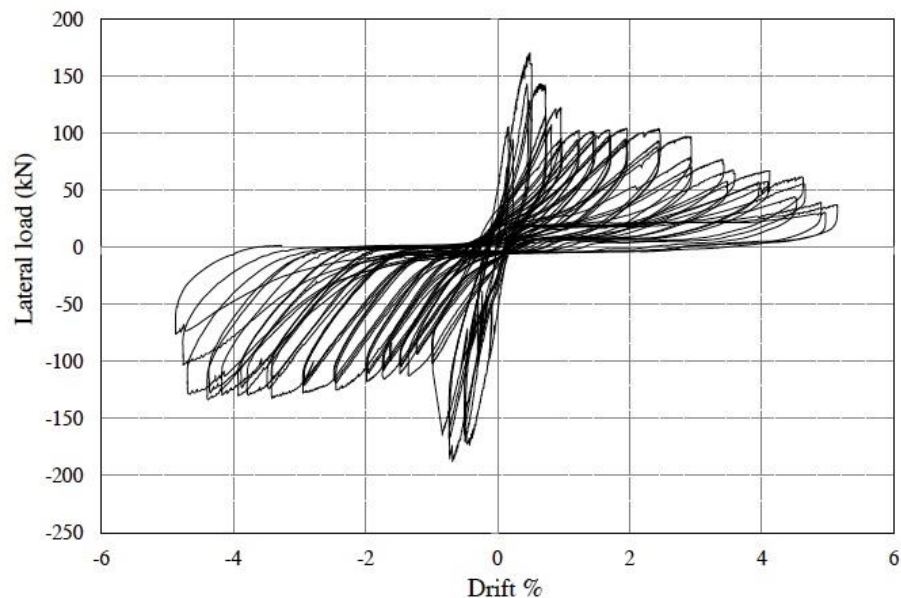
Fig. 14 – Hysteretic Relationship of Retrofitted PRM Wall

The wall reached its maximum lateral load resistance of 165 kN and 174 kN in push and pull during 0.5% drift cycles. At this stage of loading the internal steel reinforcement yielded. The lateral load capacity was limited by debonding of the FRP from the foundation, followed by the pull-out of the extreme tension

anchors from the foundation. Pull-out of the remaining CFRP anchors was observed during the subsequent 0.75% drift cycles in the push direction. This resulted in a drop of lateral load resistance to 138 kN. The wall continued resisting increased force resistance during the pull cycles, reaching 182 kN at 0.75%. However, the CFRP anchors on the tension side started pulling out at about 1% pull cycles and the load dropped to 120 kN. The deformation cycles at 2.5% drift resulted in masonry toe crushing near the east end when the load was in the push direction. The internal #15M bars and the compression resistance of masonry resulted in reduced wall capacity until after 4% lateral drift. The hysteretic relation recorded during the test is shown in Fig. 14. It was observed after the test that some of the CFRP anchors had not been fully inserted to have the full required 100 mm of embedment depth, hence did not develop their full capacities.

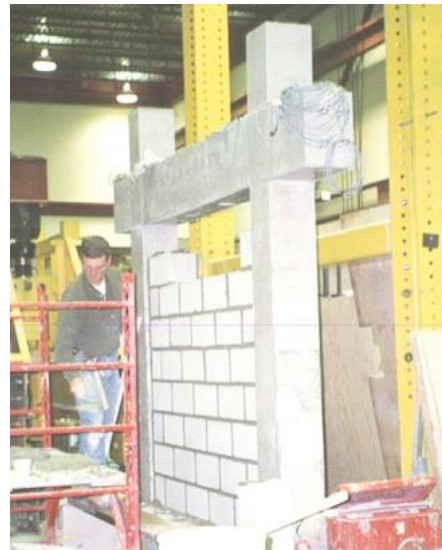
Fig. 15 – Infilled Frame (BL-1), (a) Geometric Details, (b) Wall under Construction

Another experimental research project was conducted at the Structures Laboratory of the University of Ottawa to improve the performance of non-ductile reinforced concrete frames with concrete block masonry infill panels (Saatcioglu et al., 2005). Three half-scale reinforced concrete frames were designed on the basis of the ACI 318 (1963) Building Code to simulate older existing building frames. The frames were constructed and the masonry walls were built to be tested under uniformly distributed gravity loads and incrementally applied lateral deformation reversals. The first specimen (BL-1) was built to reflect the majority of existing buildings constructed prior to the 1970's, with a gravity-load designed frame. Figure 15 illustrates the details of the specimen. A professional contractor was hired to build the masonry infills to implement the actual practice in industry. Two additional companion specimens were built for retrofitting with CFRP sheets. Two aspects of the retrofit strategy were of concern; i) the amount and arrangement of CFRP sheets and ii) the possibility of debonding of sheets and measures against them. It was decided to retrofit one of the walls (BL-2) with two layers of CFRP sheets per face, covering the entire wall surface, where each layer was oriented such that the fibers were parallel to one of the diagonal as shown in Figure 16(a), and the other layer was oriented to have the fibers parallel to the opposite diagonal. This resulted in four layers of sheets, two per wall face. The diagonal orientation of fibers was selected to increase their efficiency since their primary function was to resist diagonal tension. The other specimen was retrofitted with diagonal strips of CFRP sheets, creating an X pattern, as illustrated in Figure 16(b). Two sheets of CFRP were used on each side, one sheet along each diagonal, and the other

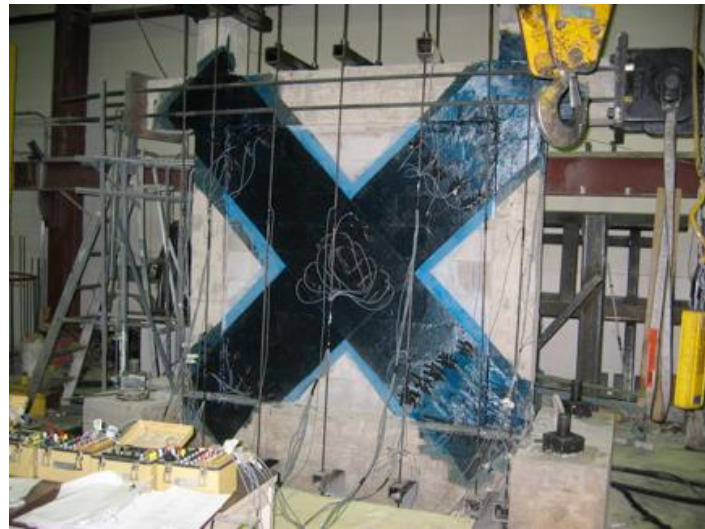
Fig. 16 – FRP Retrofitted Walls, (a) Specimen BL-2, (b) Specimen BL-3

along the opposite diagonal. Two additional strips were used on the other side of the wall, creating symmetric retrofitting, resulting in a total of four strips, two in each direction. The strip width was equal to 625 mm.

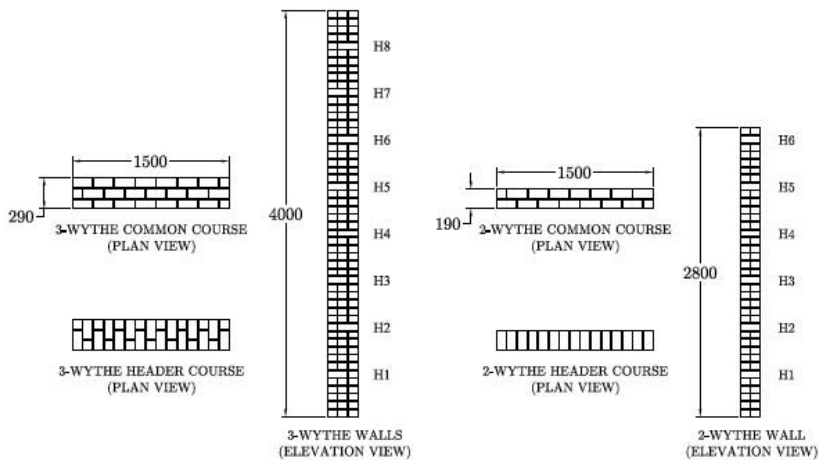
Fig. 19 Wall Geometry (Penner 2014)

A comprehensive experimental and analytical research project was conducted at the Earthquake Engineering Research Facility (EERF) of the University of British Columbia (Penner 2014; Penner and Elwood, 2015a; Penner and Elwood, 2015). The objective of research was to assess the dynamic one-way out-of-plane bending response of URM walls connected to flexible supports. Full-scale shake table tests were conducted with varying support flexibilities. A total of five wall specimens were constructed and tested. Figure 19 illustrates the wall geometry and Fig. 20 shows a typical wall specimen prior to testing. The walls were tested using the single degree of freedom shake table in the EERF. The tests were conducted using two ground motion records, with one motion selected for significant long period spectral response (recorded during the February 22, 2011 Christchurch Earthquake) and the other for a dominant short-period spectral response (recorded during the October 18, 1989 Loma Prieta Earthquake).

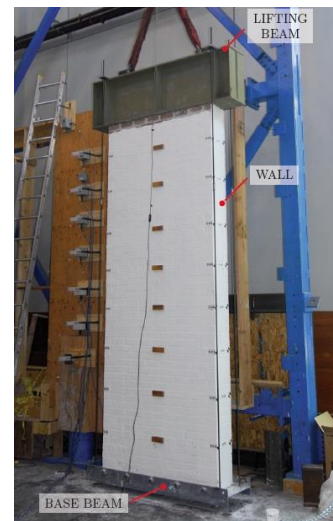
Fig. 20 Typical Wall Specimen Prior to Testing (Penner 2014)

The wall specimens were supported through coil springs at the top and bottom to simulate the flexibility of floor diaphragms. The test variables included diaphragm stiffness and wall height. Walls were first subjected to cracking ground motions with rigid diaphragms. They were then tested to failure with flexible diaphragms. All walls sustained horizontal cracks at about their mid-heights. The ground motion intensity varied with boundary conditions. The lowest collapse condition was obtained under 60% of the as-recorded amplitude, while the highest was about twice this level. Flexible diaphragms resulted in higher motion intensities. The wall tested with rigid diaphragms showed lowest intensity at collapse. This wall also experienced the highest rocking prior to collapse. The walls with a flexible top diaphragm and rigid bottom diaphragm showed virtually no rocking until collapse, though they withstood the highest intensity of ground motion. The force demands at the top and bottom in stable runs were about 50% higher than those predicted by the use of the spectral acceleration of the input motion and the period of the system. Demands on the bottom connection were consistently higher than those on the top connection.
