Seismic and Performance Monitoring Instrumentation on the Lions Gate Bridge

Jason Dowling¹, Yavuz Kaya², Eric de Fleuriot¹, Kent Hodgson³

¹ Structural Engineer, Associated Engineering, Vancouver, BC, Canada.

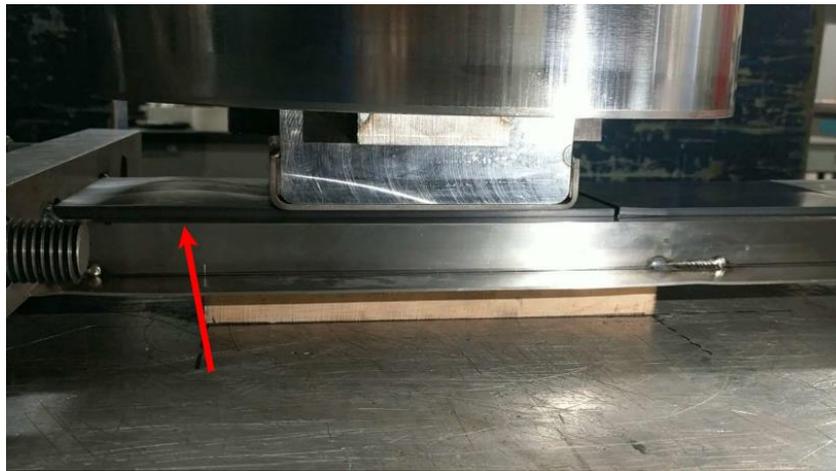
Figure 7. Testing a UHMWPE specimen to buckling failure.

The sliding surface material included in the bearings installed in 2001 was PTFE. The PTFE slid on stainless-steel, but at the time of the design of the current bearing replacement, the PTFE had completely worn away in many locations, resulting in the stainless-steel sliding directly on the mild steel of the bearing assembly. During the new bearing design, three new materials were considered in place of the PTFE. The new materials were UHMWPE variants, similar to materials used in mechanical bearings or in other demanding environments. As these materials were not used in such bearing applications in the region, a testing program was devised to demonstrate their suitability. The bearing materials were tested systematically, to failure, as can be seen in the example test shown in Figure 7. As a result of the testing program, a solid-lubricant-filled UHMWPE material was selected and installed in the new bearing assemblies.
