## Base Isolation Seismic Upgrade of a Heritage Building at Lord Strathcona Elementary School

Keywords: seismic upgrade, base isolation, heritage building, 3D non-linear analyses, earthquake ground motions

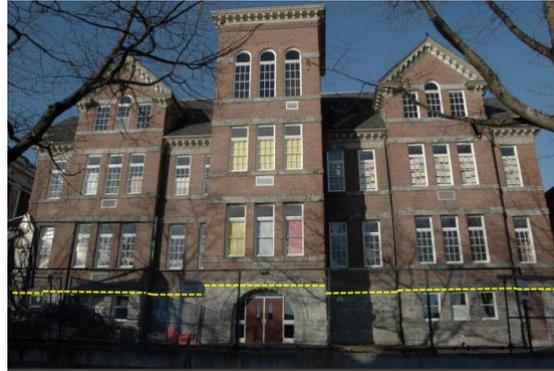
*Figure 2. Basement, two storeys plus attic heritage classroom building; level of seismic isolation plane shown by dashed line.*

The isolation scheme developed had the isolation plane at the upper level of the basement below the main floor and just above the windows, (not at the ‘base’ below the foundations); see Figure 2 for an exterior view of the building and the location of the isolation plane.

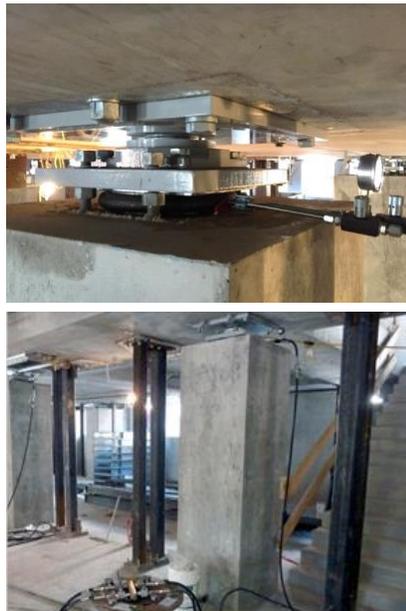
Figure 10. a) View of slider during jacking (left, top) b) Slider location atop column, shoring in place (left, bottom) c) Force-Deflection summary after load transfer complete.

The jacking created a separation plane below the new concrete slab in order to decouple the upper portion of the building from the lower portion. Hydraulic jacks were located between the top of the concrete columns and the bottom of each isolator with shoring in place until the jacking was complete; see Figure 10a and Figure 10b (following page). The first use in Canada of ‘flat jacks’ or ‘plate jacks’—approximately 450 mm in diameter and 25 mm thick—were expanded only 3.3 mm to transfer the building load onto the new isolators. A system was developed to first pressurize all 30 flat jacks using a ‘water like’ fluid, then return and re-balance (fine tune) the loads and deformations at each location, and finally transfuse high strength epoxy into the jacks making them a permanent part of the vertical load carrying system. This involved 9 set up locations, 22 increments of loading, and 22 surveys and visual inspections to ensure specific load and deflection criteria were met and no damage occurred to the exterior heritage façade. A summary of final loads and deflections after balancing and epoxy transfusion is shown in Figure 10c (following page); the maximum vertical movement to achieve load transfer was 3.3 mm, and the maximum jacking load was 921 kN.
