## Seismic test of “effective full penetration of T-butt welds” in welded moment resisting connections.

Hafez Taheri<sup>1</sup>, G. Charles Clifton<sup>2</sup>, Pingsha Dong<sup>3</sup>, Michail Karpenko<sup>4</sup>, Gary M. Raftery<sup>5</sup>,  
James B. P. Lim<sup>2</sup>

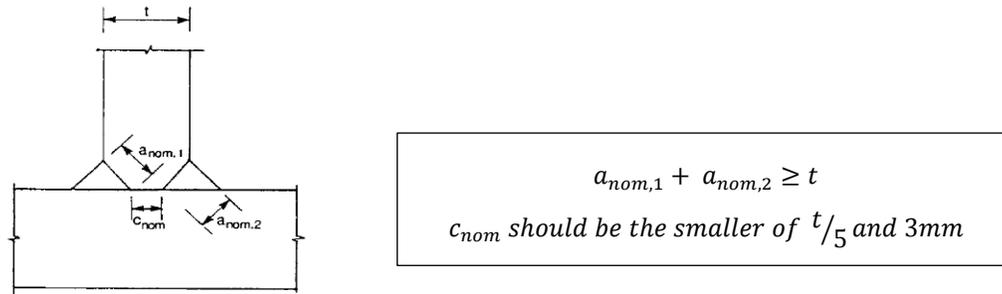
Figure 1. Effective full penetration of T-butt welds after EN 1993-1-8.

Steel moment frames are used widely as a structural system for multi-storey buildings providing a long-span plan and high local and global ductility for structures in seismic areas [1, 2]. Fully welded moment resisting connections using in moment frames have been qualified by many standards and codes such as NZS 3404 [3], Eurocode 3 [4] and AISC 341 [5]. The web and both flanges of the beam are welded to the column using fillet or butt welds. Dubina and Stratan [2] reported that the details of welds or welding defects could be a possible cause for premature fracture in welded connections. Woerner, et al. [6] addressed the effects of weld geometry on the failure mode and performance of the fully welded connections. However, there are no reports of experimental testing to determine the performance of MRCs with “effective full penetration T-butt welds” in accordance with the EN 1993-1-8[4] (Figure 1) under simulated seismic loading conditions.

According to EN 1993-1-8 [4], effective full penetration of T-butt welds must meet two conditions. Firstly, the total throat thickness of welds on both sides should be equal to or larger than the thickness of the stem plate ( $t$ ) on the T joint. Secondly, the un-welded gap between the roots of the welds should be the smaller of 3 mm or  $t/5$ . See Figure 1. The EN 1993-1-8 Standard [4] considers the strength of the effective full penetration T-butt weld providing these two conditions to be equal to that of a full penetration butt weld. However, many studies have shown that the porosity or notch formed due to discontinuities at the root of the welds make these welds susceptible to low cycle fatigue failure in seismic regions [7, 8, 9]. It should be noted that for marine structures, it has been well established that an effective full penetration T-butt weld can be achieved as long as fillet

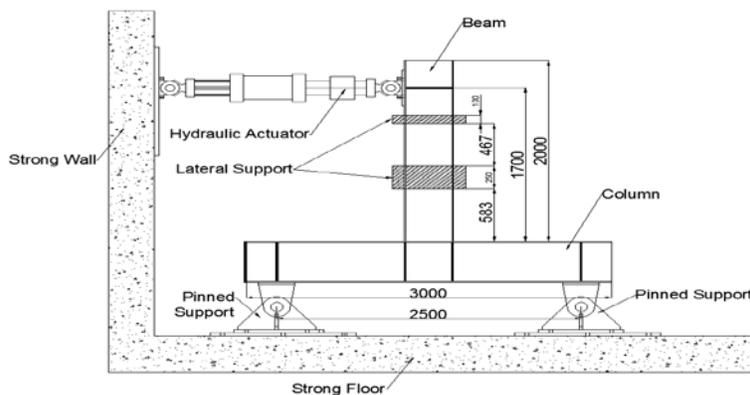
Figure 2. Test set-up based on the SAC protocol. All numbers in millimeter [mm].

The testing was conducted in accordance to the SAC testing protocol [17]. Three T-shaped large-scale specimens representing the exterior beam-to-column moment frame connections were tested under cyclic loading (Figure 2). Pinned supports were embedded at the end of each side of the column (horizontal member), and the actuator applied the force at the tip of the beam. A Shore Western 913D Series hydraulic actuator with maximum  $\mp 330$  KN rated load, and stroke length of  $\mp 150$  mm was employed in the tests. Two lateral supports at different heights of the specimen were intended to prevent out-of-plane movement of the beam, thus ensuring the required in-plane response was achieved. The beam and column section sizes for each specimen are given in Table 1. All beams had similar plastic moment capacity but with very different depths, flanges and web thicknesses. The tensile coupon tests were conducted on the web and flange of all specimens. Table 2 displays the tensile strength results and the section properties for bending. The column sizes were chosen considering the overstrength factor according to the NZS 3404 Standard [3]. Consequently, the ratio of moment capacity of the column to beam should be more than 1.15 representing the overstrength factor for category 2 members (Table 2). The beams in specimens 2 and 3 were welded sections with fillet weld size 10 mm and effective full penetration butt weld size of 6.5 mm respectively.

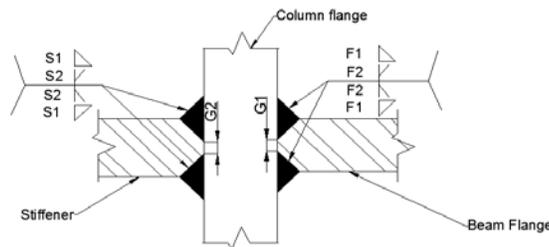
Specimens	Drawing weld size [mm]					
	F1	F2	S1	S2	G1	G2
1	4.4	4.4	4.8	4.8	2.1	2.3
2	8.5	8.5	8.5	8.5	2.9	2.9
3	14.5	14.5	14.5	14.5	2.9	2.9

Figure 3. Dimensions of effective full penetration of T-butt welds based on the drawings.

All the welded connections designed based on the NZS 3404 Standard [3]. The doubler plates were welded into the panel zone of all specimens. The thickness of the stiffener plates was identical to the thickness of beam flanges in all tests except test 1 with stiffener thickness of 12 mm. All welds were performed according to AS/NZS 1554.1 Standard [18] with weld category SP and the E49 electrodes. Figure 3 and associated table illustrates the drawing weld details and sizes designed for welding the beam flange and stiffener to the top column flange in all specimens. In addition, the weld leg sizes were measured after fabrications with the weld gauge, and Figure 4 demonstrates the measured weld sizes.

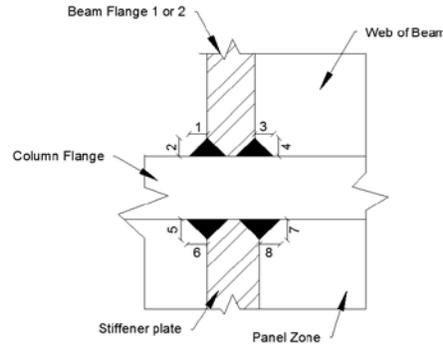
Specimens	Beam flange	Average measured weld sizes [mm]							
		1	2	3	4	5	6	7	8
1	Flange 1	8.06	9.25	8.37	10.5	8	8	10.5	10.75
	Flange 2	8.25	10	9.12	9.25	7.37	8.87	9.37	10.75
2	Flange 1	11.5	8.87	10.25	10.62	9.12	12.12	9.5	13.62
	Flange 2	11.12	9.37	11.62	11.87	9.62	11.75	9.62	12.87
3	Flange 1	19.37	17.12	19.62	18.87	19	19	16.62	18.62
	Flange 2	18.56	16.06	18.12	19	16.37	18.75	17.25	18.125

Figure 4. Measured leg size of welds.

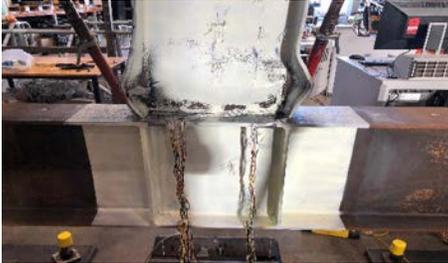
Figure 5. Specimen 1 after failure.

Moment frames with a weak beam, strong column strength hierarchy enables considerable absorption of the incoming earthquake energy through plastic hinge formation. This is beneficial for overall building response. The weld's strength must be sufficient to allow the desired beam plastic hinging to occur. Otherwise, weld rupture before developing beam plastic hinge reduces energy absorption as well as potentially detrimentally affecting the overall structural performance [2]. Figures 5, 6 and 7 illustrate the failure of all specimens after applying the cyclic loads for tests 1, 2 and 3, respectively.

Plastic hinges were created in the specimen 1 under cyclic load test with clear local flexural buckling. The crack initiated at the plastic hinge zone on the beam flange when the basic load history reached to step 9 (Cycle 31). The lateral supports did not work ideally during the test, and there was slight lateral movement in the beam and column members. In specimens 2, as it is evident from Figure 6, both torsional and flexural buckling developed in the specimen. The fracture happened after applying 38 cycles of load. The beam flange crack initiated after significantly unplanned torsional movement in the beam and minor axis bending in the column due to the inefficient lateral restraining system. The extensive paint peeling indicated the large plastic deformation of beam flange and web. Contrary to the specimens 1 and 2, the lateral movement of the specimen 3 was fully prevented by the restraining system. A considerable amount of in-plane plasticity was observed on the beam flanges during the test. The crack initiated after a high number of cycles (94 Cycles) at the toe of the fillet weld and propagated toward the web of the beam. Some other minor cracks around the fillet weld toe were observed as well. Local buckling of the flange due to the plastic flexural demand was not observed in specimen 3, due to the very low slenderness ratio of the beam flange. The visual inspection results did not show any cracks or damages on the welds. The measured weld leg sizes (Figure 4) were approximately double that of the specified weld leg sizes for test 1, and 3~4 mm bigger than specified for test 2 and 3.

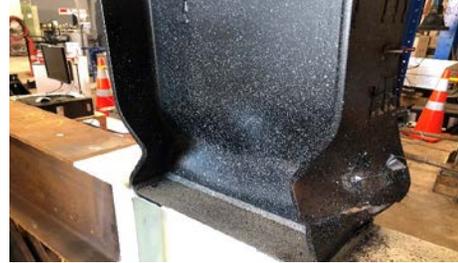
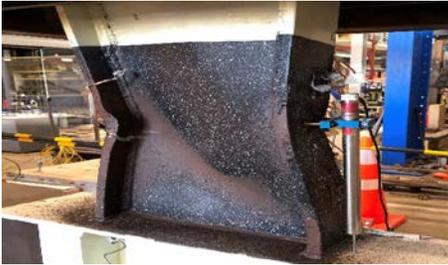
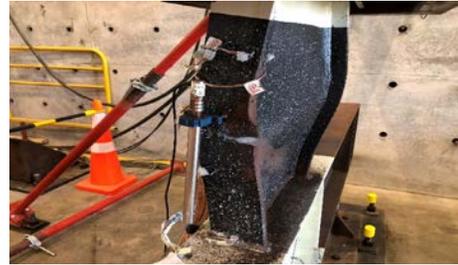
Figure 6. Specimen 2 after failure.

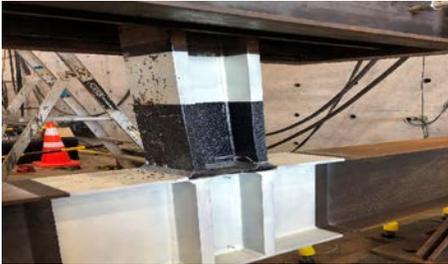
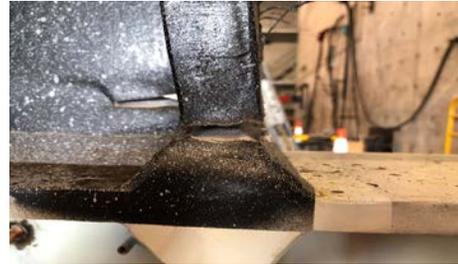
Figure 7. Specimen 3 after failure.

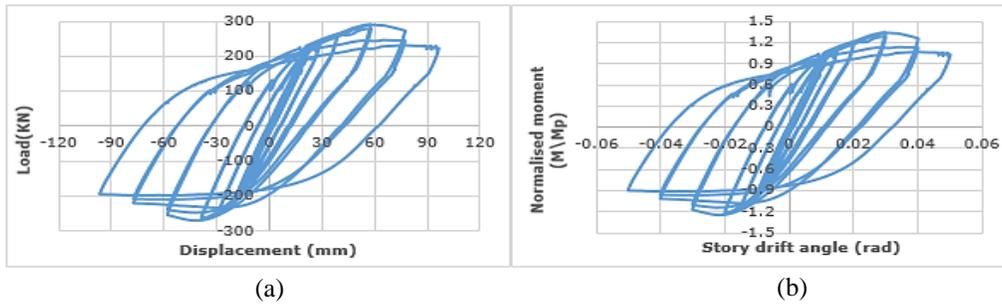
Figure 8. Hysteresis behaviour of connection in specimen 1: (a) load-displacement curve, (b) Normalised moment versus story drift angle.

Since the section (plastic) moment capacity of all beams was similar, it was expected to obtain the same ultimate load in all connections. Figures 8-a, 9-a and 10-a show the load versus displacement curves. The results implicated approximately same ultimate strength of 300 KN for all specimens. The tests were stopped after 20% of load drop in the connection at which point the specimen was considered failed. The ultimate load occurred at load step 7 (Cycle 28) and load step 9 (Cycle 30) for tests 1 and 2, respectively. The graphs 8-a and 9-a and data analysis revealed that ultimate load did not correspond with maximum displacement in the cycles with high amplitudes in test 1 and 2. The lateral movement and local buckling of the specimens could explain this mismatching between ultimate load and maximum displacement during the test. The maximum load for test 3 happened at load step 10, and the load gradually dropped after increasing the number of cycles.

The maximum allowable plastic hinge rotation for the members with negligible axial force considering the earthquake loads or effects is 0.04 rad according to Table 4.7.1 of NZS 3404 [3]. Furthermore, based on the ANSI/AISC 341-10 Standard [5], the beam-to-column connections used in the seismic force resisting system shall reach to at least rotation angle of 0.04 rad with providing measured flexural resistance equal or greater to 80% of moment plastic capacity of beam section at this drift story angle. Figures 8-b, 9-b and 10-b illustrate the normalised moment versus story drift angle for each specimen. As it is obvious from the graphs, all connections provide sufficient story drift angle and flexural resistance according to NZ and US standards.

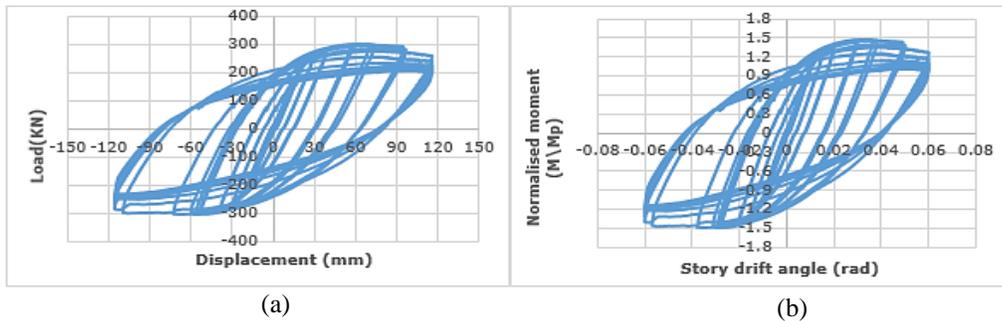
Figure 9. Hysteresis behaviour of connection in specimen 2: (a) load-displacement curve, (b) Normalised moment versus story drift angle.

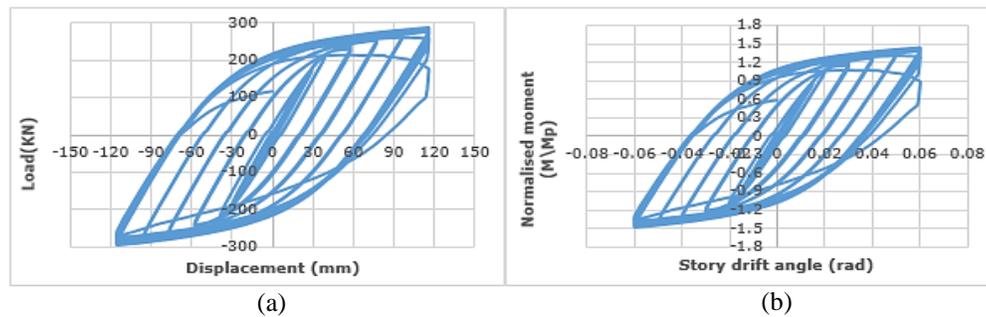
Figure 10. Hysteresis behaviour of connection in specimen 3: (a) load-displacement curve, (b) Normalised moment versus story drift angle.

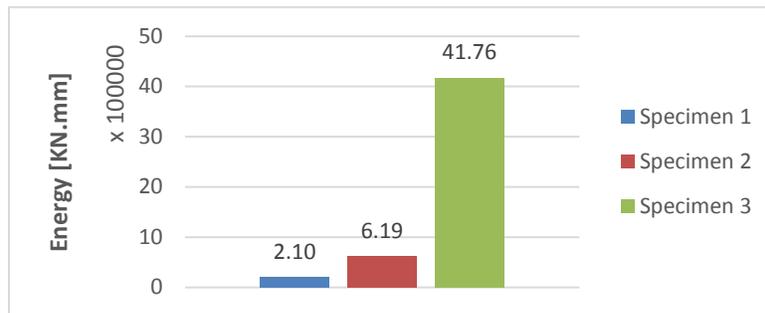
Figure 11. Accumulated energy dissipation.

Moreover, the amount of energy dissipation of the connection was obtained by adding the area of each hysteresis loop. Figure 11 shows accumulated energy dissipation for each specimen. The amount of energy absorption in test 3 was considerable by taking account of the high number of cycles before failure.
