Seismic Risk Management Program for Municipal Bridges in the City of Vancouver, B.C.

Grant Fraser, P.Eng.¹, Shane Cook, P.Eng.¹, Dane Doleman, P.Eng.²

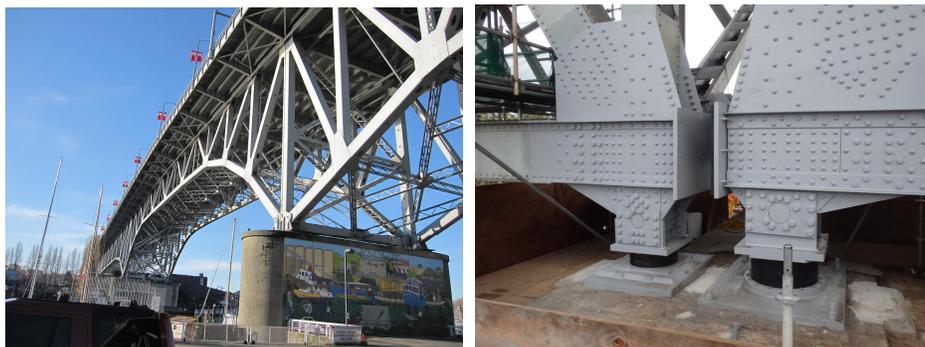
Figure 3. Granville Bridge: (a) elevation view, (b) replacement isolation bearings

Granville Bridge was built circa 1955, and comprises a deck truss main span and concrete T-girder approaches on brittle reinforced concrete piers. The bridge carries considerable traffic, and spans over not only False Creek, but Granville Island, a popular tourist destination with densely populated zones and considerable cultural importance. The bridge underwent a minor seismic retrofit in the 1990s. In 2011, the City sought to replace the original truss bearings, due to the presence of toxic PCB lubricants in the rollers. As part of this task, the City considered the synergy of combining these works with a seismic retrofit and after evaluation with the consulting team, proceeded with the retrofit. The existing truss bearings were replaced with lead-rubber isolation bearings, designed using project-specific performance-based design criteria. As of this writing, all on-shore bearings have been replaced, with marine pier bearings slated for replacement in 2019. As the bearings required replacement regardless of seismic performance goals, the incremental cost of seismic isolation bearings was small relative to the overall project cost of bearing replacement but provided significant value to the City in protecting this important link between the two cores. Granville Bridge is shown in Figure 3 below.

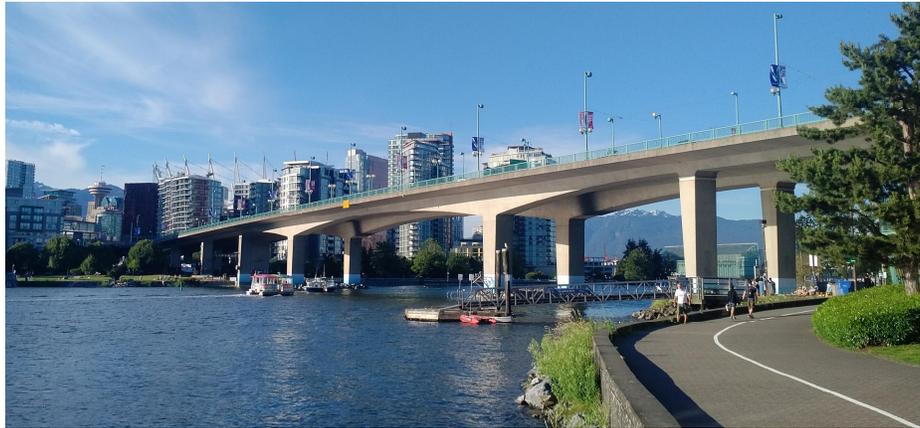
Figure 3. Cambie Bridge

Cambie Bridge was built circa 1984, and comprises post-tensioned spine beams on reinforced concrete piers at both the main span and approaches. Though relatively modern, it was designed to a 100-year return period earthquake, and is quite stiff and brittle. As the most modern and heavily trafficked route over False Creek, Cambie Road is an important link connecting the two cores of Vancouver. The City has undertaken seismic performance assessments, including geotechnical investigations, and has recognized its seismic vulnerability. It is currently engaging with consultants to study the determine appropriate performance targets and retrofit strategies for this structure, with construction expected to begin in 2020. The expected timing of this construction is to maximize synergy with a large infrastructure project in close proximity to the North approach spans, which will reduce costs, when compared to conducting a standalone retrofit. Cambie Bridge is shown in Figure 3 below.

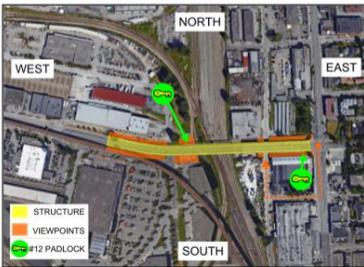
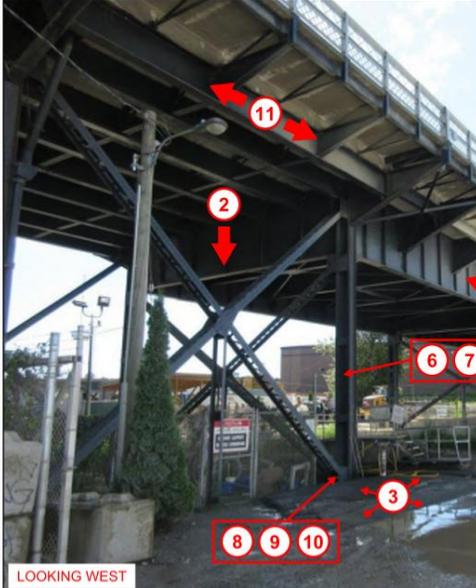
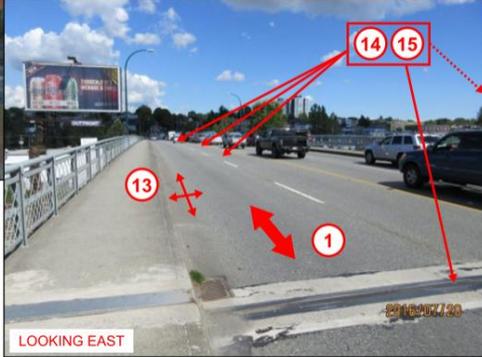
Figure 5. Post-earthquake inspection drawing

The variety and complexity of structural systems on the bridges over False Creek necessitated a manual for inspection guidance, however the City also owns numerous overpasses and viaducts that will require rapid inspection following an earthquake. For these less complex structures, the City developed bridge-specific inspection drawings. Similar to the manuals, these drawings provide inspectors with at-a-glance information about the bridge location, photos, utilities, access and vantage points and inspection guidance. Figure 5 below shows an example of a post-earthquake inspection drawing.

LOOKING WEST

• In general, there is no **Ideal Arrival** approach to the bridge, as the structure is too large to be viewed from one location, and both sides of the train tracks are accessible.

• **Access Below the Structure** for several of the spans over the train tracks near the center of the bridge will require coordination with the Railway Authority.

• **Access Below the Structure** for several spans just east of the train tracks will require coordination with the Vernon Drive Silt Recovery Site.

• Misalignment in the **Train Tracks** below the middle of the structure is a strong indicator that soil displacement has occurred which can affect the stability of the pier foundations.

LOOKING EAST

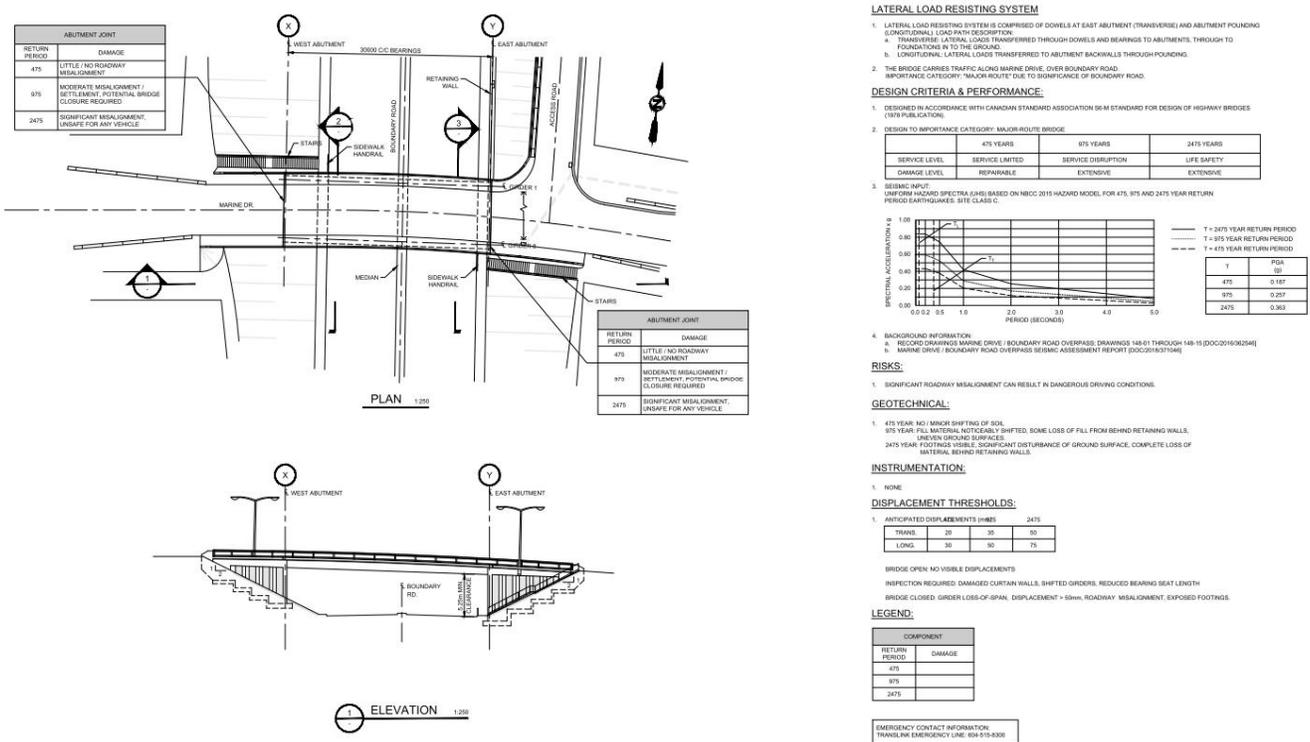
Figure 6. Seismic Performance Drawing

The post-earthquake inspection guides are intended to provide teams with vital at-a-glance information about the bridge characteristics and assessment points of interest. To pair with these guides, the City developed seismic performance drawings to provide a guide for more detailed investigation and analysis of the structures following the initial inspection. These drawings are intended for use by inspectors in the field and bridge engineers. They generally provide the following information:

1. Detailed description of the lateral load resisting system;
2. Seismic design criteria including design code, current uniform hazard spectra, anticipated period of vibration;
3. Seismic performance levels (service level and damage level as defined by S6-14);
4. Geotechnical conditions;
5. Descriptions of expected damage at various design earthquake (475-, 975- and 2,475-year);
6. Expected damage states, similar to the post-earthquake inspection guides; and
7. Damage-dependent recommendations for bridge usage, similar to the post-earthquake inspection guides.

Figure 6 below shows an example of a seismic performance drawing developed for the City by a consultant.

When combined with the initial rapid assessment (and additional inspections, as necessary), this information will help engineers make important determinations about the earthquake characteristics and bridge performance. Perhaps more importantly, it will help engineers quantify the bridges' post-earthquake condition and provide confidence in City-led decision making regarding availability of routes within the transportation network to carry emergency response and/or public traffic in the days and weeks following an earthquake.

In addition the benefit provided in the immediate aftermath of an earthquake, these performance drawings also provide valuable information for future use by engineers, who may be working to conduct seismic assessments or retrofits. The City is currently refining the format of these drawings on existing bridges, but recognizes that significant benefit will be realized when these are generated as part of new design and retrofits, as comprehensive design and performance information is often not well documented on design drawings, making it challenging to gather information in the years and decades following.

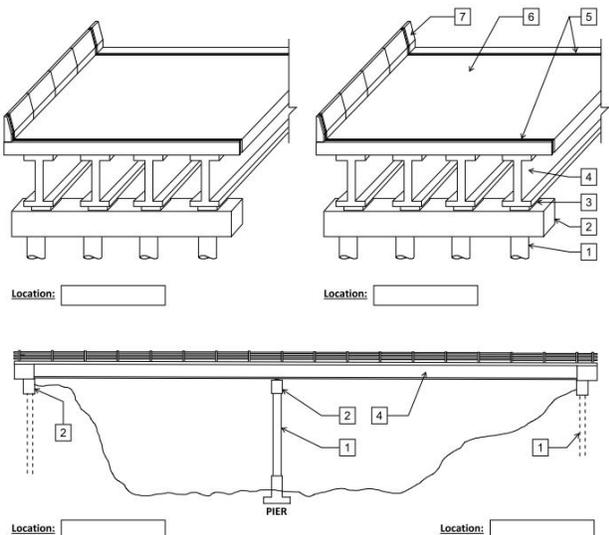
Figure 7. Bridge Evaluation Form

To expedite the initial rapid assessment process, the City has developed inspection forms. These forms provide the inspection teams with a clear, consistent format to document their findings. It is formatted to ask direct questions with simple 'yes' or 'no'

answers, a space for comments, and a simplified sketch of the typical bridge components for marking. Figure 7 below shows an example of these evaluation forms.

- 1) Piles (at abutment), or Columns (at pier).
- 2) Abutment (if at end of bridge), or Pier Cap (if at top of pier)
- 3) Bearings
- 4) Girder
- 5) Deck Joint
- 6) Deck
- 7) Edge Barrier/Railings

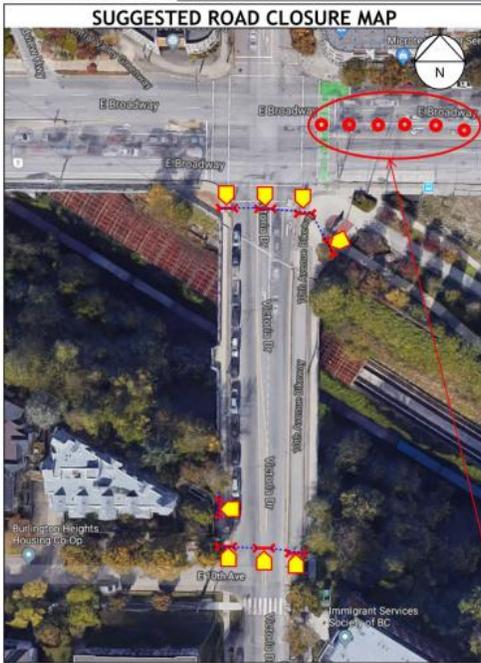
Figure 8. Bridge Closure Form

The City has also developed bridge closure sheets, in the event that the initial rapid assessment and/or additional investigations lead the City to close a bridge. These sheets are bridge-specific and are intended for use by City operations and traffic management staff to aid in implementing the closure. These forms include suggested barricade, caution tape and placard placement, plus a checklist for City staff regarding actions taken. Figure 8 below shows an example bridge closure form.

TOTAL MINIMUM SUGGESTED MATERIALS REQUIRED
 HORSE BARRICADES = 8
 CAUTION TAPE LENGTH = 90 meters (300 ft)
 PYLONS = 0 FOR FIRST RESPONSE, 6 FOR SECONDARY
 PLACARDS = 8

SECONDARY RESPONSE ROAD CLOSURE REQUIREMENTS. LOCATION AND NUMBER OF PYLONS ARE APPROXIMATE
