Performance of Suspended Ceilings during Seismic Events

Geoff Davidson¹, David Lau², Jeffrey Erochko², Kazuhiko Kasai³

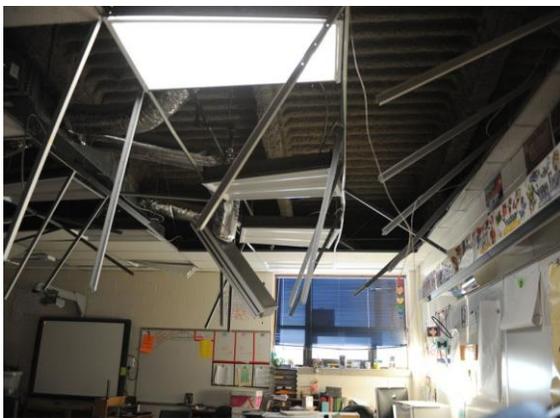
Figure 2. Classroom of Hanshew Middle School [4]

On November 30, 2018 a 7.0 magnitude earthquake hit South Central Alaska. There were multiple aftershocks that took place following the earthquake, with some reported magnitudes above 5.0. This recent seismic event has further shown the importance of the performance of non-structural elements. Schools in South Central Alaska suffered significant damage, mostly due to the failure of their suspended ceilings. Although there were no reported injuries, many of the schools had to be closed for a week. Two schools were damaged so severely that it is unlikely the schools reopen this school year and possibly the next. The figures below show the collapse of suspended ceilings located in the classrooms of Hanshew and Houston Middle School, Figure 2 and 3 respectively [4].

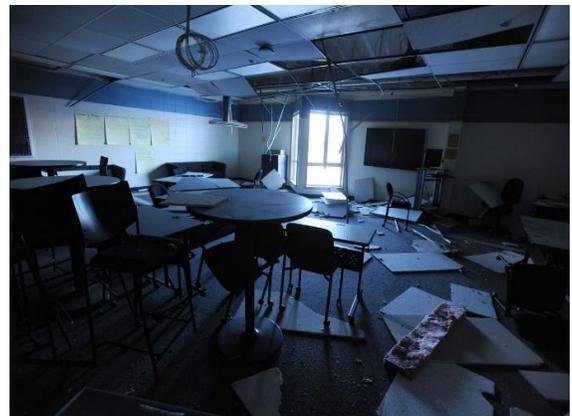
Figure 3. Classroom of Houston Middle School [4]
