## Benefits of Using Access Panel for Post-earthquake Structural Inspection: Concept and a Case Study

**Abstract:** Access panels may be placed in buildings so that structural damage can be quickly inspected and possibly repaired without damaging building non-skeletal elements (NSEs) after earthquakes. Such access panels are readily available, and can be placed near the dissipative elements of building structures for inspection. This paper describes the concept of structural access panel (SAP) and the benefit from analysis considering inspection cost and downtime. When damage inspections are required after the peak ground acceleration is greater than SLS level, the SAP can be beneficial for structural inspection when structural damage occurs at lower shaking levels than the levels causing building irreparability, or major NSE damage. A 6-storey 3-bay eccentrically braced frame structure using different levels of earthquake intensity shaking is conducted and simulated by nonlinear time history analysis, to evaluate the changes in structural inspection costs in buildings with and without SAPs. It is shown that the probability of the SAP being beneficial decreases as the shaking inte

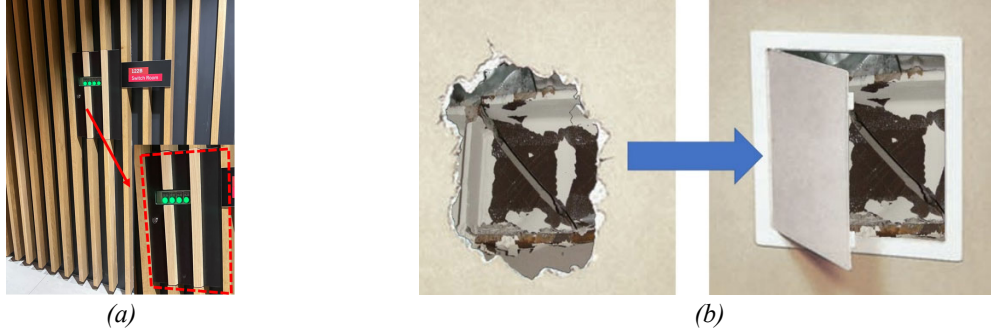
*Figure 3. Access panels used for structural maintenance: (a) Access panel for MEP, (b) Proposed structural access panel (SAP)*

This paper proposes an innovative post-earthquake structural inspection scheme, which is using an openable access panel, termed a structural access panel (SAP), installed on NSEs to facilitate visual structural inspection and repair. This concept has been already widely used for mechanical, electrical and plumbing (MEP) maintenance in buildings, as shown in Fig. 3(a), which has low cost and good aesthetic effect for architecture. Similarly, these openable access panels can also be installed near the dissipative elements of structure, then a reliable visual inspection and repair for structures can easily be achieved without damaging any NSE, as illustrated in Fig. 3(b). Therefore, the advantages of SAP in post-earthquake structural inspection and repair work can be emerged in the aspects: 1) Effectively saving the cost of opening and repairing the access holes on NSE for structural inspection and repair; 2) Greatly reducing the downtime and improving the speed of building function recovery.
