The Use of ASCE 41 for the Retrofit of Rubble Wall Buildings: A Case Study in a Moderate Seismic Zone

Keywords: Seismic Retrofit, ASCE 41, Rubble Walls, Case Study, Unreinforced Masonry

This paper focusses on the analysis and retrofit of the structural elements of one of the heritage buildings, Pavilion L, a rubble wall structure, following ASCE 41 [4] and using seismic hazard compatible with NBCC 2010 [5]. This resulted in innovative retrofit strategies to preserve their heritage significance. Furthermore, in addition to the seismic evaluation according to ASCE 41, it is to note that all structural elements were also checked against gravity load combinations, but these will not be discussed.

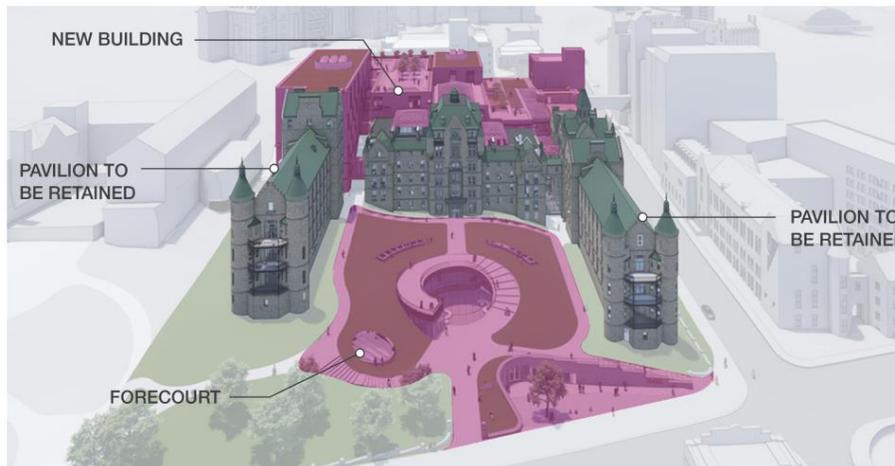
Figure 1. Overview of the New Vic Project, with the retained buildings, the new building and forecourt to be added.

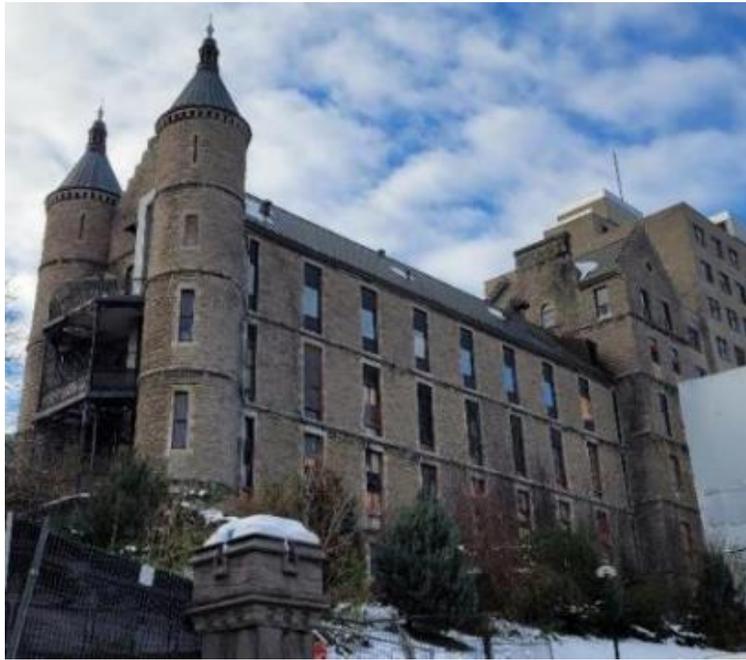
The studied Pavilion L is shown in Figure 2. It has a narrow rectangular plan view, around 10 metres wide and 50 metres long. Its 4-storey high central portion, originally an open plan hospital wing, is completed by two round towers at the south end of the building, and a rectangular tower to the north which is 6-storeys high.

Figure 2. Current photo of Pavilion L as seen from the South-East.

The lateral load resisting system relies on the perimeter stone walls. These are rubble walls built integrally with the stone façade, with cut stones on visible faces. They are typically between 600 and 800 mm wide, and this thickness is constant over the height of the building. The walls rest directly on competent rock. Diaphragms are mainly composed of wooden elements, and all will be replaced to accommodate the new use and fire rating requirement of the spaces. Note that horizontal diaphragms are present under the gabled roofs as well. New diaphragms will rely on concrete on steel deck and steel beams in all cases.

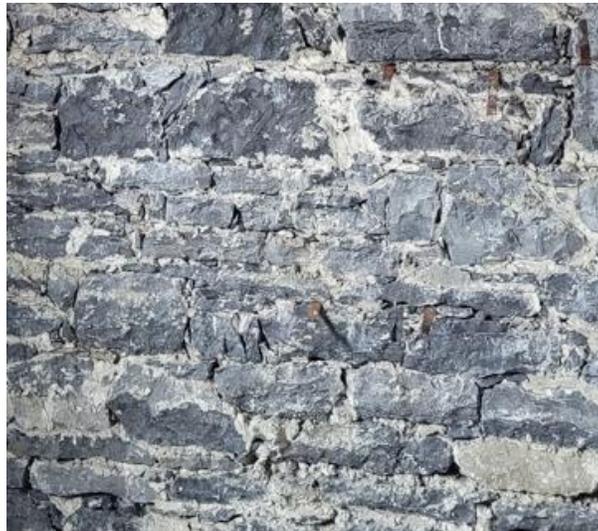
Figure 4. View of the interior face of a rubble wall observed on site.

Extensive mortar and stone testing allowed to identify the rubble walls as Montreal Limestone, of an average tested compressive capacity of 100 MPa or more, bonded primarily with non-hydraulic lime mortar, although some later repairs were made using Portland cement mortar mixes. ASCE 41 does not provide specific material properties for this type of structure. Furthermore, testing of assemblies is not practical, given the difficulty to replicate the on-site conditions. In order to determine the overall assembly characteristics, an extensive literature review [9-21], combined with the findings of the component testing, was used. Recognizing the inherent variability of this historic material, upper and lower bound characteristic strengths were retained for the analysis and design, as indicated in Table 1. Tabulated values for masonry for ASCE 41 were used to determine expected strengths from characteristics strengths when called for in the procedure. Figure 4 shows an example of the interior face of the rubble wall.
