Seismic Retrofit of a Previously Partially Retrofitted Heritage Hospital Building

ABSTRACT

Keywords: Seismic retrofit, Performance-Based Design, Hospital, Healthcare, Building Heritage, Unreinforced Masonry

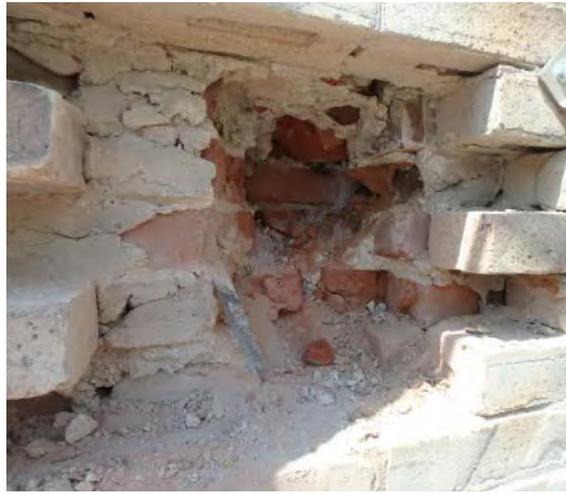
Figure 2. Building A unreinforced masonry brick load-bearing walls composition

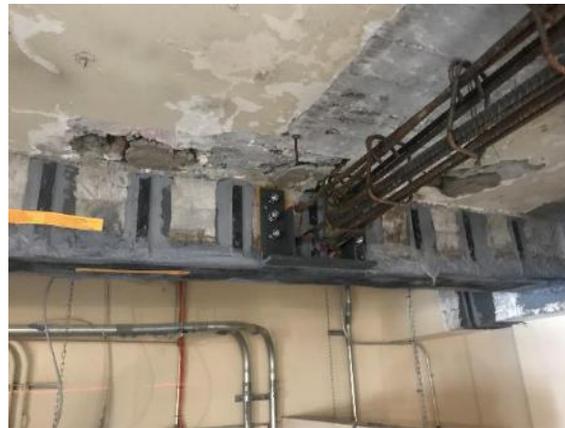
Figure 11. Collector Beam in B wing

As maintenance of clinical services was vital, the retrofit project was ineluctably staged by story as the Hospital could sometimes only afford one inoperative floor at a time to maintain adequate services. Restrictive measures were imposed to the construction activities to minimize disturbance to neighboring environment. Among those figured dust containment and drilling vibration limits as care was given nearby to patients. Figure 11 shows a collector beam installed in such conditions.

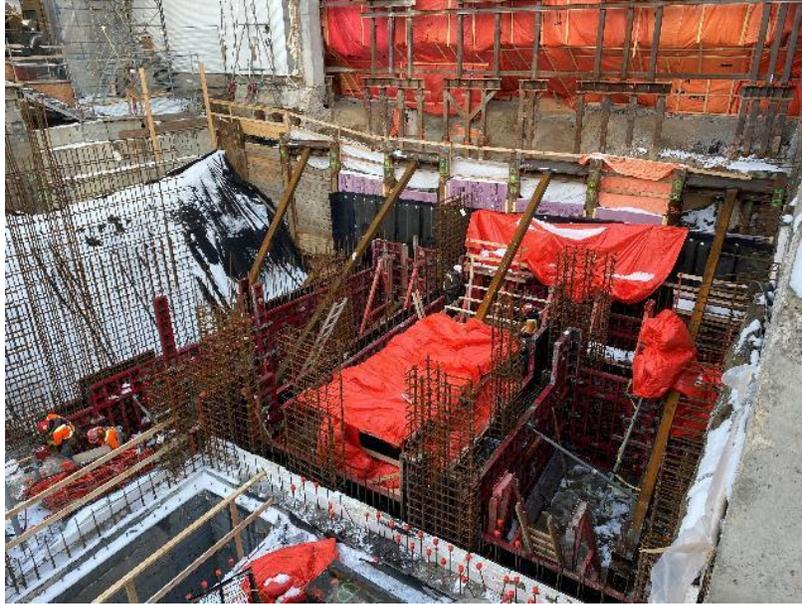
Figure 12. Retrofit interventions at building ensemble SABC (a) New elevator core shear walls (b) Construction of new peripheral reinforced concrete chords

Figure 12 illustrate others retrofit interventions undertaken since the beginning of the construction phase of the project.
