## Monitoring of the Recovery Process in Minami-Aso Village from the 2016 Kumamoto Earthquake based on Multi-Temporal Lidar Data

### ABSTRACT

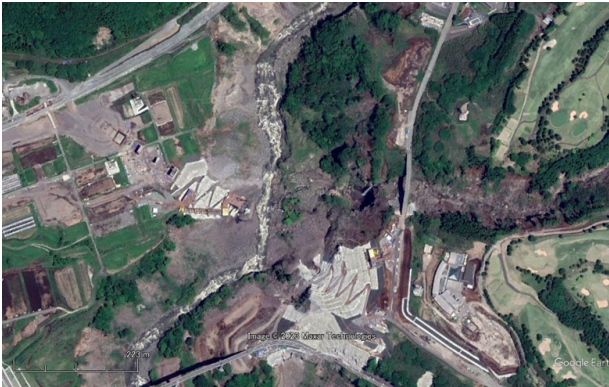
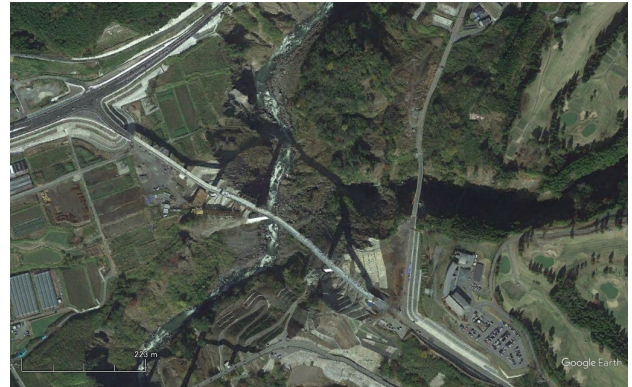
Figure 10 shows the DSM differences and optical images showing the construction of the New Aso-Ohashi bridge. From (a) and (c), the slop stabilization works of the river cliff were recognized to build the bridge piers and abutments. Filling works of the connecting road were also seen in red color. From (b) and (d), the bridge was seen to be almost completed together with the approach roads on November 2020. Figure 11 shows the 3D random point LiDAR data around the New Aso-Ohashi bridge observed in November 2020. The LiDAR data clearly exhibit the whole shapes of the bridges even three high piers, in spite of the vertical shouting scheme of laser pulses of airborne LiDAR. The top of the piers, however, cannot be seen from the 3D plot since the laser pulses did not reach under the bridge girder.

Figure 10. The DSM differences and optical images showing construction of the New Aso-Ohashi bridge

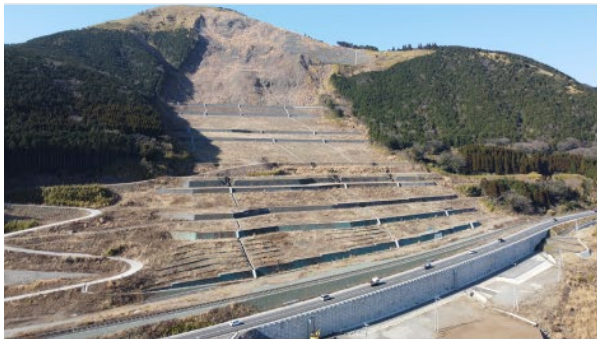
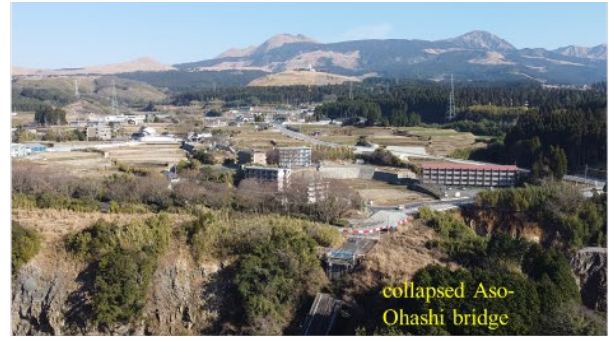
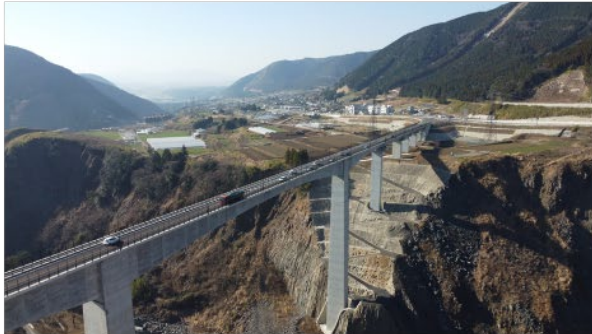
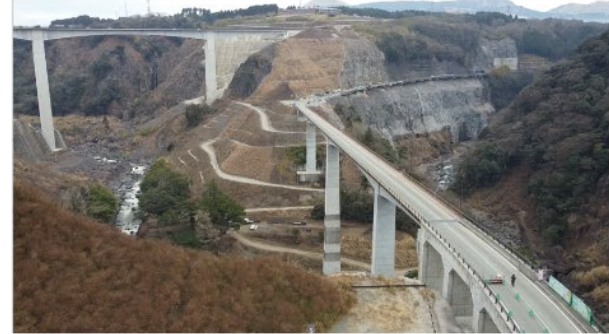
(a) Slope stability works for the largest landslide

(b) Kawayo district and collapsed Aso-Ohashi bridge

(c) Completed New Aso-Ohashi bridge

(d) Choyo bridge and New Aso-Ohashi bridge (back)

Figure 12. UAV photos in our field survey on 2021/12/23

For gathering the damage and reconstruction information of Minami-Aso village from the 2016 Kumamoto earthquake, the authors have conducted field surveys of the affected area a total of six times (2016/06/6-7, 07/3-4, 08/8-9, 2021/07/21, 2021/12/23-24, 2022/12/4-5). We flew a UAV (DJI Phantom 4) over some affected areas in the survey during 2016/08/8-9 [9]. In the field survey during 2021/12/23-24, we also flew a very small UAV (DJI Mini 2, 199 g) from off-road open space. Figure 12 shows aerial images recorded by a 4K camera, taken from the UAV at the altitude about 30-50 m [25]. (a) shows the restoration works of the largest landslide and the reconstructed national highway No. 57 in Tateno district. (b) shows an overview of Kawayo district, where the collapsed Aso-Ohashi bridge still exists. The newly constructed Aso-Ohashi bridge in (c) and the repaired Choyo bridge in (d). Aerial surveys from UAVs are considered to be quite useful to monitor the recovery process of wide areas.
