## Seismic Upgrade of the Canadian Parliament Building: Part 3 – Testing Program

Centre Block was constructed in 1916 using materials and techniques considered state-of-the art at the time. This included a combination of unreinforced masonry, steel framing, reinforced concrete, plain concrete, and hollow terracotta tiles. As a precursor to the building's seismic upgrade design, an extensive testing program was completed to investigate the structural properties of its unique materials. The program included in-situ tests, laboratory tests of extracted specimens, ambient vibration tests and cyclic testing of hollow terracotta tile floor subassemblies. This paper provides an overview of the tests and a summary of the results.

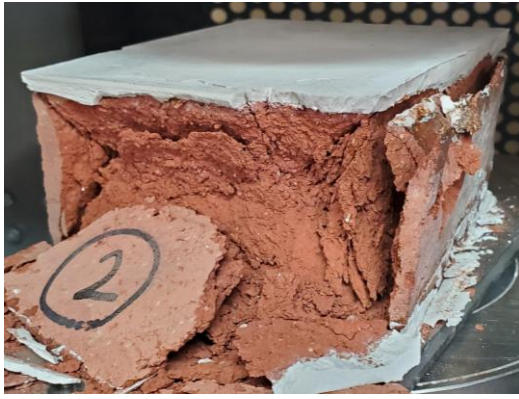
Figure 2: Brick unit compression test

- Clay brick unit compression strength - see Figure 2
- Mortar compression strength - see Figure 3
- Sandstone unit compression strength
- Brick prism (5 course assembly) compression strength (ASTM C1314 protocol) - see Figure 4
- Sandstone prism (3 course assembly) compression (ASTM C1314 protocol) - see Figure 5
- Brick masonry coefficient of friction (ASTM C1531 protocol)
- Stone masonry coefficient of friction (ASTM C1531 protocol)
- Mortar flexural bond strength (ASTM C1072 bond wrench test) – see Figure 6
- In-situ brick masonry stiffness (ASTM C1197 protocol)
- In-situ stone masonry stiffness (ASTM C1197 protocol) - Figure 7
- Concrete compressive strength
- Structural steel tensile strength
- Reinforcing steel tensile strength

| Clay brick compression strength | $f_m = 37.4 \text{ MPa}$ | |

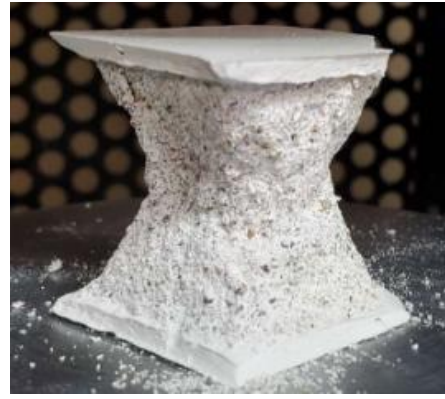
Figure 3: Mortar sample compression test

| Mortar compression strength | $f_m = 52.9 \text{ MPa}$ | |

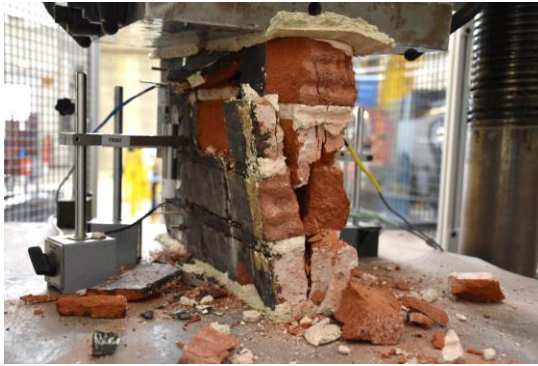
Figure 4: Brick prism compression test

| Clay brick masonry | $f_m = 10.3 \text{ MPa}$ | $E = 5\,800 \text{ MPa}$ |

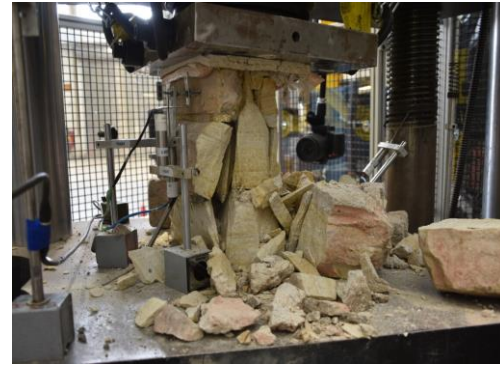
Figure 5: Stone prism compression test

| Sandstone masonry | $f'_m = 25.6 \text{ MPa}$ | $E = 13\,300 \text{ MPa}$ |

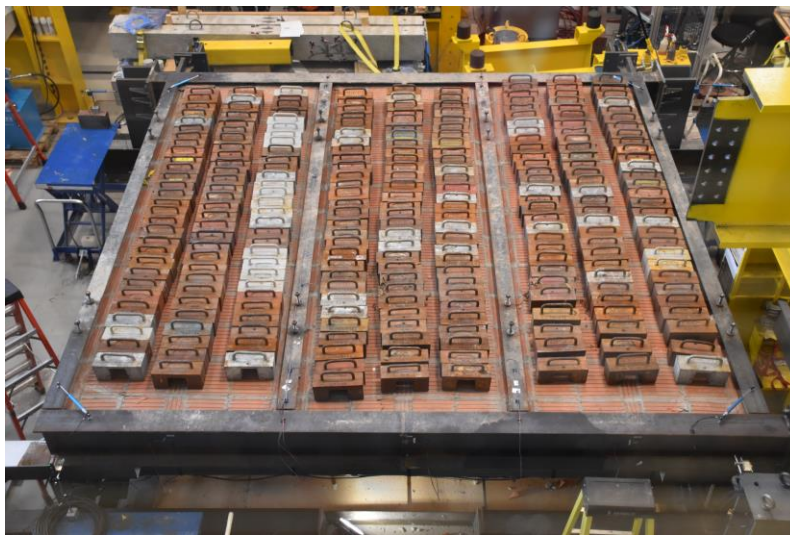
Figure 8: Hollow terracotta floor tile diaphragm reversed cyclic lateral load testing

Cyclic lateral load testing was conducted on replica specimens of Centre Block's hollow terracotta floor assemblies to establish their existing performance as a structural diaphragm (see Figure 8). The same tests were repeated on strengthened assemblies. Two strengthening options were tested: 1) strengthening with a thin ultra-high-performance concrete (UHPC) topping and 2) strengthening with in-plane steel cross-bracing installed beneath the floor.

The tests demonstrated that both upgrade options are viable and provide substantial performance improvement. However, the UHPC topping upgrade option is able to provide a larger strength and stiffness enhancement relative to the upgrade option using steel cross bracing. Furthermore, the UHPC option requires less physical space to implement and is simpler to construct. Consequently, it has been selected as the preferred diaphragm upgrade option for Centre Block's rehabilitation.
