## A Review of Experimental Testing of SE-SMA Reinforced Concrete Slender Shear Walls

Dan Palermo<sup>1\*</sup> and Austin Martins-Robalino<sup>2</sup>

<sup>1</sup>Professor, Department of Civil Engineering, York University, Toronto, ON, Canada

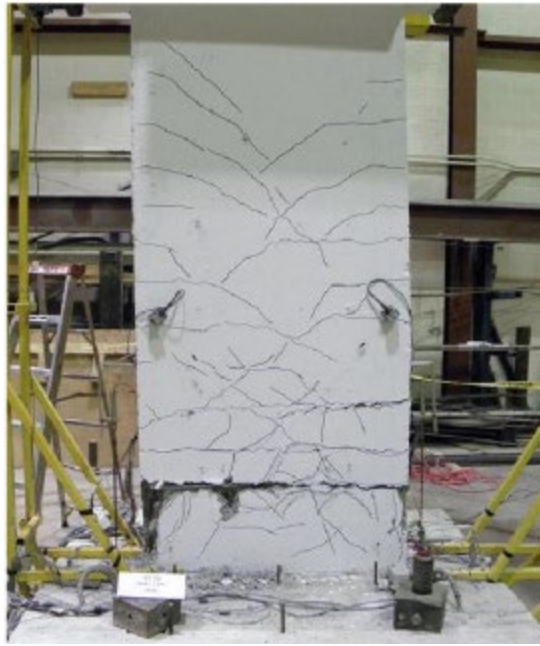
The failure of Wall SWN-A was controlled by a prominent flexural propagating through the entire length of the wall and located approximately 350 mm above the base of the wall and adjacent to the end of the starter bars (Figure 4). Failure occurred at 108 mm displacement (4.5% drift) and consisted of the wall sliding along the crack surface. Prior to failure it was noted by that concrete crushing, spalling, and buckling of an SMA bar occurred at this flexural crack. Drops in lateral load observed during the second cycle at 72 mm, the second cycle at 84 mm, and the first cycle at 94 mm correspond to rupture of longitudinal deformed steel bars in the web region adjacent to the SMA bars. Removal of damaged concrete after testing revealed that one of the SMA bars had fractured at the mechanical coupler 900 mm above the base of the wall. This SMA fracture is responsible for the last drop in lateral load which prompted the termination of the test.

Figure 4. Cracking pattern of SWN-A after 72 mm (3.0% drift cycle)[1].

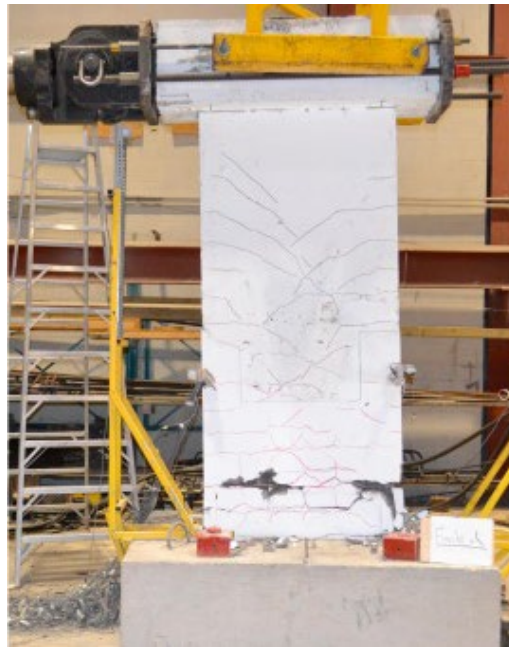
Wall R-SWN-Z which lacked starter bars and had SMA bars shortened to a height of 425 mm above the base of the wall had crack formation limited to the repaired region of the wall with no new cracks forming above the plastic hinge and existing cracks only reopening. Initial cracking occurred at 140 mm, 260 mm, 440 mm, and 690 mm above the wall with the cracks at 260 mm and 400 mm corresponding to the just below and above the six-inch couplers used to connect the shortened SMA bars to the deformed steel reinforcement. Loading beyond a displacement of 54 mm (2.25% drift), it was observed that the critical crack formed at a height of 260 mm with spalling occurring in the boundaries (Figure 5). During the second 62 mm cycle (2.5% drift) an SMA bar fractured leading to drop in lateral load of 13%. Additional SMA bars fractured during the positive and negative loading of the 72 mm cycle (3.0% drift) and during the second cycle at 90 mm (3.75 % drift). All fractures were found to have occurred at the termination of couplers at approximately 260 mm above the base. The location of rupture of the SMA, directly below the location of the couplers, in both SWN-A and R-SWN-Z suggest that the screws used in the couplers induced a plane of weakness leading to premature fracture of the bars.

Figure 5. Cracking pattern of R-SWN-Z at end of testing [3].
