BRIDGE SEISMIC DESIGN LESSONS LEARNED FROM WENCHUAN EARTHQUAKE OF CHINA

Kehai Wang¹, Qian Li², Han Wei², and Jiangpeng Yang³

ABSTRACT

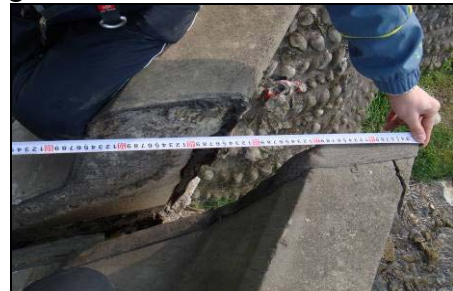
Figure 11. Maweihe Bridge in Mianzhu City

According to our observation, the damage of the skewed bridges was damaged more serious than the orthogonal bridges. The behaviors expressed as collision between the girders or girder and the abutments, shear keys failure, offset in the longitudinal and transverse direction. In most cases, the superstructures of the skewed bridges may rotate by a small angle along the vertical axis, such as the Maweihe Bridge in Mianzhu City(See Figure 11).
