## SEISMIC EVALUATION OF SCHOOL BUILDINGS IN VENEZUELA

A. Marinilli<sup>1</sup>, N. Fernández<sup>1</sup>, O. A. López<sup>1</sup>, and G. Coronel<sup>1</sup>

### ABSTRACT

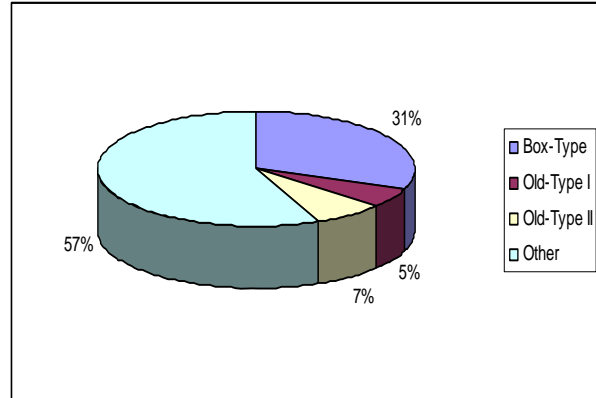
Figure 5. Building type for the inspected school buildings.

Figure 4 shows the distribution of year of design and/or construction for all the inspected school buildings. A total of 80% of the inspected buildings are dated before benchmark year 1982 and 5% before benchmark year 1939. Figure 5 shows the distribution of building type for all the inspected buildings. It can be seen that 36% of the inspected buildings are similar to those collapsed during 1997 Cariaco Earthquake (Box-Type and Old-Type I).

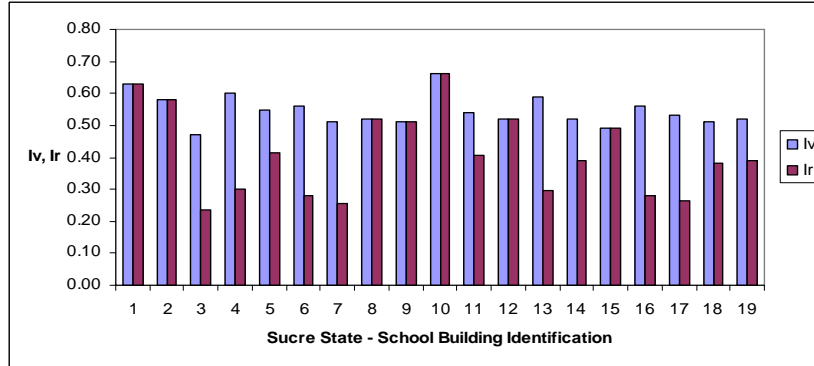
Figure 8. Vulnerability Index ( $I_v$ ) and Risk Index ( $I_r$ ) obtained for school buildings inspected in Sucre State.

Figure 8 and Figure 9 show the vulnerability index and risk index values obtained at each school building in Sucre State and Carabobo State, respectively. Figure 10 shows that 80% of the sample showed vulnerability index values equal or greater than the value obtained for Raimundo

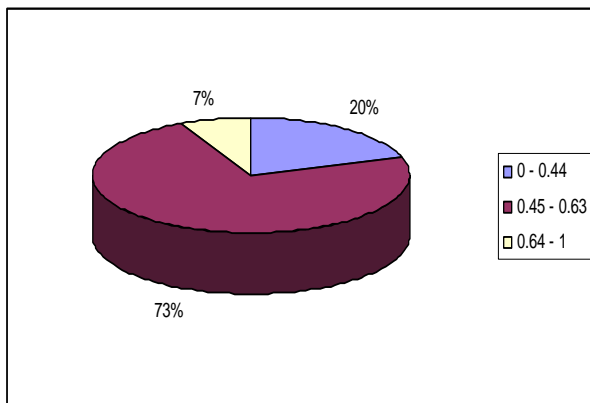
Figure 10. Vulnerability Index ( $I_v$ ) obtained for the inspected buildings.

Martinez Centeno High School ( $I_v = 0.45$ ), regardless of the seismic zone where they are located. Otherwise, Figure 11 shows that 55% of all of the inspected school buildings showed risk index values equal or greater than the value obtained for Valentin Valiente School ( $I_r = 0.32$ ).
