## **SPATIAL DISTRIBUTION OF DAMAGES TO BURIED PIPES FOLLOWING THE 2007 NIIGATA-KEN CHUETSU-OKI, JAPAN, EARTHQUAKE**

K. Kimishima<sup>1</sup>, Y. Maruyama<sup>2</sup> and F. Yamazaki<sup>3</sup>

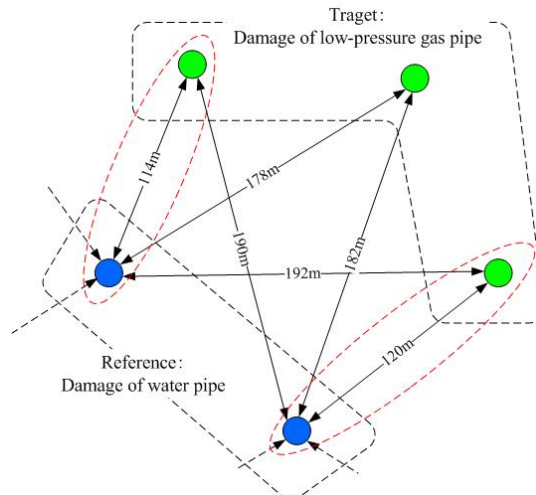
Figure 6. Definition of the shortest distances between the damage incidents.

To evaluate the probability that earthquake damages are caused simultaneously, the shortest distances among the locations of the various damages were analyzed. The distances to neighboring damages were obtained for all the damage incidents (Fig. 6), and then the shortest

distances were found for all the damage locations of water, low-pressure gas, and mid-pressure gas pipes, sewage lines, houses, and liquefaction occurrence. Because of the data structure in GIS, the polylines, which indicate the damage locations of sewage lines, were divided into the points with 1m intervals, and then the shortest distances were calculated. Table 2 shows the ratio of the damage incidents with the shortest distance less than 250 m.
