IN-SITU PUSHOVER TEST AND NUMERICAL SIMULATION OF A REAL REINFORCED CONCRETE FRAME STRUCTURE

Xilin Lu¹, Jiang Qian¹, Tuo Lei², Liang Lu³ and Guangye Zhao²

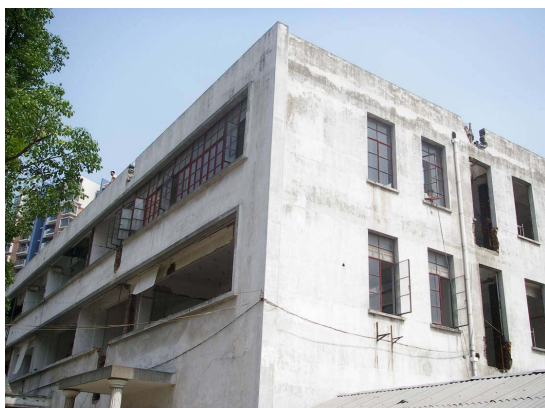
Figure 1. South-east elevation view

The original building was a three-story frame structure built in 1983 with story height 4.84m (the first floor), 4.18m (the second floor), and 4.18m (the third floor) respectively. Outside the internal frame there is an external masonry wall system attached. Floors are made by 120mm thick precast concrete slabs. Fig. 1 shows its south-east elevation and the typical structural layout is given in Fig.2.

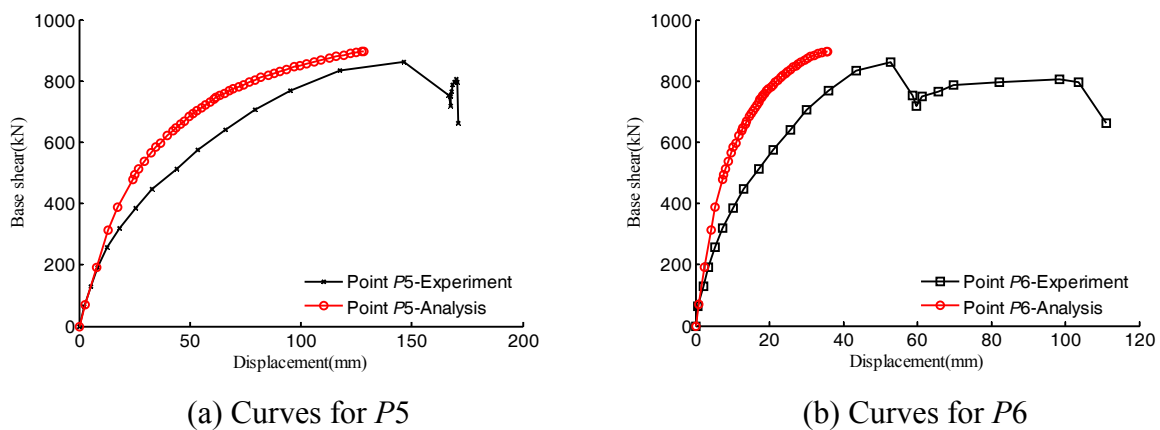
Figure 12. Base shear-displacement curves and Comparison

A preliminary computation has been performed using the established FE model. The loading pattern used in pushover computation follows the similar way as that in test. Fig.12 shows base shear-displacement curves at loading points *P5* and *P6* respectively. There are some difficulties in simulating post-ultimate behavior of the testing frame by using a loading program following the test proceeding. The arc length method might be considered in the further computation. However, the extreme values of base shear compare well with that tested one.

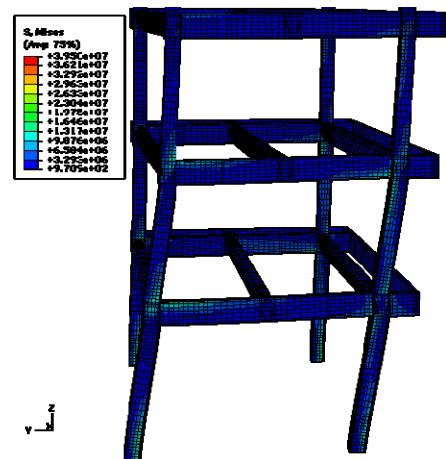
Figure 14. Stress distribution in concrete

It can be seen in Fig.13 that the structure is undertaken an obvious torsional deformation due to the participation of the perimeter walls. Figs.14 shows the Mises stress distribution in concrete at the last load step. Fig. 15 indicates that some longitudinal reinforcement yield at this load step, they occur at the end of columns on axis ③. Fig.16 shows the stress level in walls with a maximum value about 3.0MPa, which is far beyond the possible strength stress of the equivalent material property.
