NON-STRUCTURAL COMPONENT PERFORMANCE IN FULL-SCALE 4-STORY BUILDING

ABSTRACT

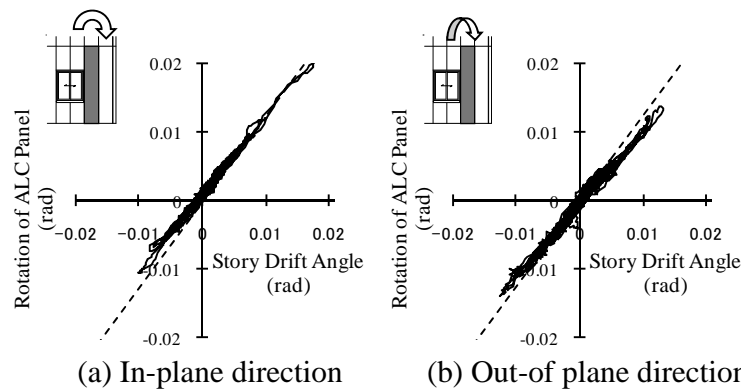
Figure 4. Rotation behavior of the ALC panels at the 1st story by 0.6 Takatori records

Figure 4 shows an example of rotation behavior of the ALC panels under 0.6 times the Takatori records. The dotted line in this figure indicates that the story drift corresponds to the rotation of the ALC panel. So the results of the experiment almost behaved on this dotted line, it is understood that the ALC panels were accommodated to the story drift for both in-plane rotation and out-of-plane rotation. Similar relationships are confirmed under 0.2 and 0.4 times the Takatori records. The results of Figure 4 were provided from the hatching area in the figure. Similar measurement to the openings of the window or the adjacent ALC panels was performed, so the same relationships between the story drift and the rotation were obtained.

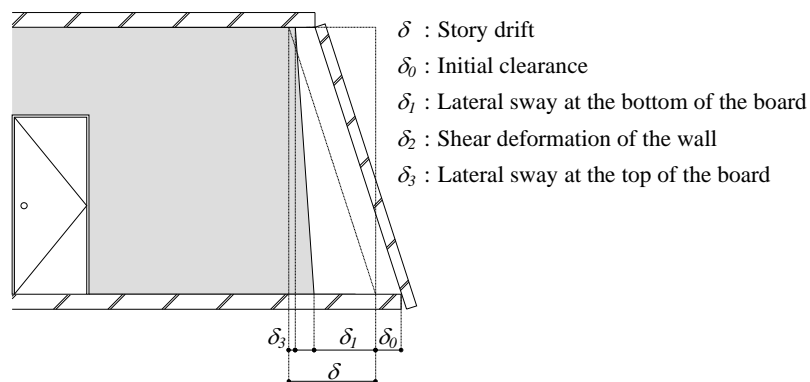
Figure 8 Sway and deformation of the drywall partition

As shown in Figure 8, the story drift δ is expected to correspond to the summation of three kind of displacement of the drywall partition. The first one is the lateral sway at the bottom of the board δ_1 , the second one is the shear deformation of the wall δ_2 , and the third one is the lateral sway at the top of the board δ_3 ; where δ_2 contains the deformation of the board, the metal-stud and the fastener. Figure 9 shows the relationships between the story drift and the lateral sway δ_1 or the shear deformation δ_2 of the drywall partition at the 3rd story under 1.0 times the Takatori records. Significant correlation between δ_1 and δ or δ_2 and δ is observed. At the moment of reaching the maximum story drift by 1.0 times the Takatori records, δ was 36mm, δ_1 was 20mm, δ_2 was 16mm and δ_3 was 0mm in the positive direction. Similarly, δ was 30mm, δ_1 was 20mm, δ_2 was 8mm and δ_3 was 2mm in the negative direction. The ratios of these values were almost constant during the shaking tests.

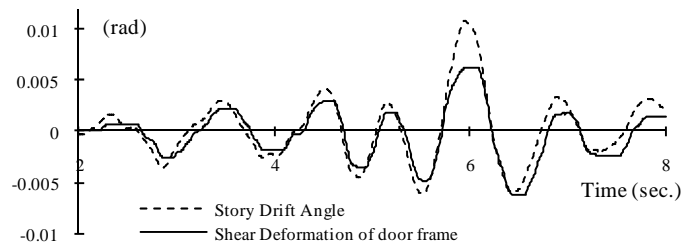
Figure 10. Shear deformation of the door frame at 2nd floor by 0.4 Takatori records

The shear deformation angle of the door frame, which is the non-seismic type at each floor, was measured. Figure 10 shows the time history of the story drift and the shear deformation of the door frame at the 2nd story under 0.4 times the Takatori records. The two values almost corresponded when the story drift was less than 0.005 rad. However, when the story drift exceeded 0.005 rad, the shear deformation of the door frame was not accommodated to the story drift without increasing. It is expected that the reasons of this result are loosening of the screw which fasten the vertical supporting frame of the door to the slab, and the local

deformation of the reinforcing bar or the steel plates connecting the door frame and the supporting frame. Consequently, the shear deformation of the door frame did not become excessive. Despite of the maximum story drift of approximately 0.02 rad during the shake test, the door could be opened and closed.
