Permanent ground displacement induced by soil liquefaction during 1983 Nihonkai-Chubu and the 1964 Niigata earthquakes

ABSTRACT: Permanent ground displacements caused by liquefaction during the 1983 Nihonkai-Chubu and the 1964 Niigata earthquakes were measured by pre- and post-earthquake aerial survey, and the causes of the ground displacements based on the geological and the topographical conditions, are discussed.

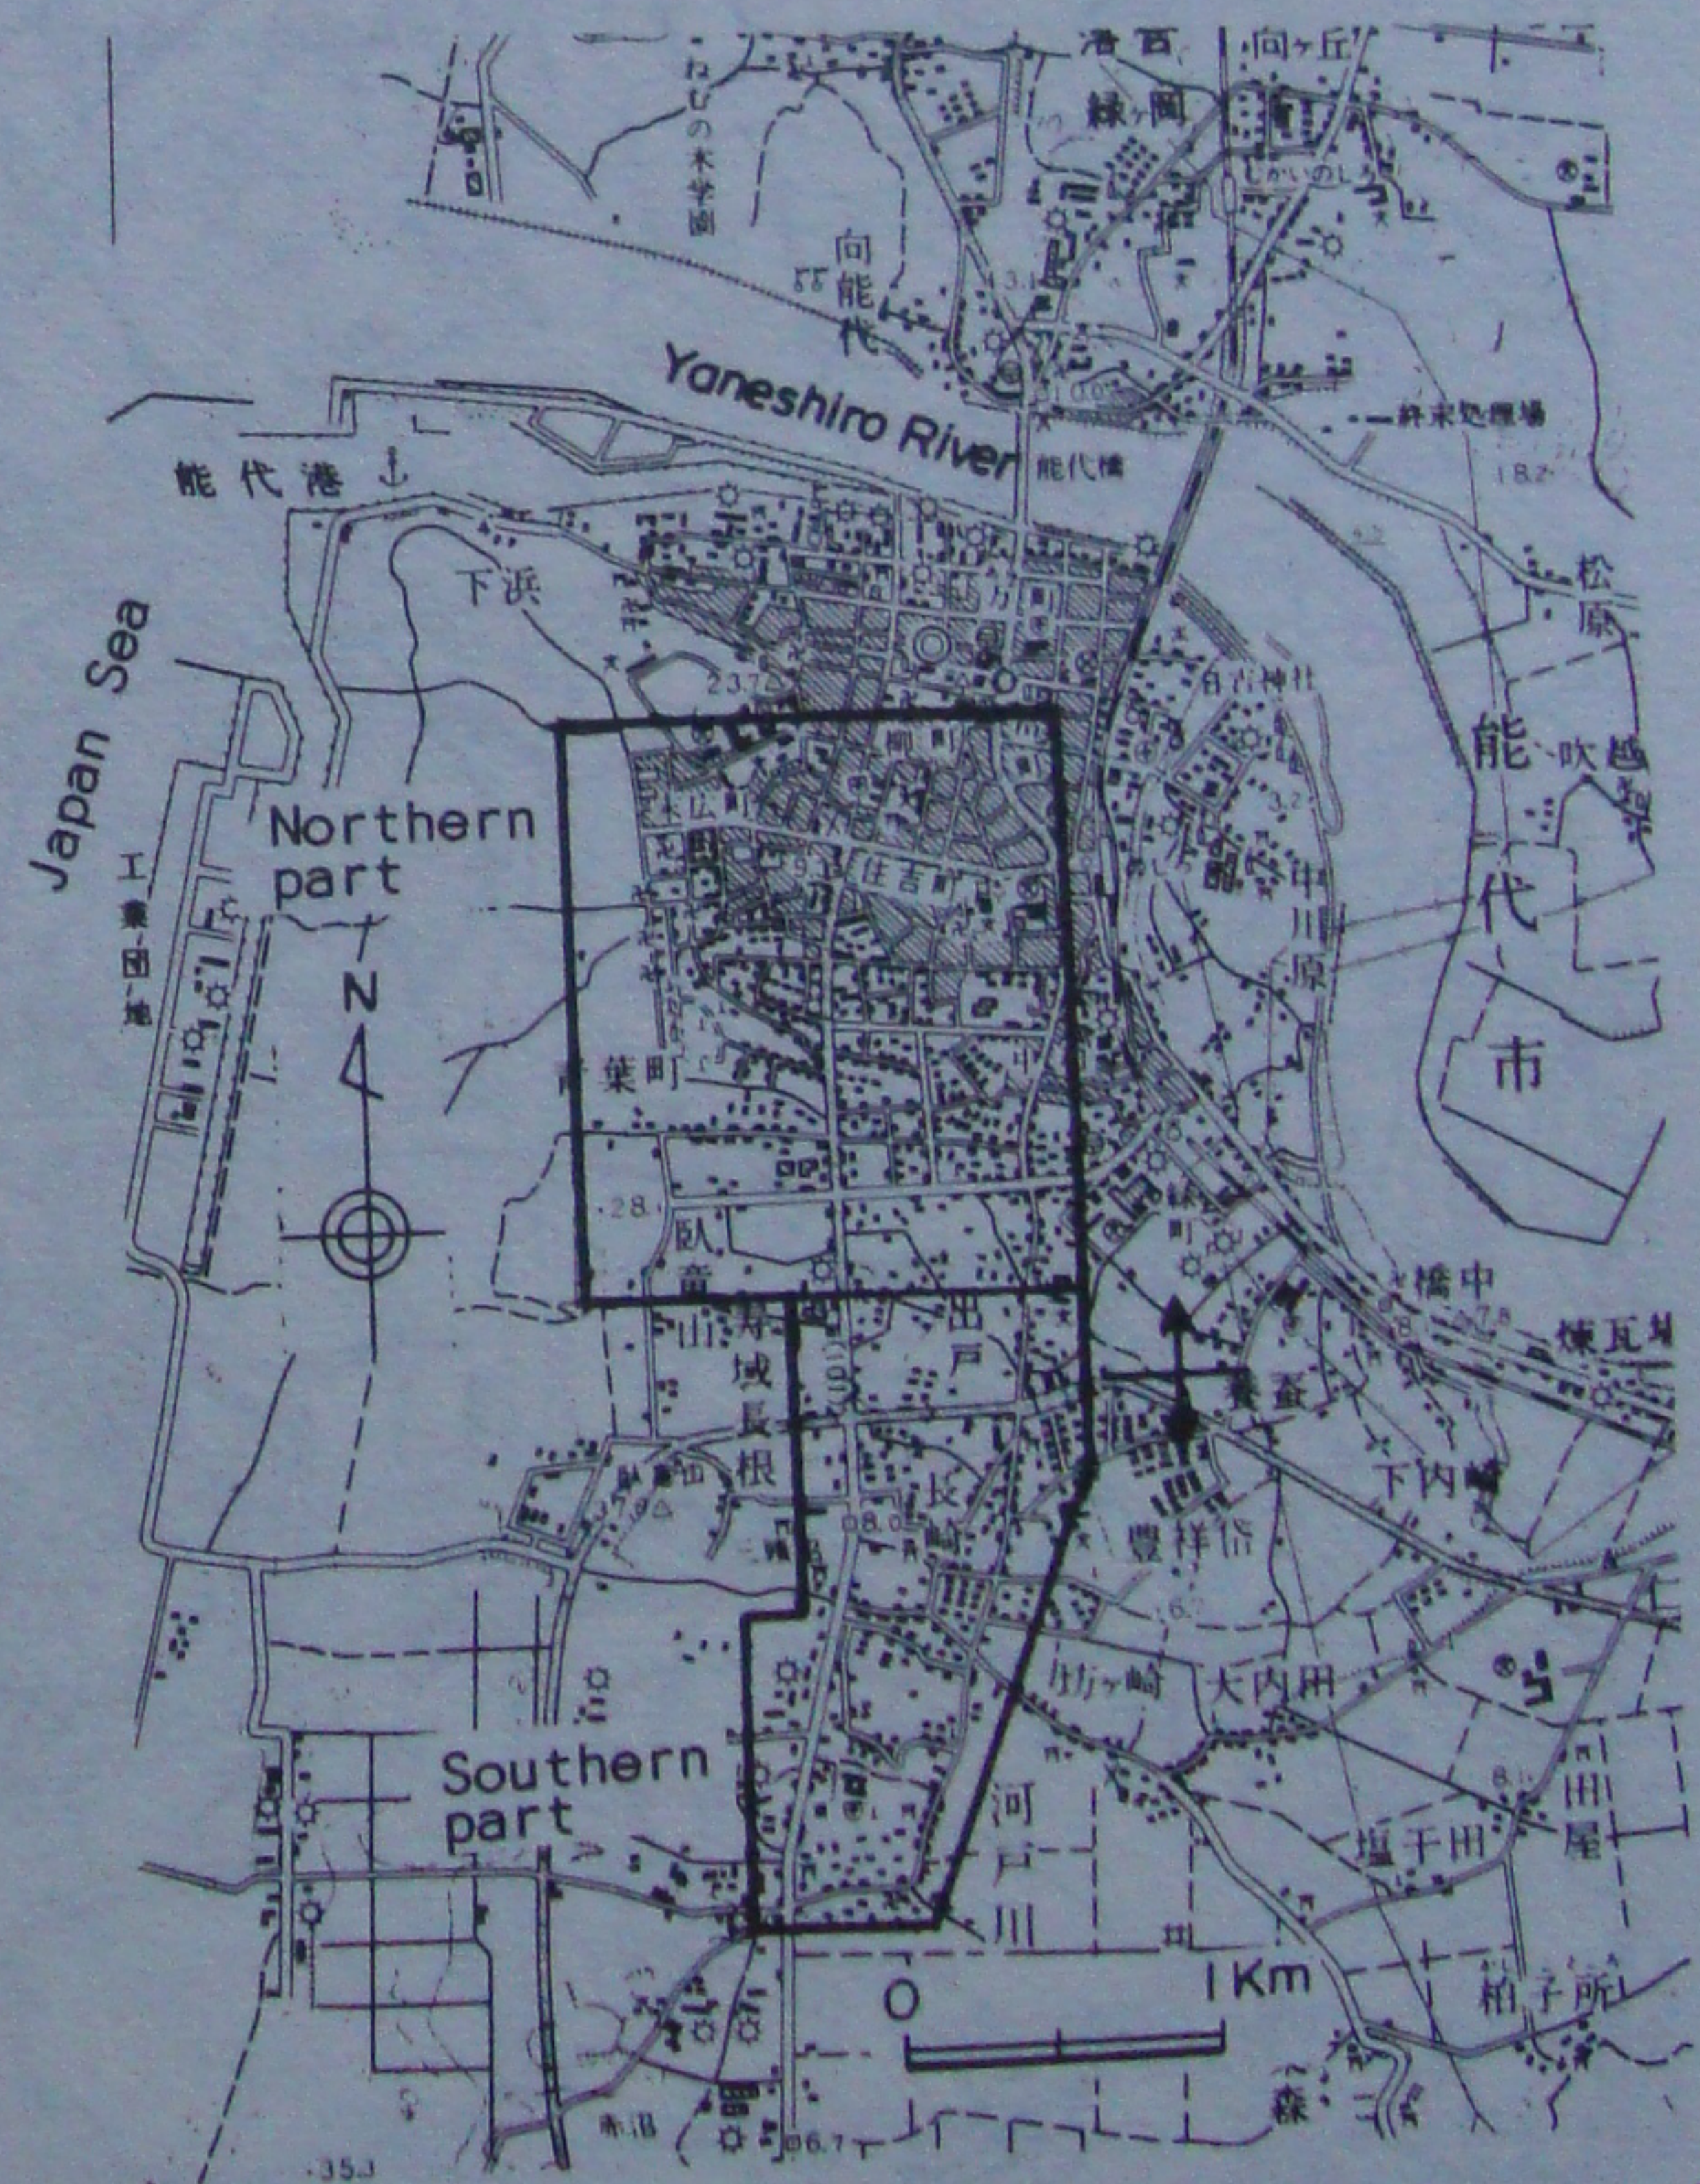
Fig. 2 Measured area of permanent ground displacement in Noshiro City

Permanent ground displacements were measured in Noshiro City (Fig. 2), where most of the urban area is built on the sand dune along the Japan Sea coast and alluvial plane of the Yoneshiro River and caused severe damage to houses, buildings, and lifeline facilities. Numerous sand volcanoes were found in the area where the heavy damage was concentrated, showing that the ground was considerably liquefied. Other ground failures such as

cracks, subsidences, bulging, etc., were also seen in the damaged area.
