Ninth Canadian Conference on Earthquake Engineering Ottawa, Ontario, Canada 26-29 June 2007

SEISMIC SAFETY OF A HISTORICAL ROW HOUSE COMPLEX BUILT DURING OTTOMAN PERIOD

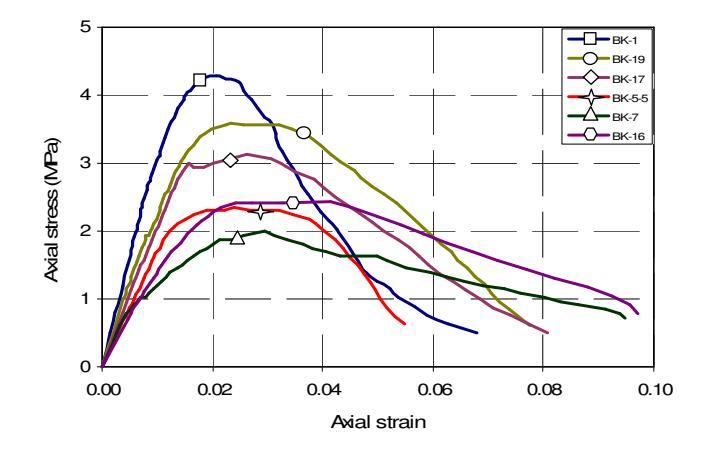
Figure 6: Axial stress-average axial strain relationships of the core samples.

The compressive strength tests are conducted on core samples taken from different floors of the structure, Fig. 5a. While evaluating the results of these tests, specimens exhibiting large variations were taken out of evaluation according to Chauvenet Criteria (Akman 1978). The compressive strengths and elasticity moduli are presented in Table 3. As seen in this table, both compressive strength and elasticity moduli of the specimens taken from the second floor are significantly lower than the specimens taken from the entrance and first floors. The buildings have not been maintained for almost more than 10 years. Therefore, this difference in compressive strength and elasticity modulus may be attributed to reduction of their capacities due to wetting and drying cycles, and humidity conditions, caused by insufficient maintenance of the roofing system. The relationships of axial stress and average axial strain are given in Fig. 6. Average compressive strength is 2.96 MPa and minimum compressive strength is 1.99 MPa. It should be noted that the allowable compressive stress for ordinary structural bricks produced in the field kilns is given as 0.8 MPa by the Turkish Seismic Design Code (2006).

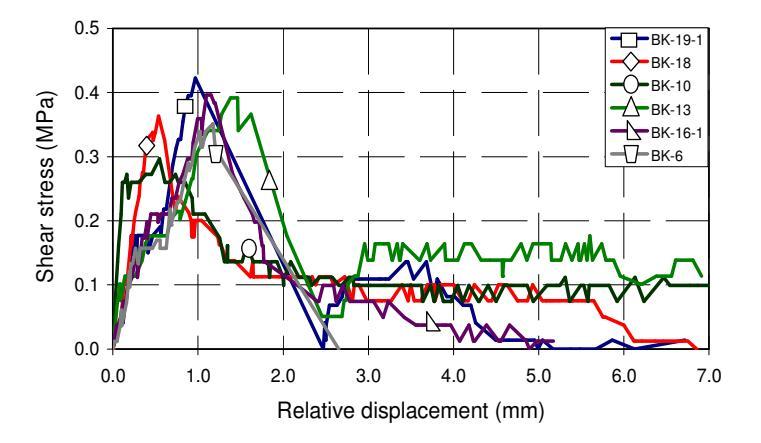
Figure 7. Shear strength-average horizontal relative displacement relationships of the core samples.

Shear strength of core specimens is experimentally found for three different vertical stress levels, which are 0, 0.15 and 0.3 MPa, Fig. 5b. These values are chosen to represent vertical stresses in different floors, namely no axial stress case represents the situation in the second floor, while the axial stress levels of 0.15 and 0.3 MPa is assumed to represent the first and entrance floors, respectively. The location of the specimens in the buildings, vertical stress, axial load and shear strength are shown in Table 4. The relationships of shear stress and average horizontal displacement are given in Fig. 7. Average shear strengths are calculated for each axial stress level and shown in Table 4. As seen in this table, shear strength of cores under varying axial stress conditions are around 0.35- 0.40 MPa. According to Turkish Seismic Code; the shear strength of walls constructed with ordinary solid bricks considered is given as 0.2 MPa, when experimental data is not available. Since the applied axial stresses on the bricks are not high, the shear strengths are found to be close to each other for different levels of axial stresses. It should be noted that many factors may also affect the shear strengths obtained, such as the quality of jointing mortar, environmental conditions, the processes during taking out the cores from walls and preparation process of cores for experiments. Therefore it is believed that the obtained shear strengths just give general information about material qualities.
