FULL-SCALE COLLAPSE SHAKING TABLE TEST OF REMOVED AND RECONSTRUCTED HOUSE OF EXISTING WOODEN FRAME CONSTRUCTION HOUSE

K. Miyazawa¹, C. Tsuda², T. Akiyama³ and H. Isoda⁴

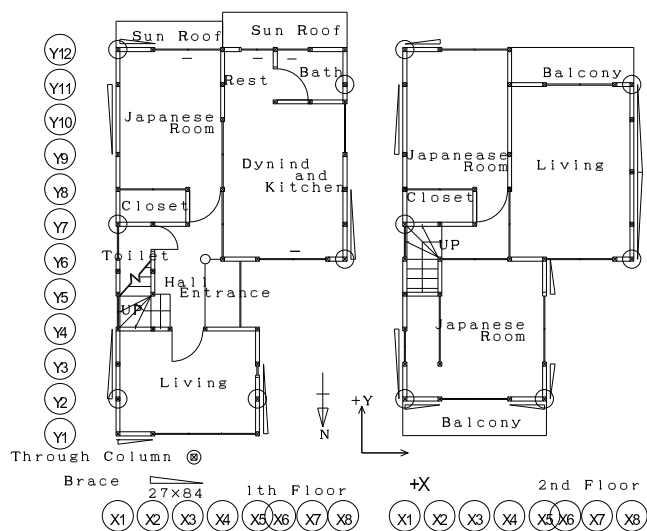
Figure 1. Existing house.

Fig. 1 shows the plan of an existing house where has built Sayama city in Osaka Prefecture. It was a two storied wooden frame construction house built in 1980. The floor space of the first floor and the second floor space were 47.8m² and 40.1m² respectively, and it was the house of a general scale at that time. The wooden braces of the section 27mm x 84mm ~ 90mm were used as a bearing wall. The groundwork of outside walls is wooden las (100mm x 9mm) and mortar finish, and moreover, the inner wall is mortar finish and gypsum board finish. This wall is effective bearing wall for the old Building Standard Law at the construction time, but, the bearing wall ratio for the necessary effective wall length is 0.37 times the present standard, so that, this building is illegal built to the present law (Table 2). Building Standard Law of Japan was greatly revised in 1981. Such a lot of existing illegal construction is remaining by revising several times of Building Standard Law, and there are a lot of houses where an earthquake-proof performance is insufficient and an earthquake retrofit is necessary.

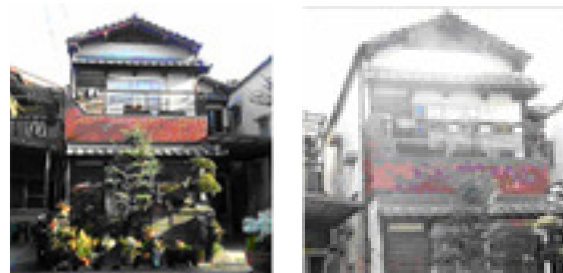
Photo 1. Existing house.

In the existing house, the crack occurred on the outside wall finish mortar, and the aged deterioration of the mortar of the adhesion power between mortar and wood las was caused. The reproduction of this aged deterioration is difficult in the test piece making. Therefore, mortar was damaged by preliminary excitation (by the greatly decreased acceleration of the recorded earthquake wave) and the aged deterioration was reproduced. Reproducibility was judged by agreement of natural period between the existing house and the reconstructed house by the micro-tremor measurement. The first natural period of the reconstructed house is 0.15 seconds and reproducibility does not succeed. The first natural period of 0.17 seconds after the first preliminary shaking came up to 0.20 seconds after the second shaking.

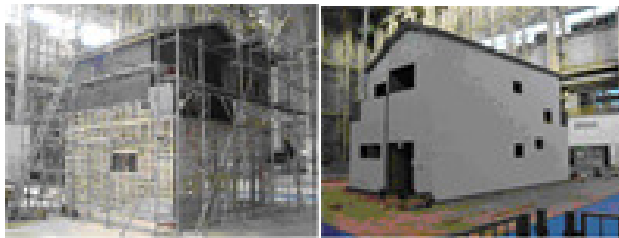
Photo 2. Reconstructed specimen.

The specimen was accurately reconstructed in the existing house as much as possible. The decomposition of structural member was performed to the unit of the material to recycle the material of an existing house to the reconstructed specimen. The mixture ratio of mortar used to finish up the outside wall was determined from a general mixture ratio when the house was constructed (1980), in considering the compression test of two and four weeks. Wood, tiles, battledore bolts and floor joists (only in the Japanese-style room) of an existing house were recycled in the removed and reconstructed house, and mortar, tree las, wire las, plasterboard, nails and the anchor bolts were used in the new one. Moreover, a part such as the first floors is not reproduced. It was judged that the second floor was strength shortage in a perpendicular direction for the loading of a weight (live load and a part of dead load). Therefore, 12mm plywood was installed with N65 nails at spacing of 150mm as reinforcement. Because it was remarkably insufficient to be X direction brace, the wood brace of 0.9m length with a section of 120×32 that the top and bottom is reversed to existing wall in Y7-X2 on the line of X3. Therefore, the effective wall length rises from 5.85m to 7.20m and from 0.37 to 0.46 in the rate of the fulfillment of the effective wall length for the present regulation. The number and how to strike the nail at the end of a wood brace (included the nail on the column) followed an existing house. Moreover, it was nailed on the position different from existing nail hole, so that the reshoot of the nail causes strength shortage. The weight of a live load and a part of dead load was evenly distributed on the second floor of the specimen by using the channel type steel and sand.

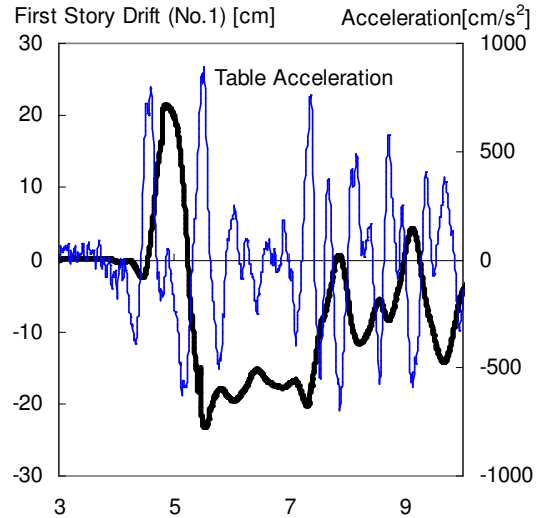
Figure 3. Response of first story drift (No.1).

It was not collapsed in the shaking table test No.1, though the X-direction story drift of Y1 frame line in the first story is 23.3cm, Y12 is 25.8cm, and the average is 24.6 cm (Table 5), The maximum average story drift of the first story is up to 1/11rad. (positive and negative are same, Fig. 2). The maximum residual story drift of the first story is as large as 1/60 rad. on the frame line Y1 shown in Table 5.

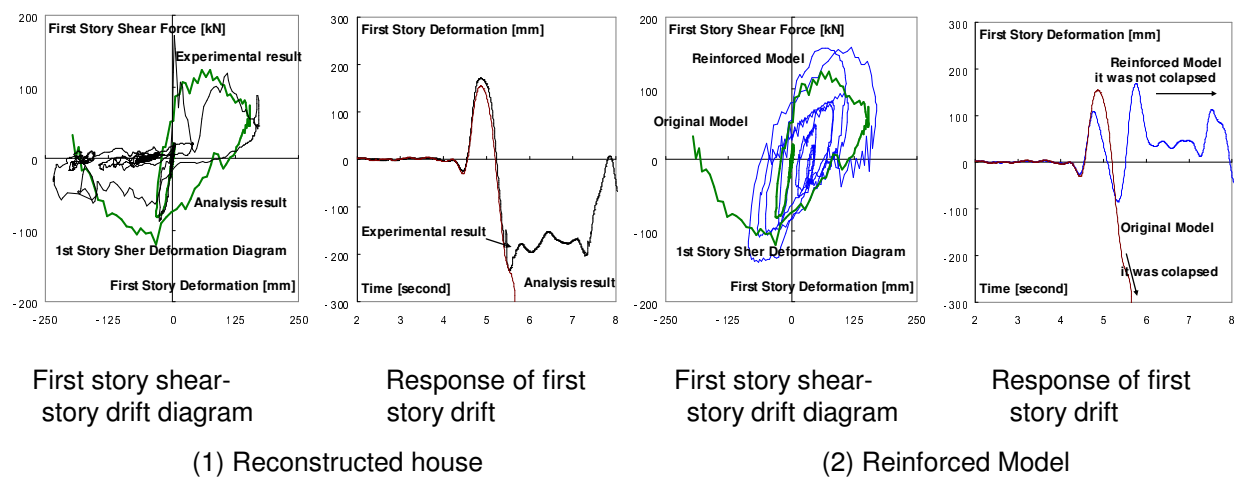
Figure 10. Result of vibration analysis.

The analysis corresponding to the shaking table test of experiment No.1 of Chapter 2 was done by the above-mentioned analytical model. The seismic wave that adjusted the maximum acceleration of the JMA_KOBE wave to 120% was used as an earthquake input. Moreover, the acceleration wave measured on the shaking table of experiment No.1 of Chapter 2 was used for the analysis. Fig. 10. shows an analytical result of the shaking table test No.1. The maximum response of first story shear is 122kN in the positive side, and the story shear coefficient is about 0.45 according to an analytical result. An analytical result indicates that the maximum story shear is on a positive side as well as the experiment, and the story shear decreases up to about 36% afterwards. The story drift at that time is about 1/2rad. then, the specimen displaces to the negative side and becomes the maximum response of story shear 120 kN in a negative side, and it becomes a collapse as story shear strength decreases. The tendency until collapse was possible to consent to be understood though there was a difference in the story shear strength of the analysis and the experimental result. In addition, the collapse limit (point that the story shear strength becomes 0 in the analysis) of the analysis is 1/1.6rad. It is roughly corresponding to an analytical result, though the point that had begun to collapse was defined as the collapse limit in the experiment. However, the specimen doesn't collapse in the shaking test No.1, but after then, it collapsed in the shaking test No.4.

Next, the structural safety and possibility of collapse by an earthquake-retrofit are examined by an analytical investigation. The reinforcement was made using plywood and wooden braces that are used as an ordinary earthquake-retrofit for a lot of wooden dwelling houses. Reinforcement assumed only the first floor to target that the ratio of the effective wall length /necessary wall length demanded by the law of earthquake-retrofit becomes about 1.0 roughly. Fig. 10 shows an analytical result of earthquake-retrofit. The maximum story shear strength and an equivalent rigidity have changed greatly by an earthquake-retrofit. In particular, the earthquake-retrofit specimen does not collapse and the response has ended, though a large deformation is caused on a positive side in the analysis.
