Report on
Earthquake Reconnaissance of
*The M7.8 Gorkha, Nepal Earthquake on
April 25, 2015 and its Aftershocks*

Canadian Association of Earthquake Engineering (CAEE)
L'Association Canadienne du Génie Parasismique
Reconnaissance Team

2017

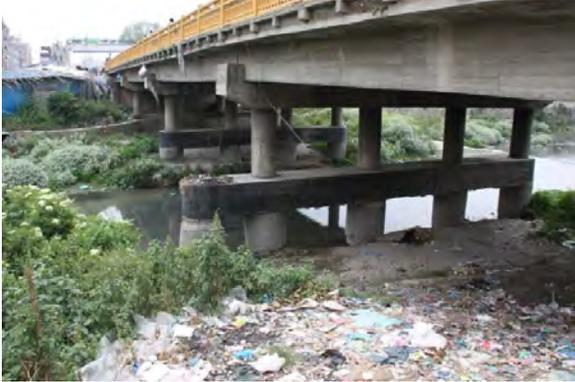
Figure 3.4: Substructure view
June 11, 2015

The bridge was functional with unrestricted traffic flow. No movements of the river banks or the piled river bents were visible to the naked eye (Figure 3.4). There were, however, signs of the bridge being subjected to longitudinal movements during strong ground shaking as seen from compressional cracking and rotation of the abutments (Figure 3.5).

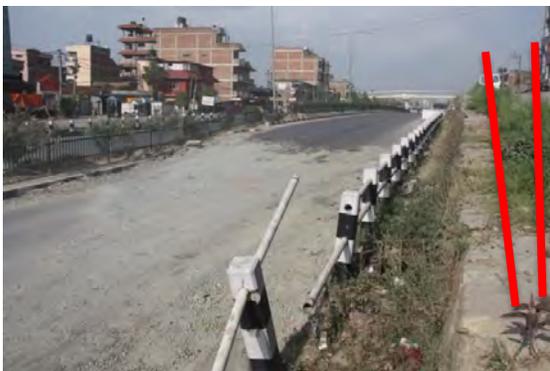
Figure 3.6: Road slump (after repair)

One of the notable earthquake-shaking-induced road slumps occurred in Lokanthali along the Araniko Highway. The area is underlain by the Gokarna Formation that consists of laminated and poorly graded silty sand. An estimated 200-m-long section of the highway slumped due to cyclic softening of foundation soils and associated lateral spreading. Local settlements of up to 1 m have occurred in the sloping areas of the highway embankment (ref. Pokrel et al, 2015).

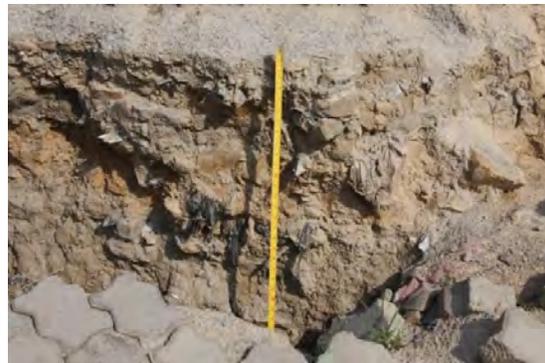
Figure 3.7: Local settlement

Low-rise structures located in the general area surrounding the road slump also indicate settlement and tilting following strong shaking from the earthquake. Permanent lateral displacements of the order of 0.2 to 0.3 m along with 3 to 4 degree tilting of the structures were common (Figures 3.6, 3.7, and 3.8).

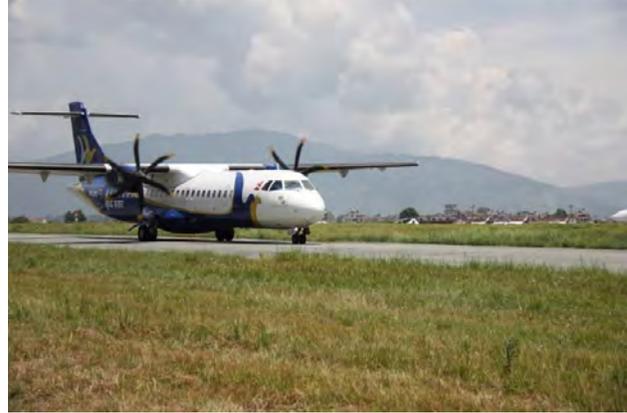
Figure 3.11: Airport runway in operation
June 14, 2015

No disruptive damage was observed in the airport runway other than some minor cracking. The runway was operational without any restrictions (Figure 3.11).

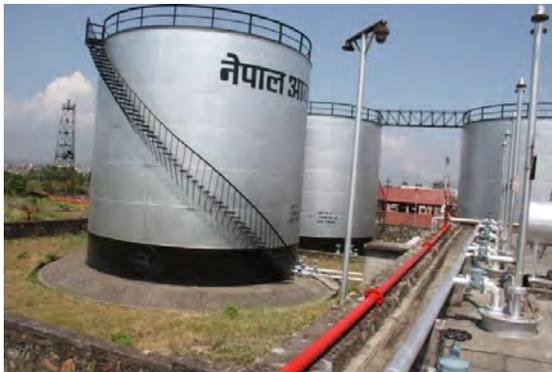
Figure 3.12: Three storage tanks in the upper terrace, June 14, 2015

No damage was visible in the tank foundations or the piping connected to the tanks at the bottom or the elevated walkway connecting two of the tanks. However, based on discussions with a contractor who was performing some repair work in the adjoining fire water pits, it is understood that some 20 kilo litres of oil spilled out of the tanks during strong shaking due to sloshing.

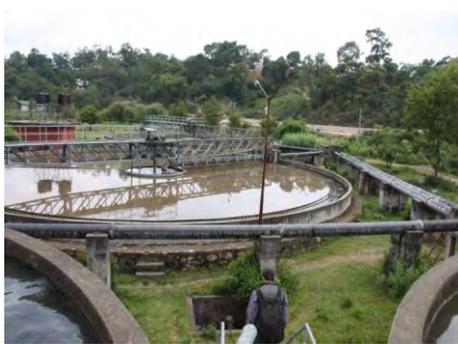
Figure 3.16: Secondary clarifiers
June 14, 2015

No visible geotechnical damage was noted in the foundations supporting the major structures comprising the treatment plant, connecting pipelines or in any of the affiliated support structures (Figures 3.16 and 3.17).

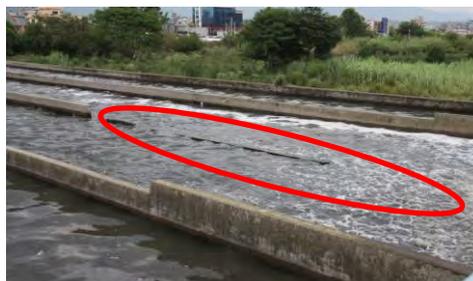
The only visible reportable damage consisted of some minor structural damage to the walls of the rectangular sludge treatment tanks (Figure 3.18).

Figure 3.18: Collapsed parts of the vertical walls of the sludge treatment tanks

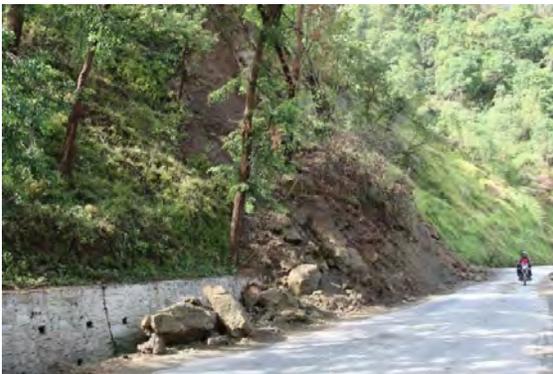
Our team observed several small landslides both on the way to and inside Dolakha on June 13, 2015. They are considered to be representative of failure of soil masses in steep terrain due to strong ground shaking (Figures 3.20 and 3.21).

Figure 3.20: Soil failure in steep terrain
June 13, 2015

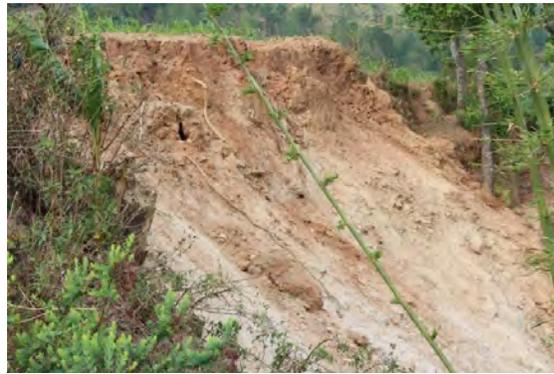
Figure 3.21: Soil failure, Dolakha District
June 19, 2015 (credit: B. Pandey)

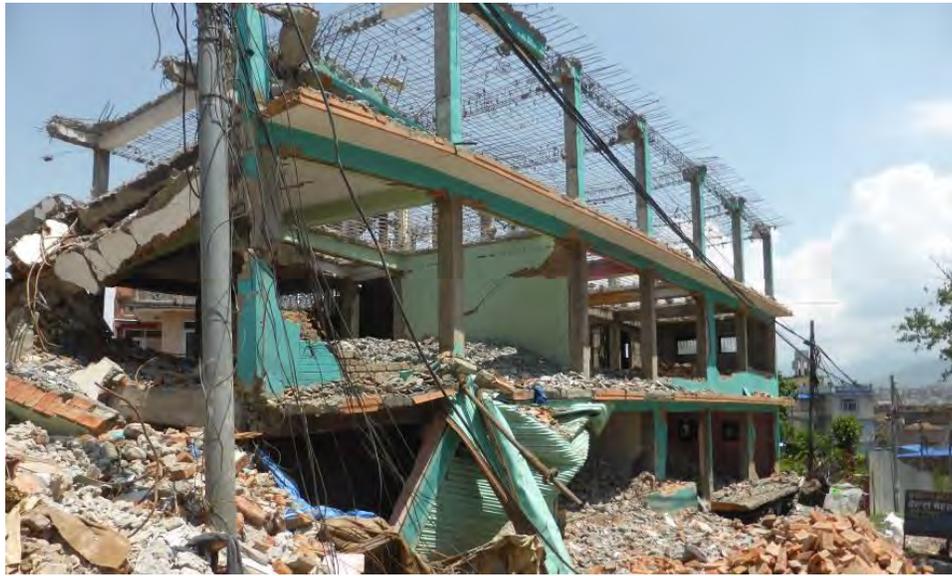
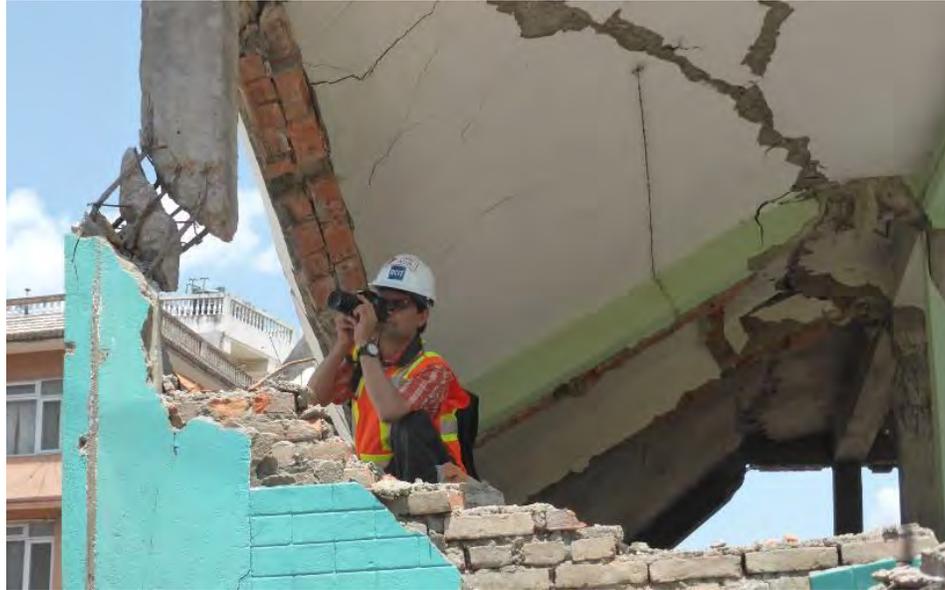
One of the collapsed buildings, located in the Sitapaila area of Kathmandu, where several low-rise RC buildings were significantly damaged or collapsed. This five-storey building was constructed in 1999, and it was built on sloped ground. The building had a regular plan shape, with 20.3 m (66.5 ft.) length and 9.45 m (31 ft.) width, as shown on the floor plan in Figure 5.7. The building had an open ground floor which was used as a restaurant; thus, two exterior sides were open (no walls). A survey of the building ruins (Figure 5.8a) showed that RC columns were 229 mm (9 in.) square, and were reinforced with 6 longitudinal bars: 4 bars with 16 mm diameter and 2 bars with 10 mm diameter. Transverse reinforcement (ties) consisted of 5 mm wires at 203 mm (8 in.) spacing, and the anchorage was provided by 90-degree hooks. Beams were 229 mm (9 in) wide and 330 mm (13 in) deep, including slab thickness of 102 mm (4 in). Longitudinal reinforcement consisted of three 12-mm-diameter bars, while transverse reinforcement was in the form of 5-mm wires at 229 mm (7 in) centre-to-centre spacing. The cause of building collapse is believed to be a weak storey irregularity, which caused a significant seismic demand on RC components at the ground floor level. Unfortunately, these RC components were not adequately designed and detailed for seismic loading (Figure 5.8b).

Figure 5.8: A collapsed RC building which had a restaurant at the ground floor level at Sitapaila, Kathmandu: a) an overall view of the building damage (note that the demolition had started at the time of the visit), and b) RC column detail (Photos: Svetlana Brzev)

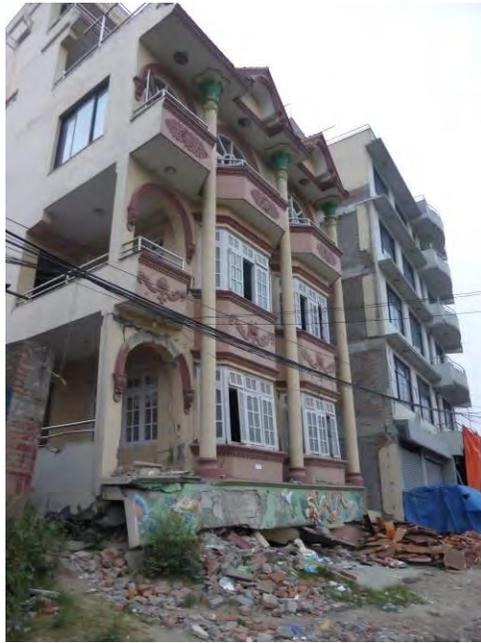
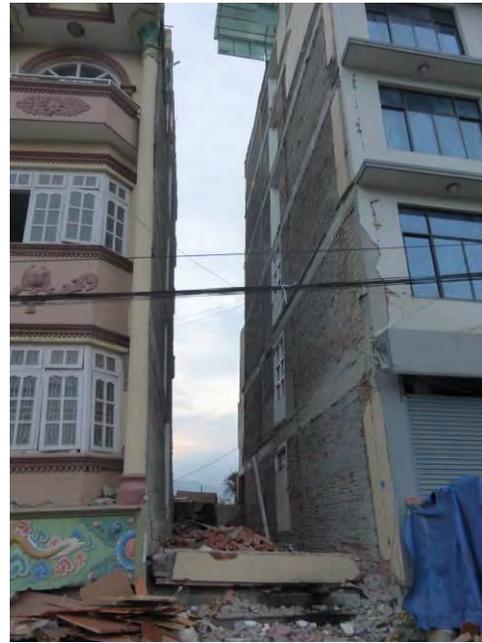
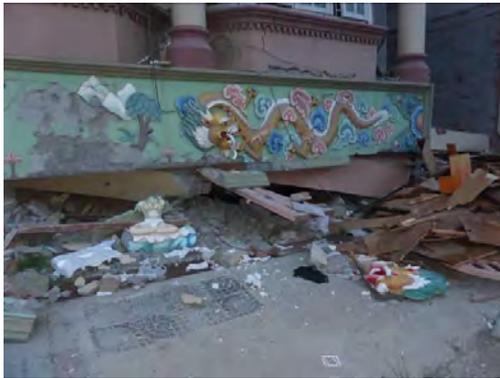
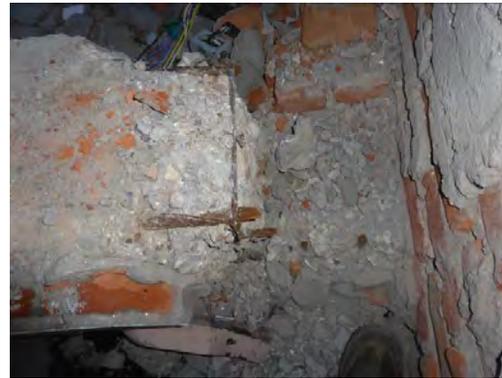
Another example of a collapsed building with a weak-storey failure mechanism was observed in the vicinity of the previous building (in Sitapaila, Kathmandu). This five-storey building had a restaurant space at the ground floor and a setback at the top floor level (Figure 5.9a). Originally standing adjacent to the neighbouring building that remained undamaged in the earthquake, when the ground floor collapsed, the building moved by more than 2 m (Figure 5.9b) and c). It was observed that the longitudinal reinforcement (made from Torkari steel) in one of the columns fractured due to significant tensile stresses at the base of the building (Figure 5.9d).

Figure 5.9: A collapsed RC building in Sitapaila, Kathmandu: a) an exterior view of the building showing the collapsed ground floor, b) a side view showing the direction of collapse, c) a detail of the collapsed ground floor, and d) a detail of RC column failure at the base showing the fractured longitudinal reinforcement (photos: Svetlana Brzev)

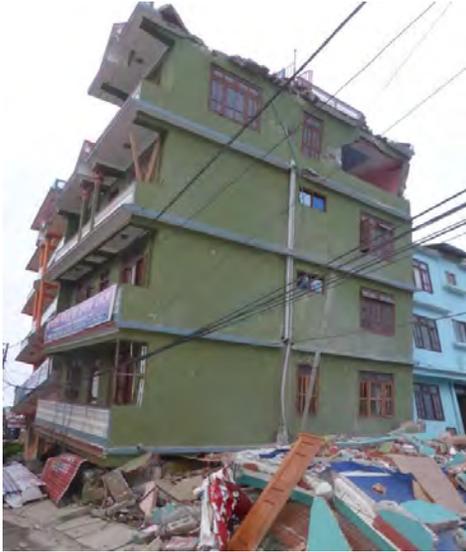
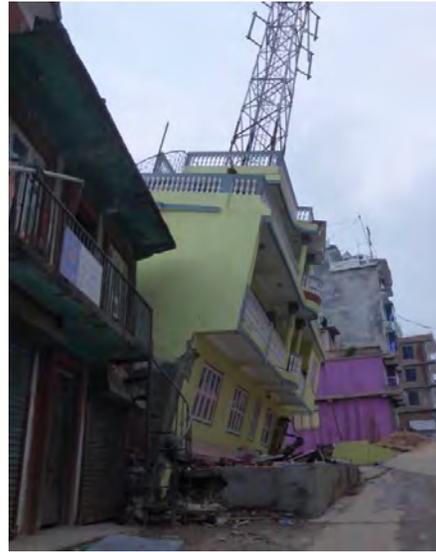
Several collapsed buildings with a weak-storey irregularity were observed in the affected regions outside the Kathmandu Valley. For example, in Charikot, the district centre for the Dolakha district, several RC buildings with open storefront collapsed, as shown in Figure 5.10. However, adjacent RC buildings in the same street and with similar construction features experienced some damage, but did not collapse (Figure 5.11). Majority of buildings in that street were hotels; thus, infill walls were continuous up the building height. It can be seen from Figure 5.11 that the masonry infill walls experienced some cracking. In some cases, these walls collapsed, but the damage in adjacent RC components was negligible.

Figure 5.10: Building collapses due to a weak-storey irregularity in Charikot, Dolakha District: a) an open storefront building and b) a building in the same street with the collapsed ground floor and a tower at the top (photos: Svetlana Brzev)

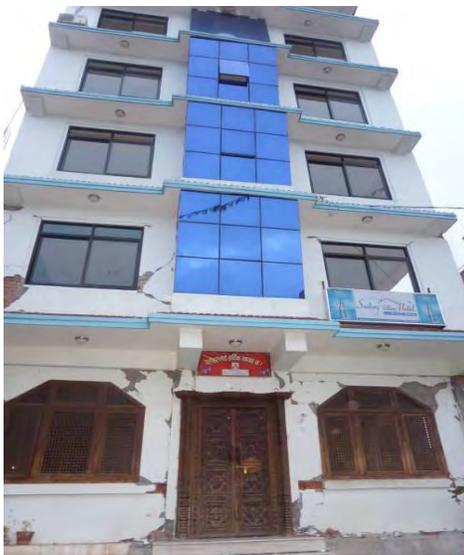
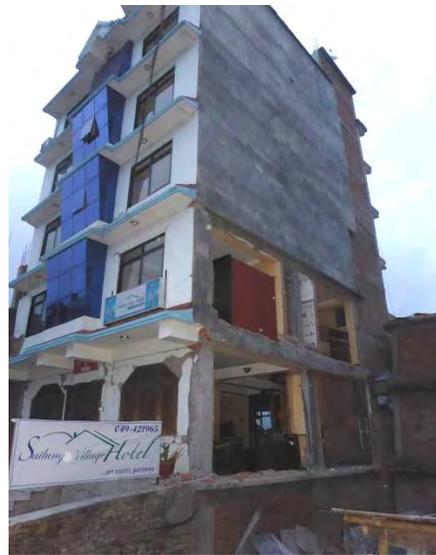
Figure 5.11: This RC building in Charikot, Dolakha District was located adjacent to the collapsed buildings shown in Figure 5.10, but it suffered only a moderate damage: a) a front elevation showing the cracks in masonry walls at the bottom two floor levels and b) a side elevation showing severely damaged/collapsed walls at the bottom two floor levels (photos: Svetlana Brzev.)

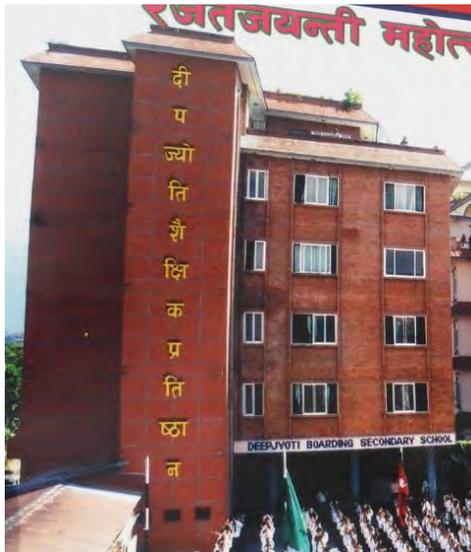
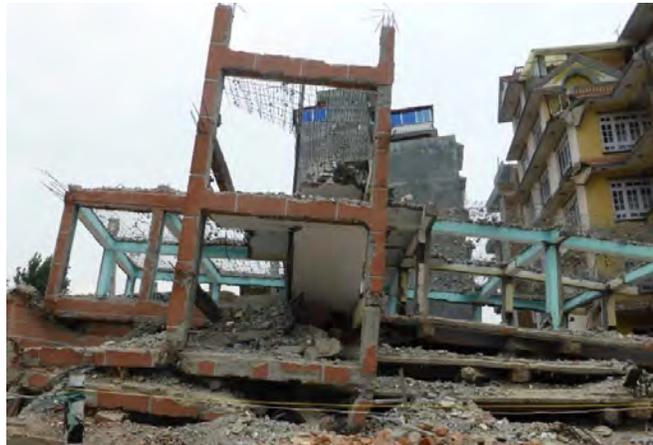
Dipjyoti School in Gongobu area of Kathmandu is another example of a building which collapsed due to an increased seismic demand caused by structural irregularities. The building was located in an area where several 5-storey high RC buildings collapsed or were severely damaged. The building was a six-storey RC frame with brick masonry infills. The building had an irregular T-shaped plan and a setback at the top floor level. Some of the infill walls were discontinuous due to an open area at the ground floor level, as shown in Figure 5.12a). It appears that the building was designed by an engineer. Typical column size was 305 mm (12 in) square, while the beams were 305 mm (12 in) wide and 432 mm (17 in) deep. It can be seen from the figure that the lowest three floors completely collapsed (Figure 5.12b). An inspection of some of the exposed columns showed closely spaced ties (including additional diamond-shaped ties), and Torkari steel used for longitudinal reinforcement (Figure 5.13). An exposed portion of the frame which did not collapse (Figure 5.14) showed absence of flexural hinging in the beams and columns (possibly because the collapse mechanism formed at the lower floors).

Figure 5.12: Dipjyoti School, Kathmandu: a) before the earthquake (as featured in a school brochure), and b) collapsed building after the earthquake (photos: Svetlana Brzev)

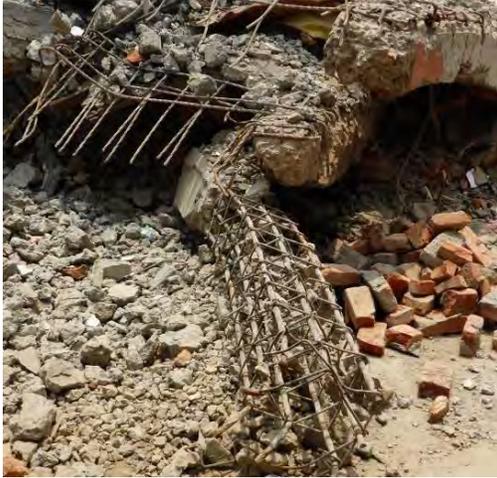
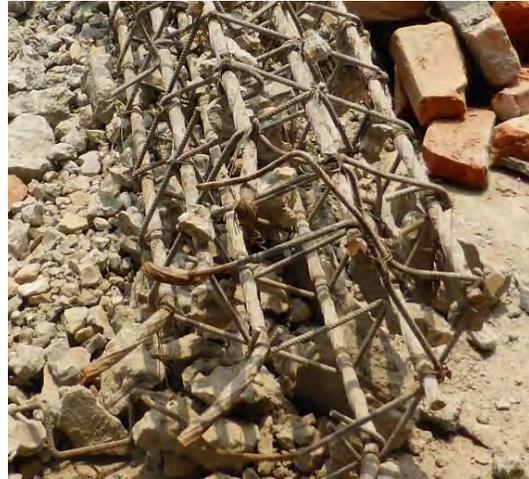
Figure 5.13: Details of the collapsed Dipjyoti School in Kathmandu; note closely spaced ties and Torkari steel used for the longitudinal reinforcement (photos: Svetlana Brzev).

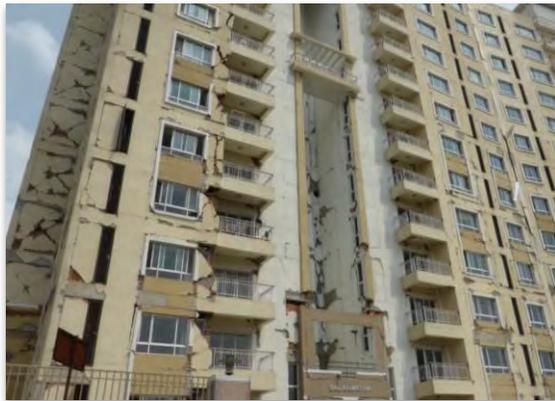
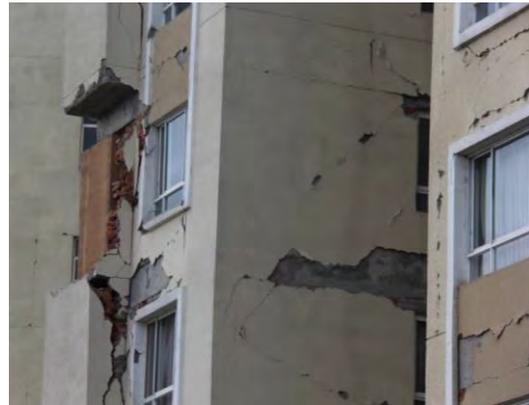
It was observed during the field survey that the buildings had suffered extensive damage. There was extensive dislodging of the exterior brick infills from the RC structure (see Figure 5.22). We were not able to access the interior of these buildings and assess the damage. We did not have access to structural drawings for the buildings. However, it appears that these buildings were designed with RC moment frames as the primary structure, and were infilled with brick masonry walls to complete the architectural and building functional requirements.

Figure 5.22: Damage patterns in medium-rise RC buildings: a) extensive diagonal cracking in masonry infills indicates a significant drift, and b) some of the unconfined masonry walls fell off the building (photos: Svetlana Brzev).

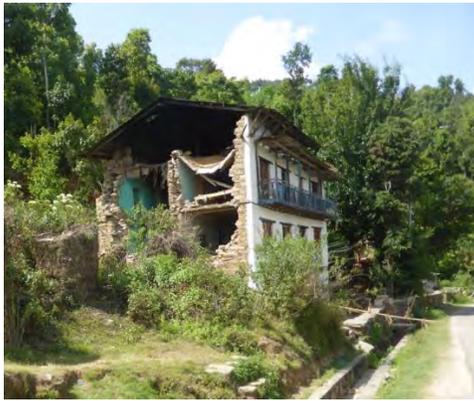
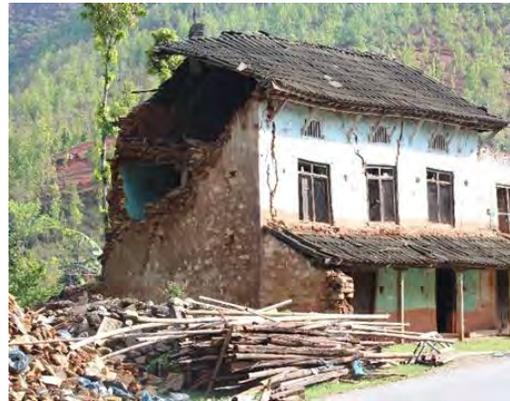
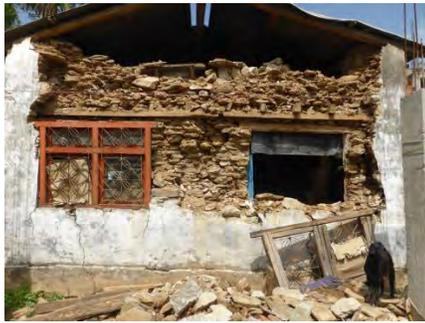
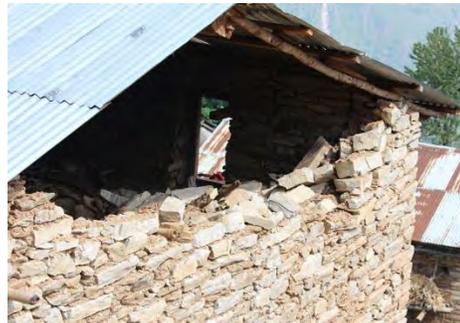
a) Complete failure of side wall

b) A partial failure of gable wall

c) Failure of gable wall extended

d) Failure of gable wall

Figure 6.10: Patterns of out-of-plane failure in stone masonry houses (Photos: B. Pandey)

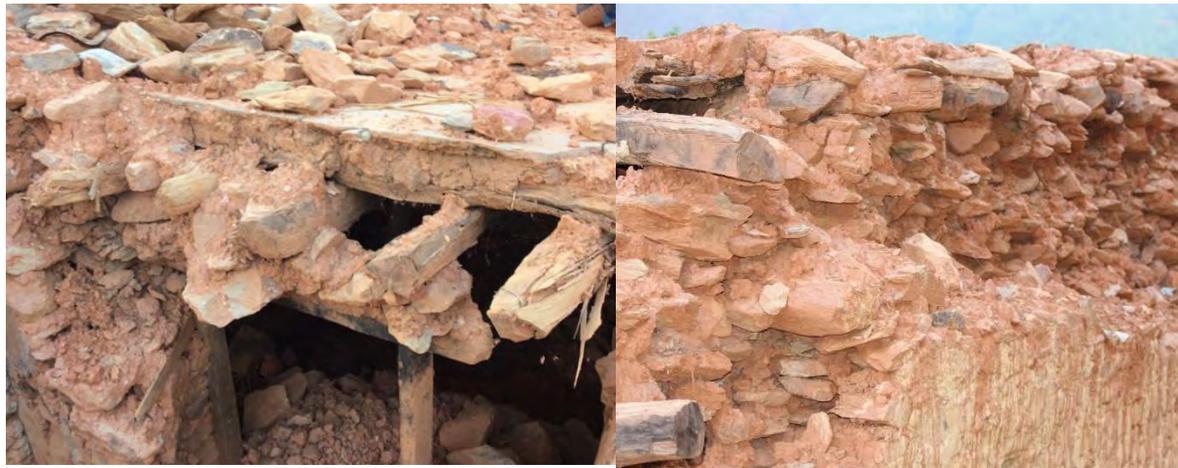
painting of joists indicates that the relative movement is about 8 cm. Figure 6.12 shows the joists supported by the wall over full length. It was evident that the floor joists restrained inner wythes of random-rubble stone masonry walls while the outer wythes collapsed in some cases due to the partial joist bearing (Figure 6.12).

Figure 6.12: Partial bearing of floor joists on a stone masonry wall: a) a view from the top and b) floor joists on top of the wall prevented collapse of the interior wall wythe (Photos: B. Pandey).

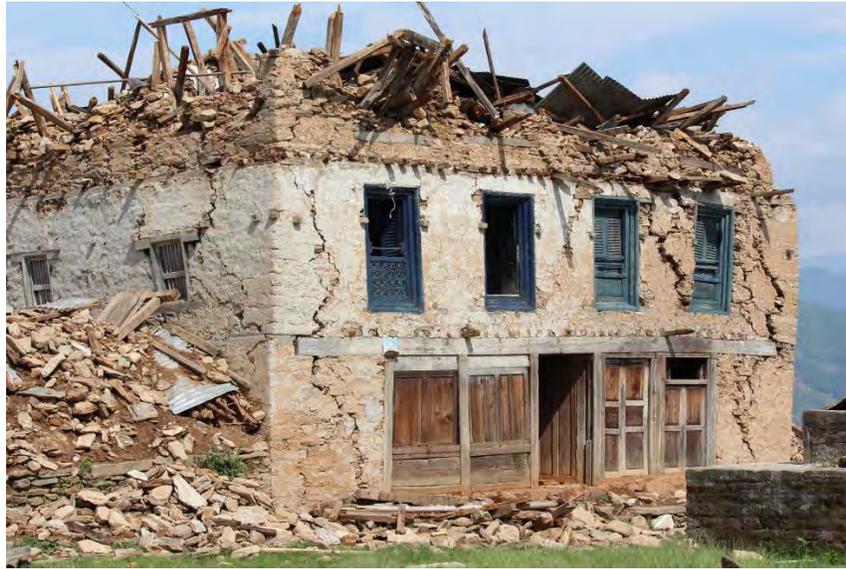
In some areas (e.g. Dolakha District), floor joists in many buildings extended over the full wall thickness, often over bearing logs running parallel to supporting walls; this resulted in comparatively better earthquake performance. Figure 6.13 shows a building with closely spaced joists at both floor levels. Although the building sustained heavy damage at the roof level, it is believed that the joists were effective in preventing the wall collapse.

Figure 6.13: A building with floor joists bearing over the entire wall thickness (Photo: B. Pandey)

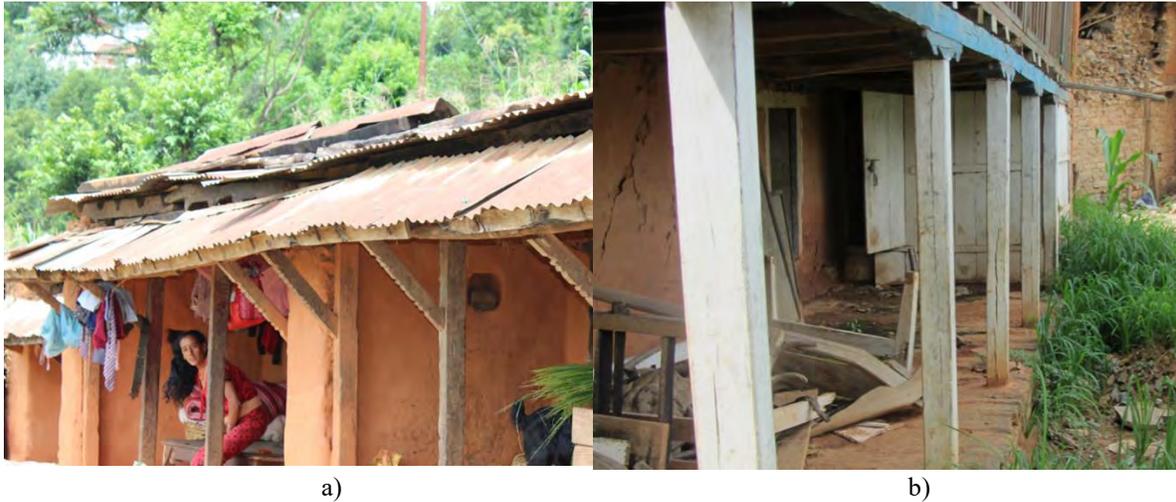
Floor joists bearing over the full wall thickness were also observed in two-storey buildings with porches or balconies, houses that performed well in the earthquake. In the village of Kalikasthan, Rasuwa District, two-storey stone masonry houses sustained the earthquake without collapse (but with heavy damage), while most single-storey houses in the same village were flattened to the ground. A careful observation of housing construction practices in the village showed that the villagers did not make fully bearing floor joists over a wall. However, at first floor level of two-storey houses, they usually have balconies that have extended joists passed over the wall. Because of the balconies or porches, the joists had to fully bear on exterior walls and extend outside the building. As a result, two-storey buildings experienced damage or collapse at the upper floors, but the ground floors remained functional after the earthquake. Figure 6.14a shows a building where the second storey collapsed in the earthquake but the ground floor remained intact due to the front porch. Figure 6.14b shows a portion of the building which survived the earthquake without significant damage; this could be attributed to the presence of a balcony.

Figure 6.14: Good seismic performance of two-storey stone masonry houses: a) ground floor of a two-storey house with a porch and b) a two-storey house with a balcony (Kalikasthan village, Rasuwa District) (Photos: B. Pandey)

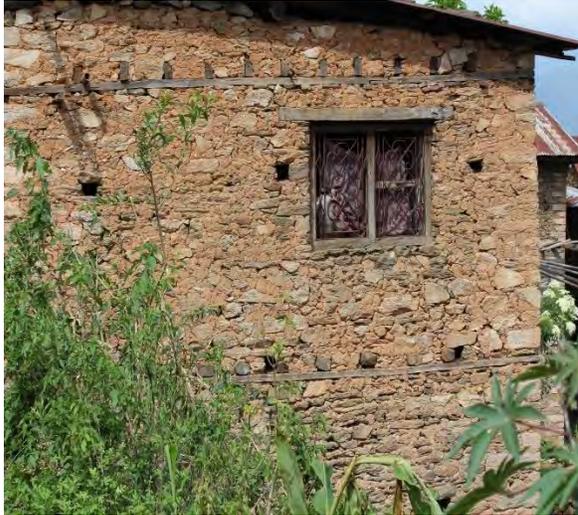
a) Details of timber bands

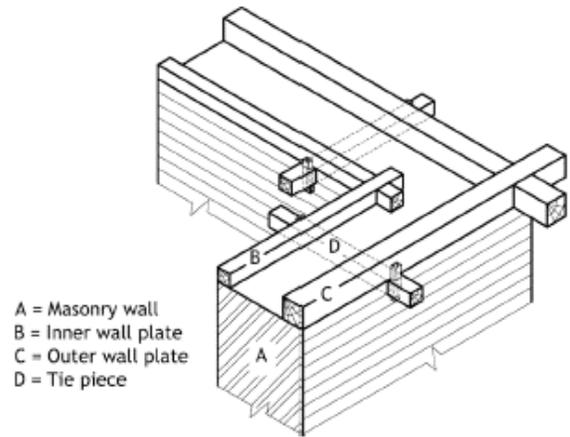
b) Timber band (a conceptual drawing)
(Shankya et al., 2014)

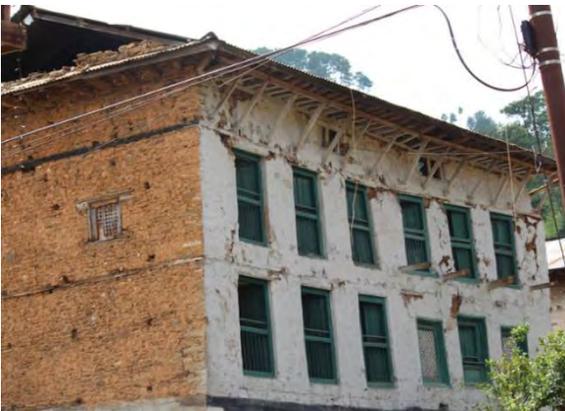
c) A stone masonry house with a large number of windows remained undamaged due to the presence of floor bands (Bhimsen).

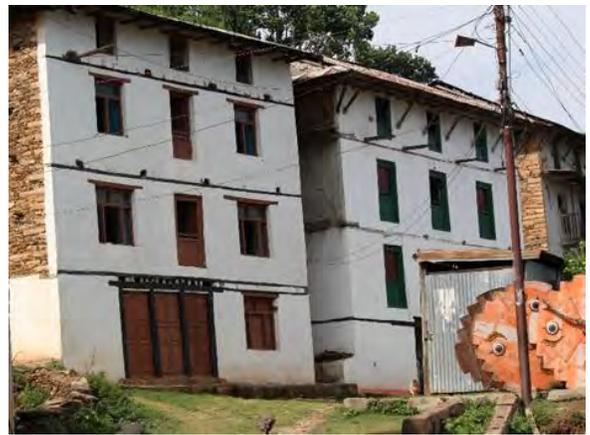
d) A four-storey stone masonry house with floor bands remained undamaged in the earthquake (Dolakha District).

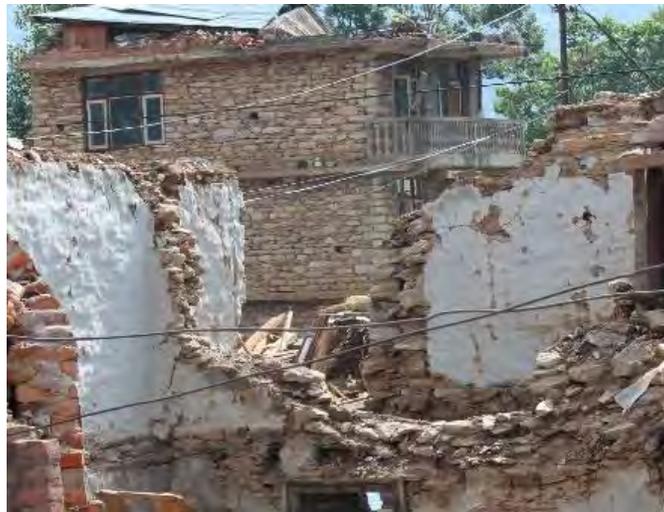
Stone masonry houses with rigid floors such as RC slabs performed well in the earthquake. Rigid RC slabs have a positive effect since they are cast on top of the walls and help maintain structural integrity of a building. For example, a four-storey house in Dolakha Bazaar had stone masonry walls and an RC floor slab, as shown in Figure 6.17 (shown in the background). The house did not experience damage at the bottom three storeys with RC slabs, but the top floor with the light-weight CGI sheet roofing collapsed. Several adjacent stone masonry houses that did not have RC floors collapsed in the earthquake.

Figure 6.17: A positive effect of RC floor slabs in a stone masonry house (Photo: B. Pandey)

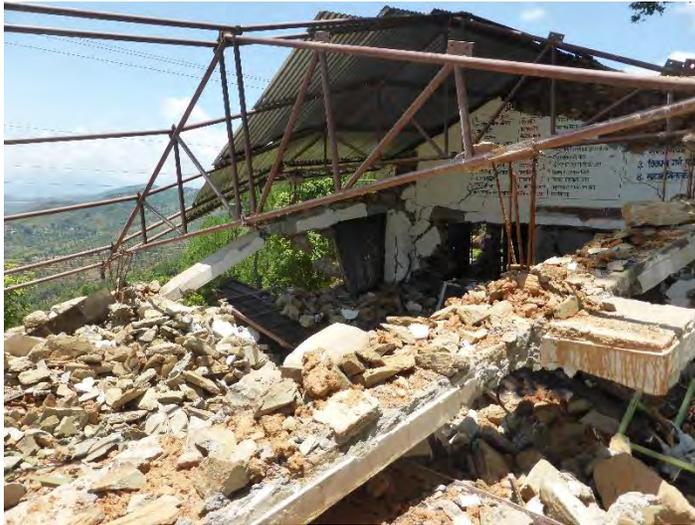
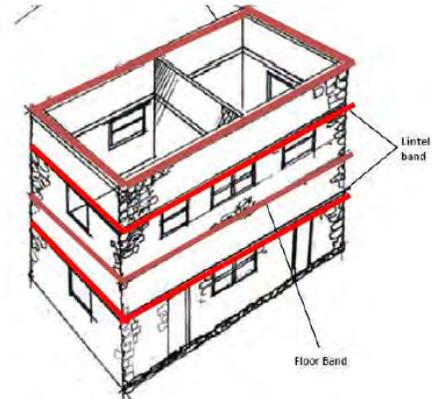
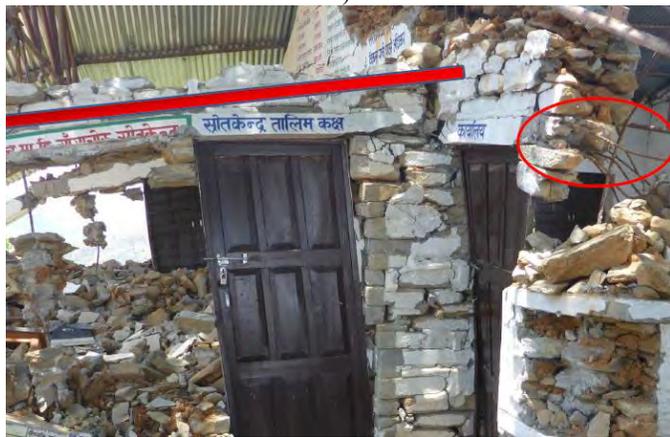
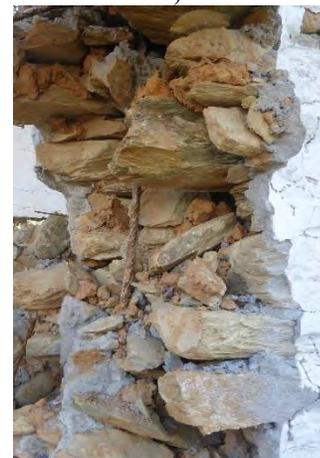
Most stone masonry buildings in rural areas of Nepal are non-engineered buildings constructed in a traditional manner without input of qualified technicians. However, the Nepal Building Code issued guidelines for non-engineered masonry buildings (NBC 203:1994), guidelines that contain a few seismic provisions for non-engineered stone masonry buildings. The key seismic provisions are: i) horizontal seismic bands at the plinth, lintel and roof levels (made of timber or RC) and ii) provision of a single vertical reinforcing bar at the wall intersections and jambs (openings). The use of cement mortar is recommended for construction of stone masonry walls. The CAEE team has not seen any examples of application of NBC 203 provisions in houses, although it is possible that some undamaged houses were constructed with seismic provisions. However, the team visited a school complex in the village of Sangachok, Sindupalchowk District. The village was severely affected by the earthquake, with 167 deaths out of the total population of 3,000. Many stone masonry houses suffered severe damage or collapse. The school complex was located on the top of a hill. The classrooms were housed in two RC frame buildings with masonry infills – one of these buildings collapsed at the ground-floor level and the other was severely damaged. A single-storey school addition built in stone masonry with steel truss roof and CGI sheet roofing collapsed in the earthquake (see Figure 6.18a). A few NBC 203 seismic provisions were observed, such as continuous RC lintel band with 4 longitudinal reinforcing bars (Figures 6.18b and c), and vertical reinforcing bars provided at the wall intersections (Figure 6.18d). The walls were about 50 cm thick and were built using mud mortar. The building was located on the top of a steep slope (Figure 6.19a), and it is expected that the topography influenced the intensity of shaking and seismic performance. It should be noted that the building was also built with pilasters, which might have prevented the collapse of the walls at the rear side of the building (top of the slope) (Figure 6.19 b).

Figure 6.18: Damage of a stone masonry school located in the village of Sangachok , Sindupalchowk District (Photos: S. Brzev)

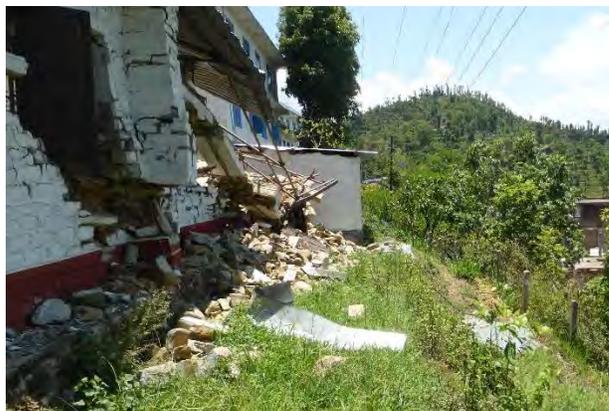
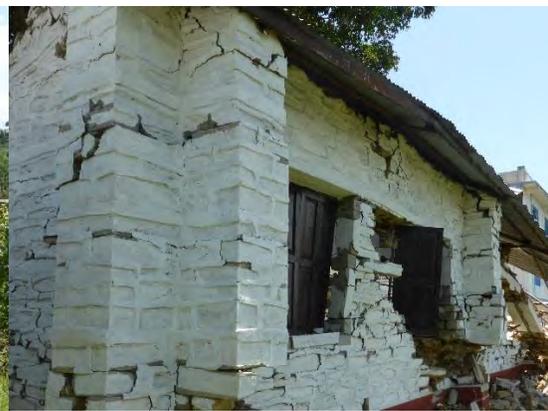
Figure 6.19: Stone masonry school building in the village of Sangachok, Sindupalchowk District: a) topography (slope at the rear side) and b) a view of the rear wall showing the pilasters (Photos: S. Brzev)

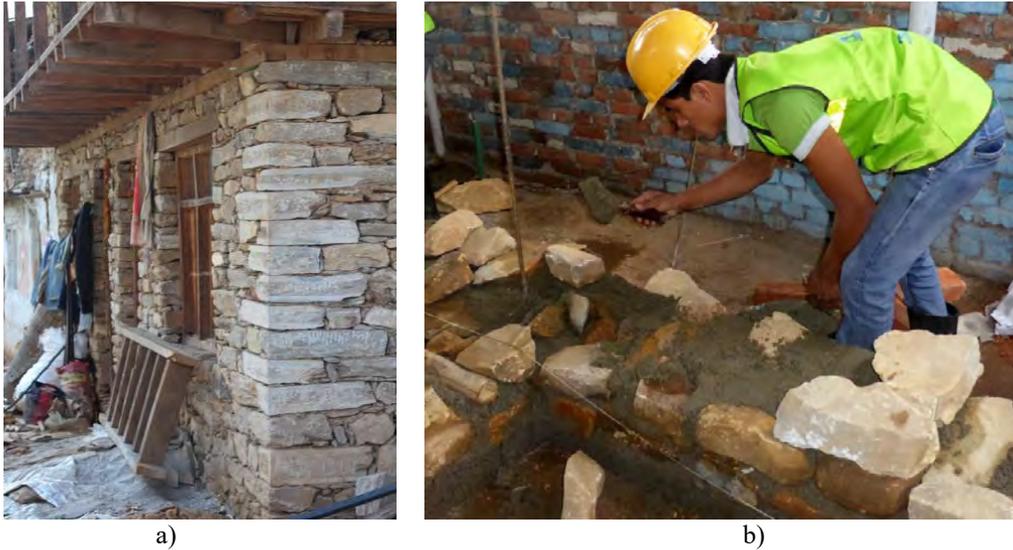
Stone masonry houses in severely affected areas constructed with timber bands and joists that fully bear on the walls performed well in the earthquake. Some owners constructed new houses with timber bands after the earthquake (see Figure 6.20a). The CAEE team also observed a class in mason training undertaken after the earthquake, a very important education initiative to ensure safe stone masonry construction (Figure 6.20b).

Figure 6.20: Reconstruction of stone masonry houses: a) a newly constructed stone masonry house with floor bands and corner stones and b) mason training program after the earthquake (Photos: B. Pandey and S. Brzev)

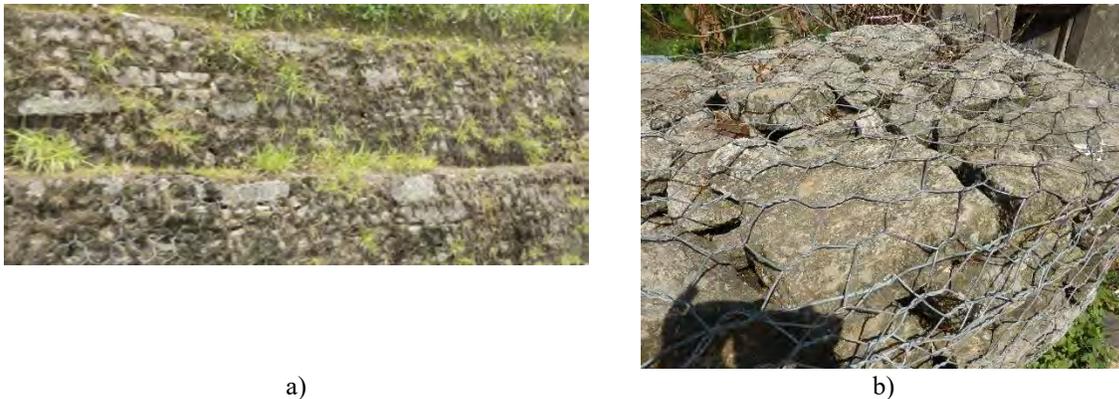
Figure 6.21: Gabion wire: a) a 30-year old application in 30-year old retaining walls in Nepal and b) a detail of the wire mesh (Photo: B. Pandey)

Since collapse of stone masonry walls in mud mortar is a major concern related to seismic safety of these buildings, a suitable technology that maintains the wall integrity while keeping the traditional construction materials is of critical importance. For example, gabion wire (galvanized steel wire mesh) could be considered for application to stone masonry walls to enhance their safety against effects of lateral earthquake loading. Figure 6.21 shows an application of gabion wire for 30-year-old retaining stone walls along the roadside in an earthquake-affected area of Nepal, confirming its durability and effectiveness.

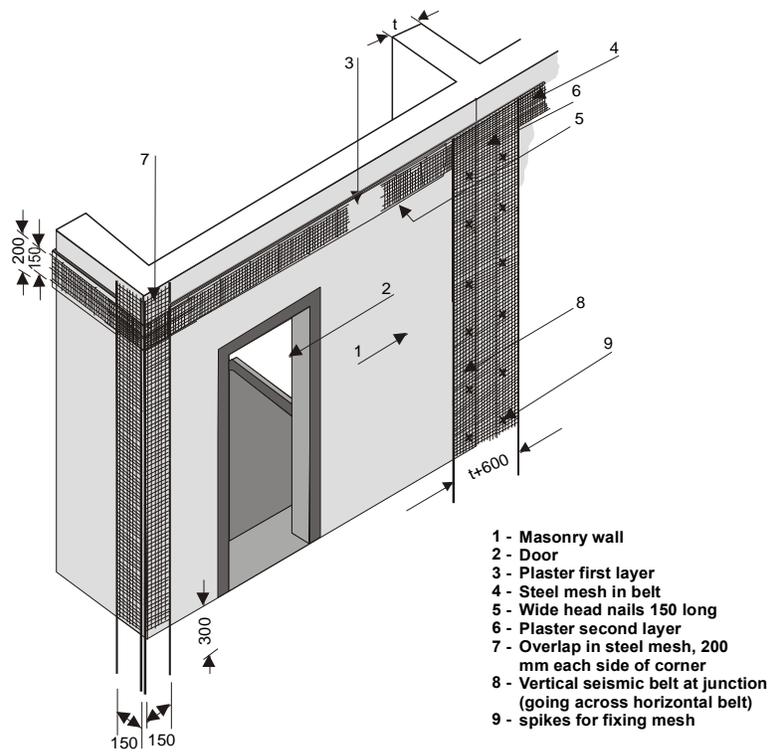
Figure 7.1: Splint and bandage technique of retrofitting of unreinforced masonry wall (Bothara et al, 2002)

The seismic upgrade of school buildings in Nepal focused mostly on unreinforced masonry wall buildings. Because of the inherent weakness of the URM school buildings and taking into account the socio-economic condition of the society of the developing country, any strategy of seismic intervention to those buildings should have considered affordability along with safety. The need was for a simple and cost-effective seismic upgrade with use of local material, avoiding any complex construction system. NSET started seismic upgrade of URM school buildings with selective reinforcement in splint and bandage along with stitching of orthogonal walls. The focus was to enhance the integrity of the building. The connections between orthogonal walls were improved by continuous reinforced micro-concrete strips in the corners and T- junctions. The vertical continuous strips, called splints, were provided from foundation to roof level. Similarly, horizontal strips, called bandages were provided to run horizontally around all the walls on both side of the walls. The splints and bandage were 50-mm-thick reinforced micro-concrete sections applied on bare walls after racking mortar from the brick work joints. The two faces of the bandages were connected using staggered dowel bars. The bandages were provided at sill and lintel levels. Figure 7.1 shows a typical construction of splint and bandage.

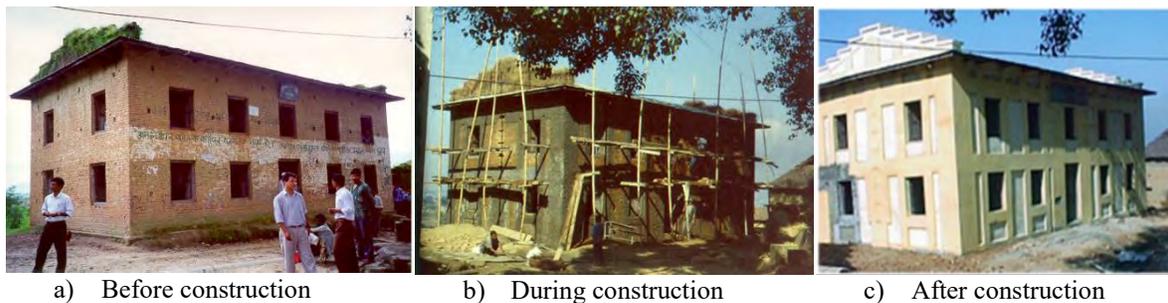
Figure 7.2: Application of splint and bandage technique of seismic retrofit in URM school building in Nepal

Figure 7.2 shows the actual construction process in Bhuvaneshowri School, Bhaktapur, the first retrofitted school in Nepal. The timber floors were replaced by a thin concrete slab to make the rigid diaphragm. The roof battens were braced and tied to the walls at the roof band. Gable walls were also reinforced and anchored to the roof system. This system of seismic upgrading is typically applied in URM school buildings. In some schools the micro concrete cover is applied over the entire wall in the form of jacketing.

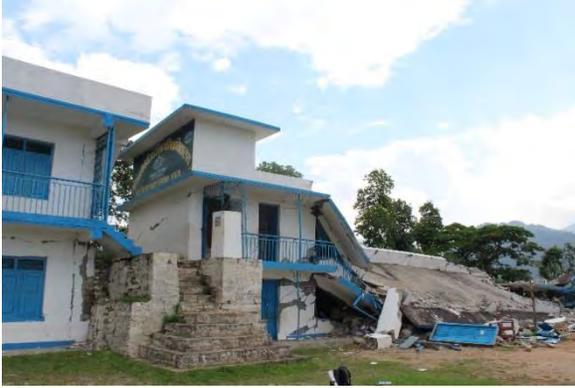
a. Kalidevi Secondary School building in Kadambas, Sindhupalchowk

It was evident from the government figures of earthquake losses in various sectors that the education sector was the hardest hit, and damage in school buildings was hence expected to be higher than that in other infrastructure or built environments. We confirmed this by the observation in the field. In the rural areas of Rasuwa and Sindhupalchowk, it was evident that performance of school buildings was poorer than that of residential houses in many communities. Figure 7.3 illustrates a case in Kadambas village in Sindhupalchowk, where a two-storey school building built with stone masonry walls and concrete slab floor had the roof collapse, leaving no air pocket space in between. If the earthquake had occurred during class time, several hundreds of children would have been under the piles of floor and roofs stacked onto each other. The school building, visibly massive when looking at the slab and walls, was lacking all necessary earthquake-resistant features. A typical class room was 5 m by 6 m in size bounded by unreinforced stone masonry walls 3 m in height and 60 cm in thickness. The floor and roof slabs were 150 mm thick, made of minimally reinforced concrete. A simple base shear check shows that the unreinforced walls were not able to bear the shear generated by the significant mass of the walls and floors, even up to acceleration of 0.1 g, which was most likely well exceeded during the main shock of the event.

Figure 7.3: School buildings are disproportionately damaged in comparison to residential houses

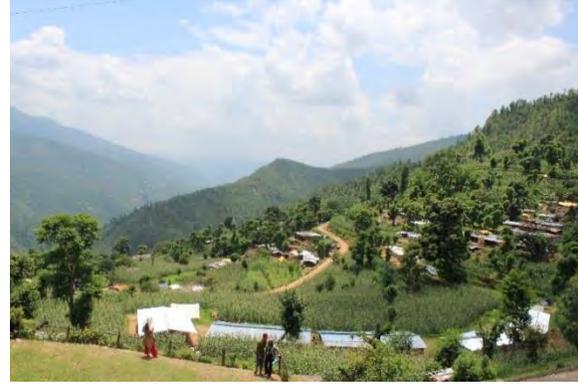
a) Village community within 100m of the Kalidevi school, Kadambas, Sindhupalchowk

This was in contrast to the damage observed in most of residential houses in the village, where a majority of them were single-storey buildings with light thatch or CGI sheet roofs. Although many of the residential houses sustained damages, very few of them completely collapsed as did the school building. The major factor for this was not necessarily that these village houses had any significant features that resist lateral shaking from earthquakes, but their dimensions and wall, floor and roof masses were not so critical as to trigger significant base shear for the earthquake event. Figure 7.3b) shows a panoramic view of the village next to the school. Most of the houses were observed to be in repairable condition, although many villagers were so afraid of cracks in the walls that they left their houses for temporary shelters. This observation of disproportionate damage of schools was observed in other villages of Sindhupalchowk and in other districts hit by the earthquake. The absence of earthquake considerations bring higher consequences in schools as the buildings are bigger and the population exposure is greater.

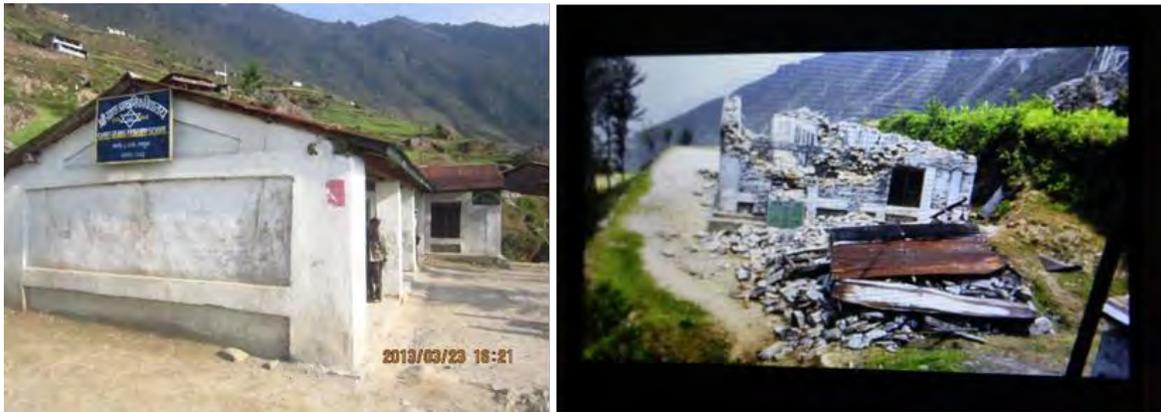
A retrofit of a rubble stone school in Rasuwa fared even worse—it completely collapsed. The block had been retrofitted by a major INGO using stitch banding technology and the community had been told the school would be safer than any new construction. The project included little training and oversight and even less adaptation to the limitations of the brittle stone building material. The donor organization sent a trained mason to the site for only two days to train local workers, none of whom had professional training as masons. During the middle of the construction process, the donor’s engineer came only once, briefly. Local workers found it impossible to adapt the stitch band retrofitting technique to stone masonry; they simply could not drill through the stone walls to stitch bands together, but the project implementation had no plan for adjusting the technology or discontinuing an unsafe solution. The result was a catastrophic collapse (Figure 7.5). The school principal captured and showed us on his smart phone how the donor-funded retrofit of his stone-and-mud-mortar school in Rasuwa did not prevent collapse in the earthquake. The left of Figure 7.5 was before the earthquake and to the right is just after the earthquake. The rubble had been removed by the time of the survey. Little training of masons and nearly non-existent technical oversight ensured that when masons struggled to implement the retrofit design, the problems were not caught and rectified. The principal estimates 120 out of 140 students and staff would have died. Had technical experts been involved in community outreach, they may have better understood the challenges of stone retrofit in a remote village and may have modified or abandoned the project for something more likely to result in a safe school.

Figure 7.5: Complete collapse of retrofitted school building in Rasuwa

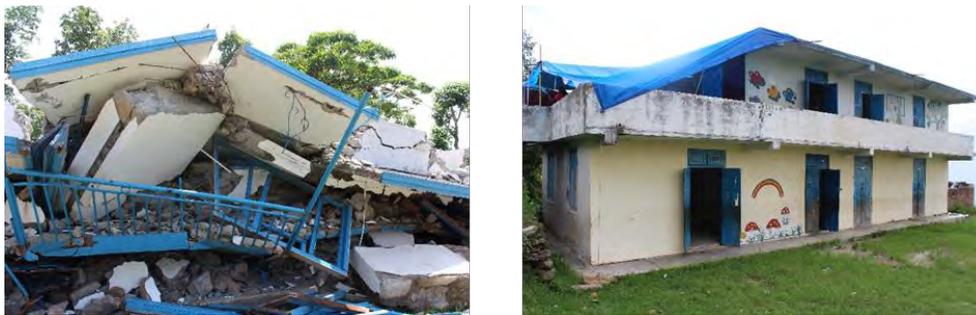
Where local masons were appropriately trained and where trained engineers oversaw the construction practice by very frequent visits or continuous onsite presence, schools performed beautifully. They were completely undamaged and few signs of poor construction practice were evident. In Figure 7.6, the first was built without technical

support; the second was built after the community was given an orientation on earthquake-safe construction and local masons were trained in safer construction techniques. An engineer and lead mason, both with experience in earthquake-safe school construction, carefully oversaw the process. After the earthquake, the second school was operational; even the terrace had been covered and converted into a makeshift workshop for the local community. Clearly, the social support of training and oversight are crucial to achieving safe school construction in Nepal.

Figure 7.6: Two neighbouring schools in Sindhupalchowk both built through international donor support but taking different approach of community outreach for technology transfer
