Report on
Earthquake Reconnaissance of
*The M7.8 Gorkha, Nepal Earthquake on
April 25, 2015 and its Aftershocks*

Canadian Association of Earthquake Engineering (CAEE)
L'Association Canadienne du Génie Parasismique
Reconnaissance Team

2017

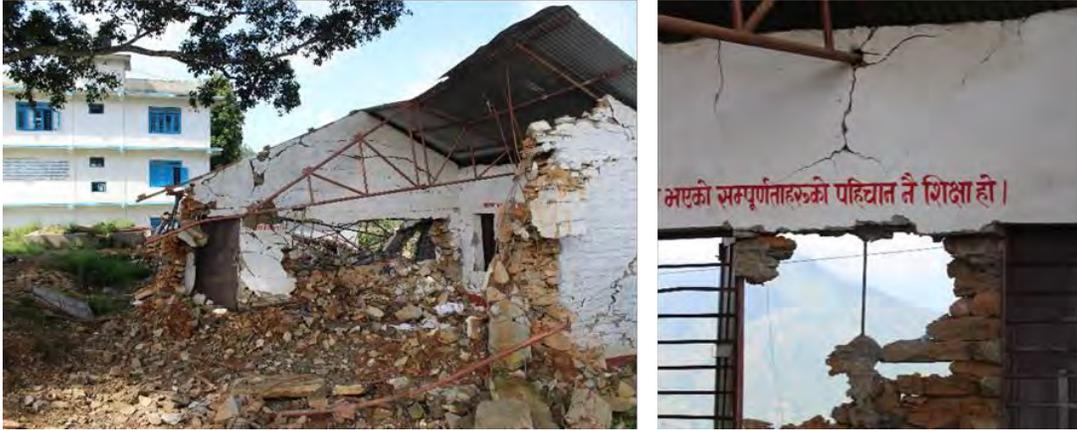
Most of the stone houses collapsed in the communities we surveyed. Most schools built with stone and mud mortar infill or load-bearing walls also collapsed, including the retrofitted school (albeit without appropriate training and oversight). Only when rubble stone was used with cement mortar and as an infill wall for a reinforced concrete frame school building, did we observe rubble stone that had not partially or completely collapsed. In Figure 7.10, a teaching resource centre on school grounds was built with stone and mud mortar. The masons employed earthquake-safety measures, such as a reinforced concrete lintel band and vertical reinforcement in the walls. However, even with these measures, the heavy shaking in Sindhupalchowk caused the stone building to collapse swiftly and completely. It may be difficult to rebuild safe schools out of this brittle material unless alternative technologies are developed and tested and extensive mason training and strict oversight are implemented during construction. A rubble-stone teaching resource centre co-located on a school site provides additional reason for caution. Even though it had been built with the earthquake-safe construction techniques commonly advised for load-bearing stone and brick construction, the resource centre completely collapsed. The resource centre had a lightweight roof, a reinforced concrete lintel band, and vertical reinforcement in the walls, though it did not appear to have a sill-level band or corner stitches.

Figure 7.10: Complete collapse of stone masonry teaching resource centre building with concrete bands

The widespread rubble-stone collapses, even in a case where a lintel band and vertical reinforcement had been used, suggests that constructing safely with rubble stone is fraught with difficulties. Further research is needed to understand how other rubble stone schools with earthquake-resistant features fared and what technical and social interventions seem to have worked well. However, until further testing or comprehensive field assessment, extreme care should be taken in building infill or load-bearing walls with this material in permanent, transitional, or temporary school buildings. Further, even if safe and appropriate technologies for rubble stone are identified, school reconstruction with this material will need to be carefully supported with robust programs for training, oversight and community outreach so that safety is achieved in actuality and communities can trust that these stone buildings will not collapse.

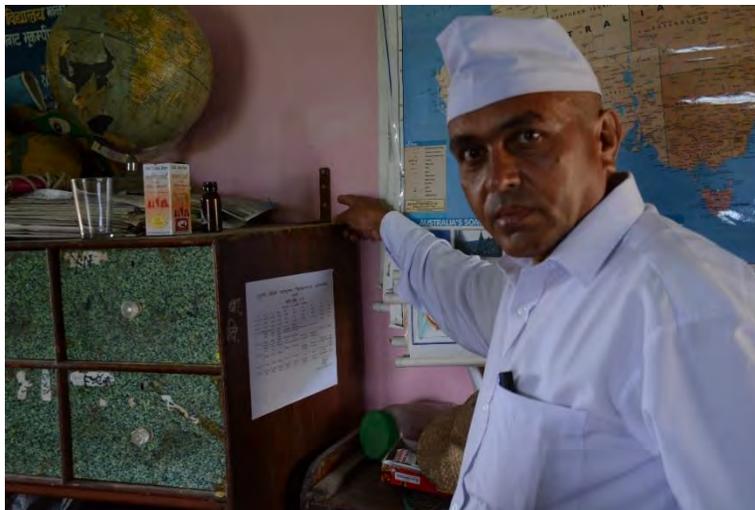
At the same event, there was also evidence of effective mitigation measures taken to reduce the impact of shaking to non-structural components in school buildings. Schools that had implemented comprehensive school safety measures performed well in aspects of non-structural safety too. Bal Bikash Secondary School in Alapot, the same village as SahidGhat School, where all the book cases and computer and science lab equipment were destroyed, saw no damage to non-structural items, as they were securely fastened to walls. The mitigation measures were simple, including such measures as anchoring of shelves to walls by angle clips and running rope across the bookshelves. In Figure 7.12, the principal of Bal Bikash School showed how angle clips, installed as part of the non-structural safety, restrained movement of bookshelves in his office.

Figure 7.12: Principal of Bal Bikash Secondary School shows the effectiveness of non- structural mitigation employed in his school

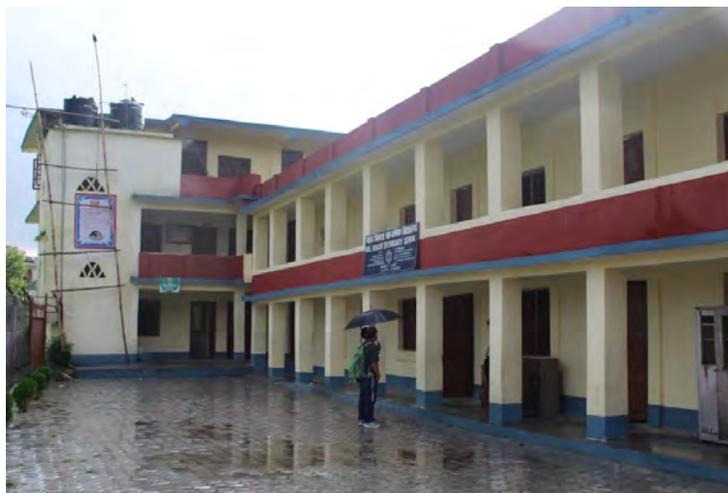
Figure 7.13: Bal Bikash Secondary school, Alapot, was used as community shelter for about a month in the aftermath of the earthquake.

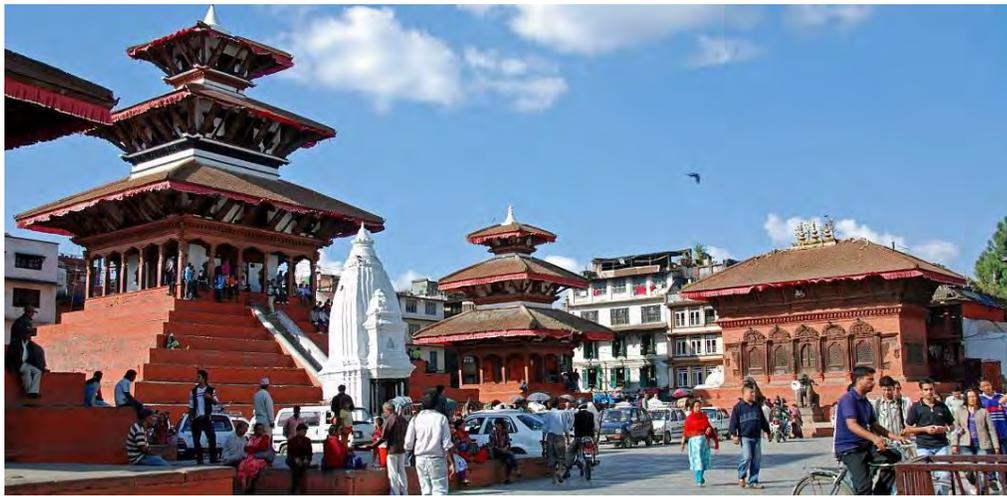
Figure 8.1: Durbar Square at Kathmandu: a) before the earthquake in 2008 showing three-tiered temples (Source: Travel 2008) and b) after the 2015 earthquake which caused the temple collapse (S. Brzev)

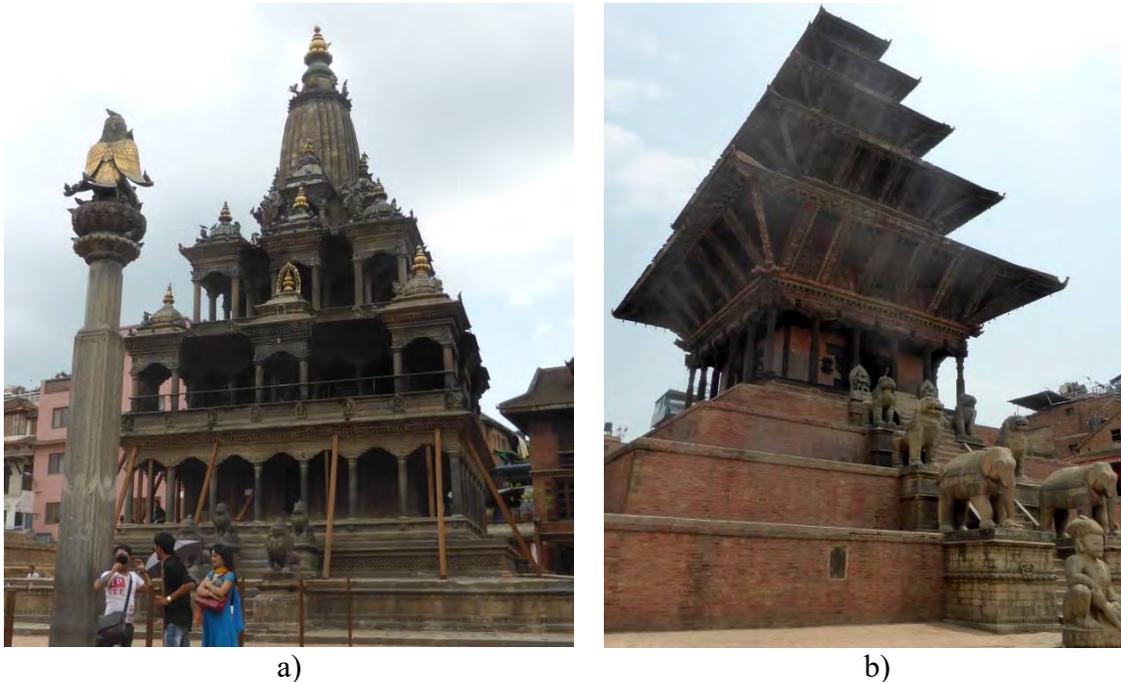
Figure 8.2: Examples of notable temples that performed well in the 2015 earthquakes: a) Krishna temple, Patan Durbar Square and b) five-tiered Niyatapola Temple, Bhaktapur (S. Brzev)

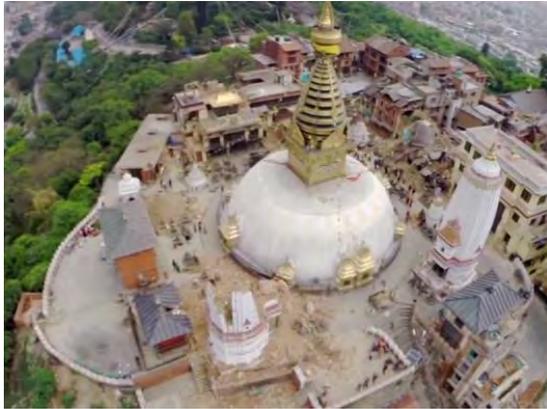
Figure 8.3: Swayambhu complex, Kathmandu Valley: a) a bird's-eye view of the complex after the 2015 earthquake (Source: CBC) and b) a site map (Source: Diamond Way Buddhism Foundation)

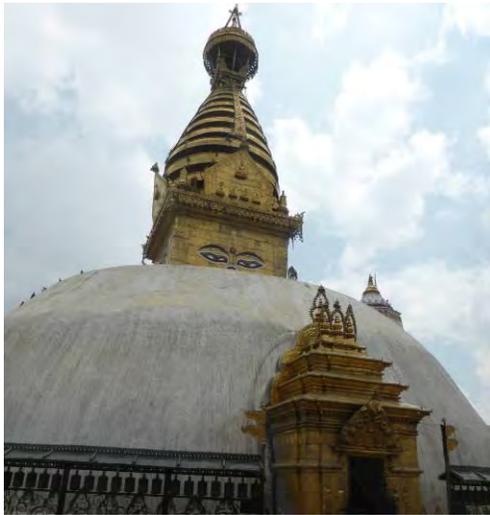
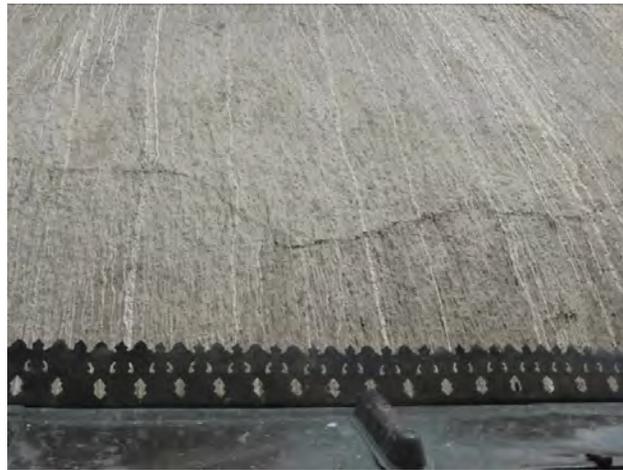
Figure 8.4: Buddhist stupa at Swayambhu: a) an overall view and b) minor cracking observed at the domed portion of the stupa (S. Brzev)

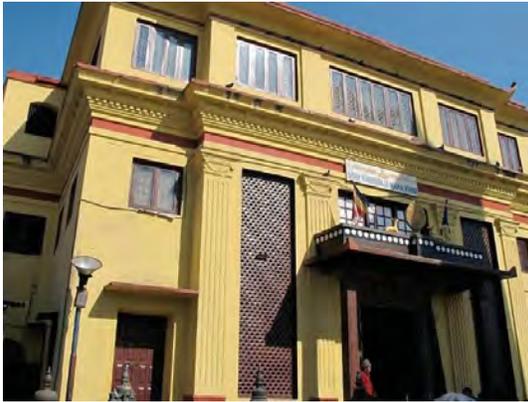
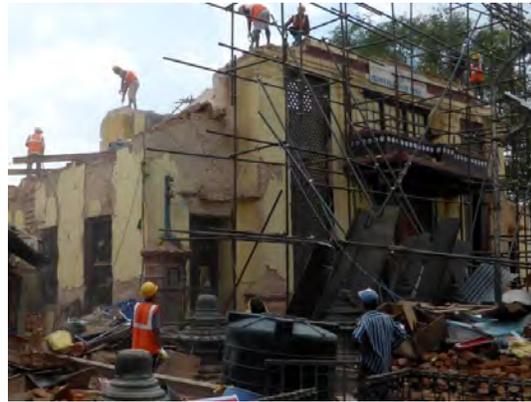
At the time of the visit (June 16, 2015), demolition of one of the buildings of the Karmapa's Swayambhu Monastery (Figure 8.5) was in progress (labelled as 8 on the site map Fig. 8.3b).

Figure 8.5: Karmapa's Swayambhu Monastery: a) before the 2015 earthquake (Source: Diamond Way Buddhism Foundation) and b) demolition in progress in June 2015 (S. Brzev)

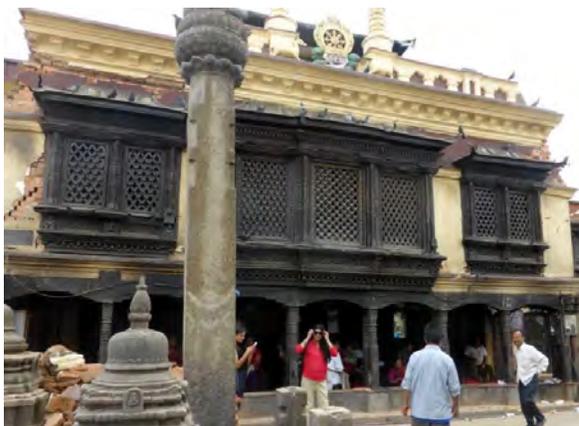
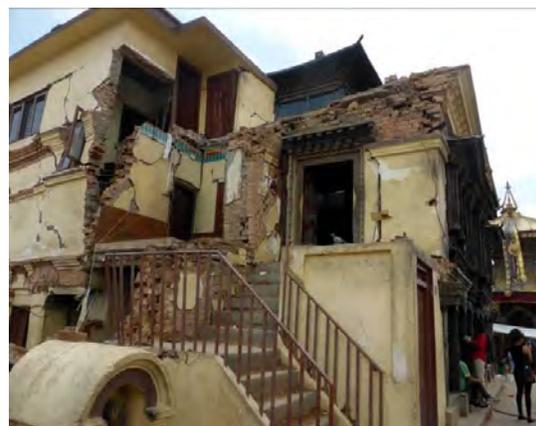
A few other monastery buildings within the Swayambhu complex were also heavily damaged, including the Drukpa Kagyu Monastery shown in Figure 8.6 (labelled as 13 on the site map Fig. 8.3b). These buildings were of unreinforced brick masonry construction with mud mortar, which resulted in a low masonry shear capacity. The buildings had timber floors and roofs that were not adequately anchored to the walls and lacked structural integrity. This is a common deficiency in these kinds of masonry buildings and a possible cause of the severe damage that the buildings experienced. The Drukpa Kagyu Monastery building was also characterized by an open front side, both at the ground floor (timber frame) and the upper floor with ornamental windows, which may have increased the seismic vulnerability of the building. It is expected that the topography (hill location) may have caused higher shaking intensity at Swayambhu compared to the adjacent sites at the base of the hill.

Figure 8.6: Drukpa Kagyu Monastery damage due to the 2015 earthquake: a) a view of the side façade of the building and b) a front view (S. Brzev)

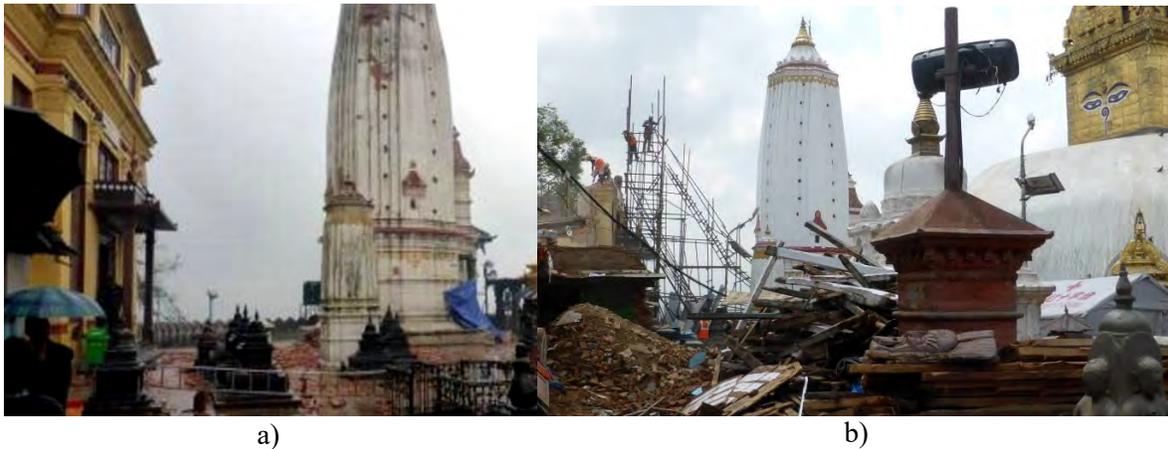
Figure 8.7: Pratappur temple: a) before the earthquake in 2011 (UNESCO, 2011) and b) after the 2015 earthquake—the temple can be seen at the rear of the photo (S. Brzev).

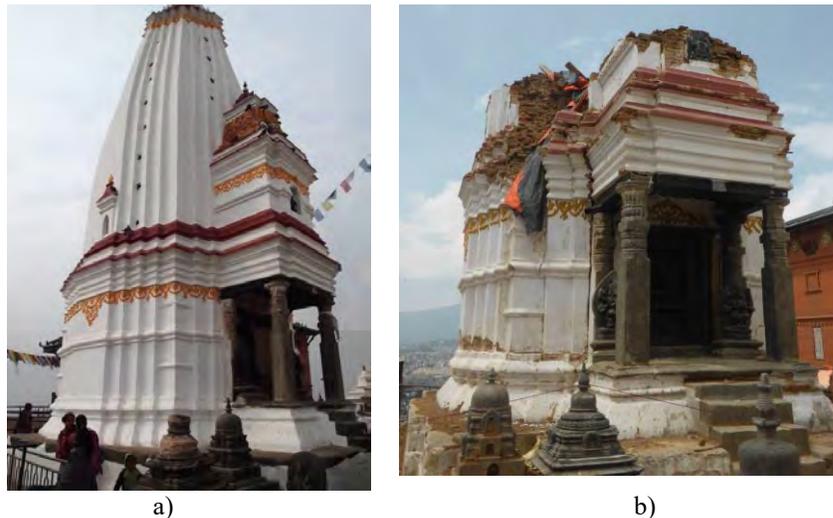
Pratappur and Anantpur are important Hindu temples located on the north and south sides of the stupa (labelled as number 11 and 10 respectively on the site map Fig. 3b). The temples were originally built by King Pratap Malla in 1654 and are characterized by very similar dimensions and construction practices. Pratappur temple suffered damage due to a fire in 2003 and lightning in 2011 (UNESCO, 2011) and was subsequently rehabilitated (Figure 8.7a). There is no evidence of any significant renovations to the Anantpur temple. The Pratappur temple performed well in the 2015 earthquake (Figure 8.7b) compared to adjacent buildings but suffered damage at the plinth level. However, the Anantpur temple experienced heavy damage and its upper portion collapsed (Figure 8.8).

Figure 8.8: Anantpur temple: a) before the earthquake in 2013 (Catbird, 2013) and b) after the 2015 earthquake (S. Brzev)

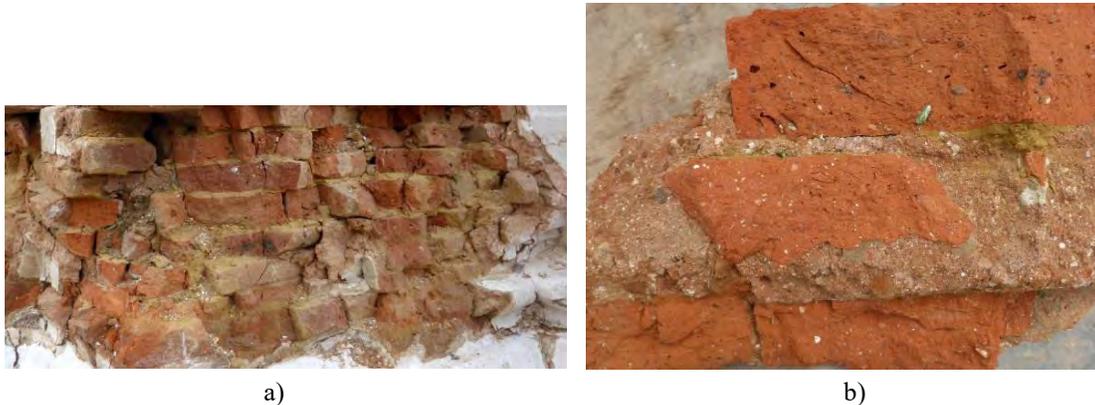
Figure 8.9: Exposed masonry construction at Pratappur temple: a) brick masonry in mud mortar at the plinth level and b) brick masonry in the lime surkhi mortar (S. Brzev)

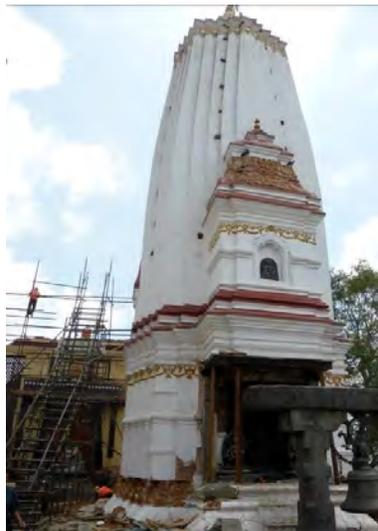
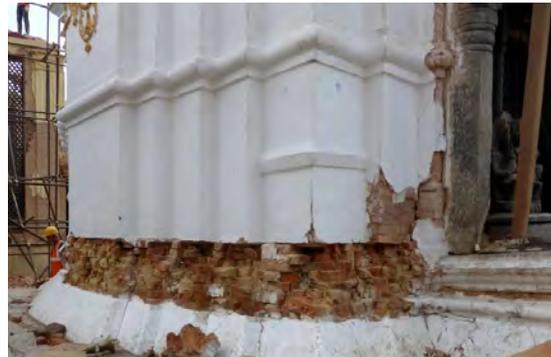
Figure 8.10a) shows the condition of Pratappur temple after the 2015 earthquake. The temple experienced damage at the plinth level, while the upper portion of the structure remained undamaged. The damage was uniform around the perimeter at the base level, and was in the form of horizontal cracking and some crushed or dislocated bricks (Figure 8.10b). This form of damage is characteristic of a sliding shear failure mechanism that is common in masonry structures subjected to relatively low gravity-induced axial compression and high lateral forces. In this case, there was no sign of movement at the base.

Figure 8.10. Damaged condition of Pratappur temple after the 2015 earthquake: a) a view of the temple showing the exposed masonry at the plinth level and b) a detail of the damaged masonry plinth (S. Brzev)

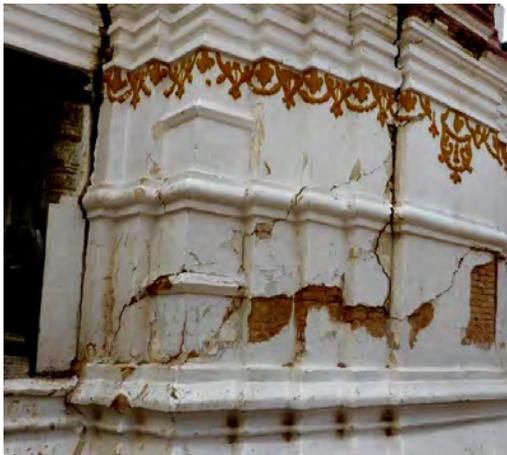
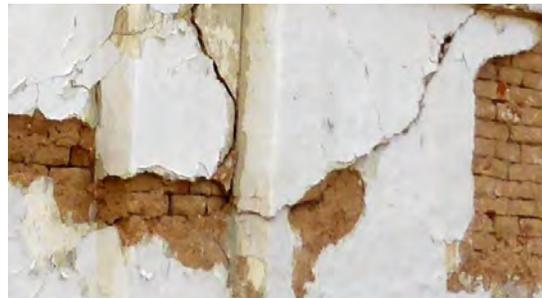
Figure 8.11a) shows the condition of Anantpur temple after the 2015 earthquake. The roof of the temple collapsed. Significant cracking was observed in the bottom portion of the temple, which can be explained by the limited shear capacity of masonry walls. The temple was constructed using adobe bricks and mud mortar (Figure 8.11b). This is different from the Pratappur temple which was constructed using burnt clay bricks. The difference in masonry shear strength might have resulted in different failure mechanisms in the two adjacent temple structures—since they had similar geometry and were originally built at the same time.

Figure 8.11: Damaged condition of Anantpur temple after the 2015 earthquake: a) a view of the side façade showing diagonal shear cracks and b) a detail of the damaged masonry wall (S. Brzev)

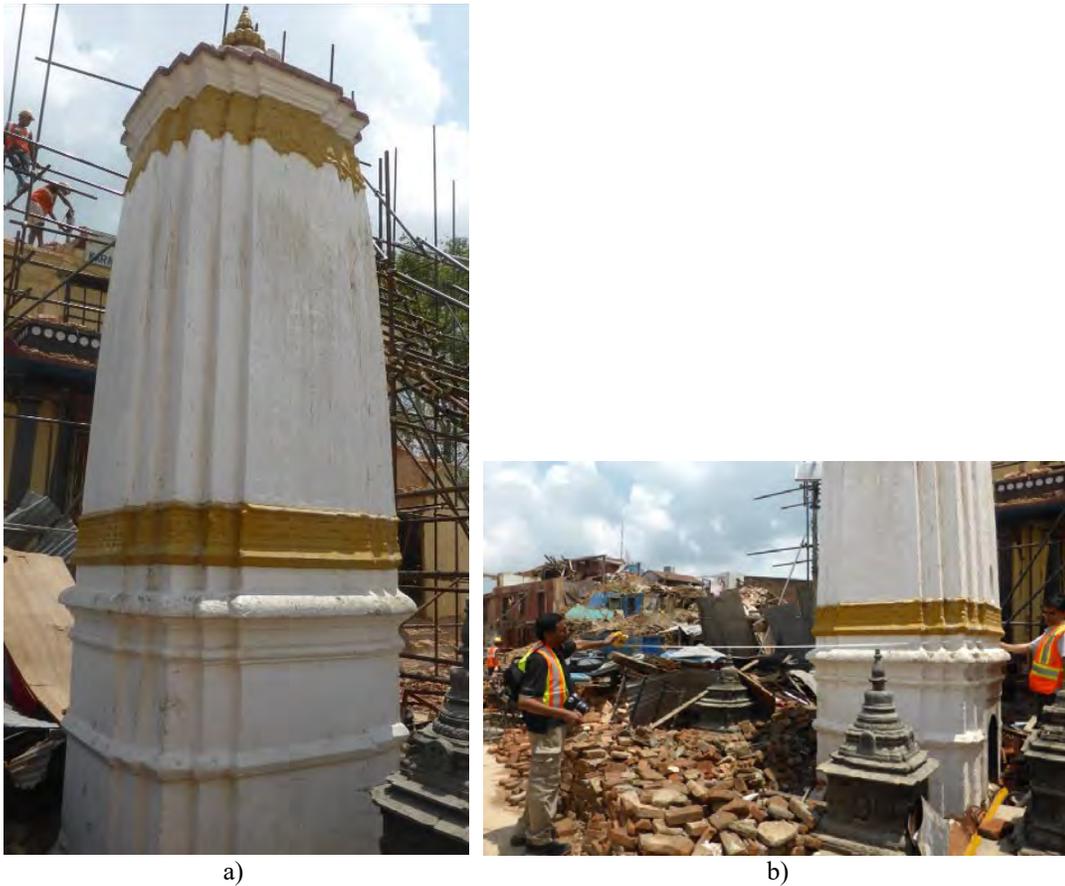
A sikhara-type shrine was observed at a location close to the Pratappur temple (Figure 8.12a). The proportions are the same, but the perimeter is 5.8 m, which represents a 1/3rd scale of Pratappur temple. The overall height above grade is 4.5 m. The wall thickness was 38 cm. The shrine remained undamaged during the earthquake. The CAEE team members took field measurements of the temples at the Swayambhu complex (Figure 8.12b).

Figure 8.12: A sikhara-type shrine close to Pratappur temple: a) an exterior view, and b) CAEE team members Upul Atukorala and Bishnu Pandey taking field measurements of the shrine (S. Brzev).

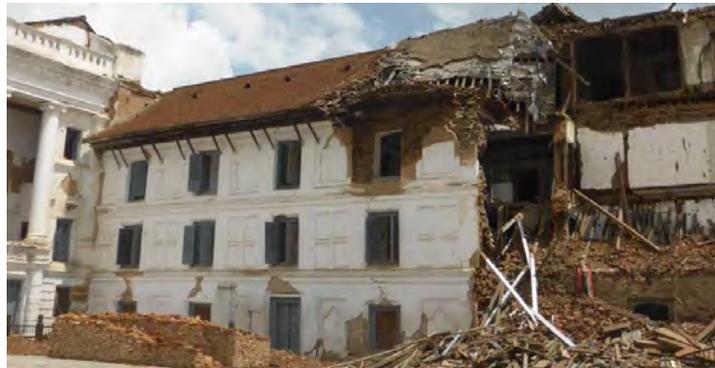
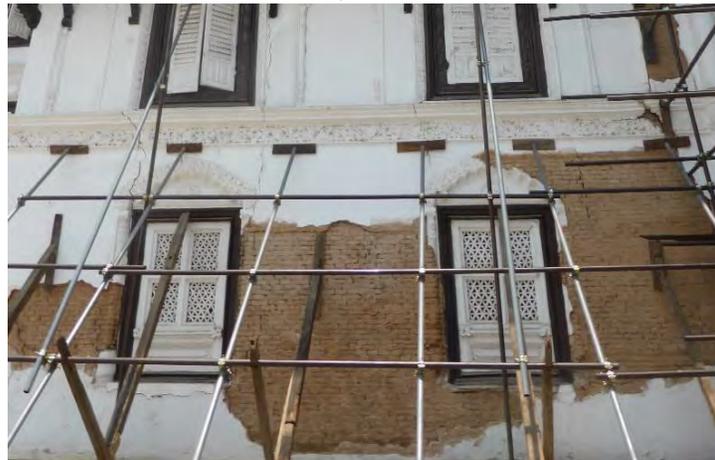
The Hanuman Dhoka is a complex of structures within the Royal Palace of the Malla Dynasty, which occupies a significant portion of the Durbar Square. Its construction started in the 16th century, but it was expanded in the 17th and 18th century. The royal family lived in the palace until the end of the 19th century. A portion of the palace is used as a museum. Figure 8.15a) shows the partially collapsed southern wing of the palace (originally destroyed in the 1934 earthquake and rebuilt c. 1935). It appears that the palace had adobe masonry walls in mud mortar, as exposed in Figure 8.15b). The palace had a timber floor and roof structure and sloped roofs with tile roofing. There is no mechanical connection between the floors/roof and the supporting walls, only friction. This is typical for older URM buildings and contributed to seismic vulnerability of these buildings and the resulting damage in the 2015 earthquake. The Basantpur Tower (see map Figure 8.14) also collapsed, and the damage is illustrated on Figure 8.16.

Figure 8.15: Hanuman Dhoka Palace at Kathmandu Durbar Square: a) a view of the south façade from the Basantpur Square (which was rebuilt after the 1934 earthquake), and b) a view of the palace from the courtyard

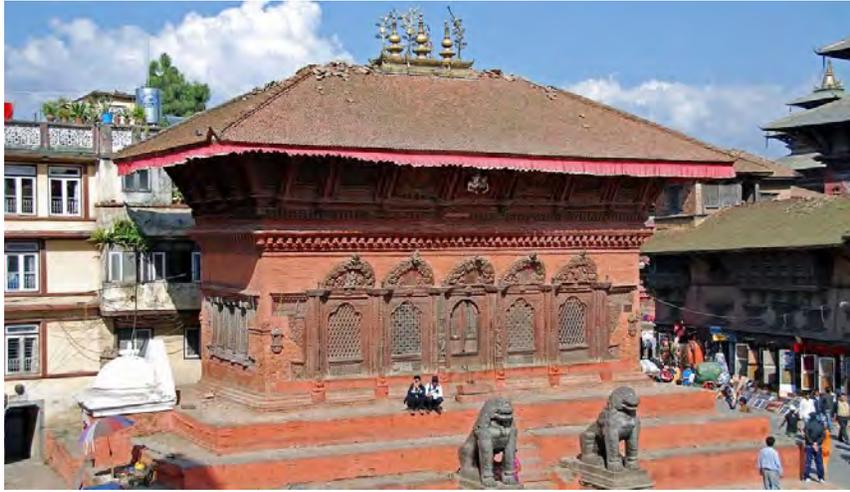
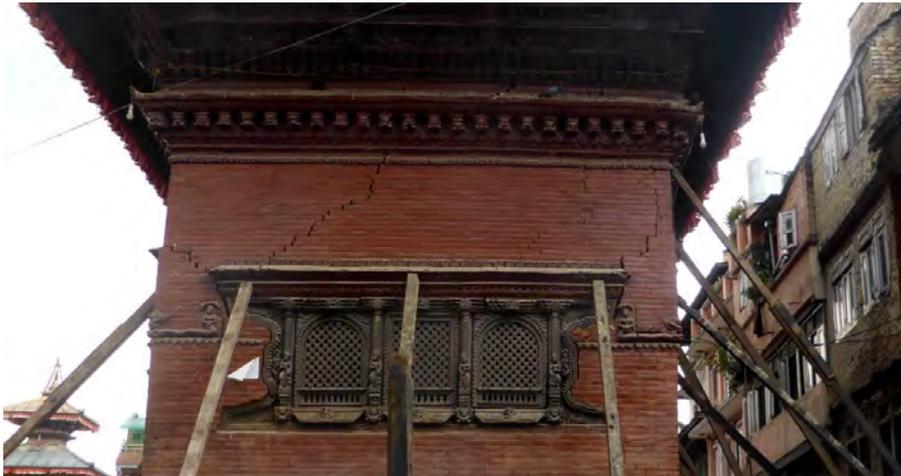
An 18th century shrine dedicated to Shiva and Parvati is located on the northern side of the Kathmandu Durbar Square (see Figure 8.17a). The shrine is a brick masonry structure with wooden elements. The lower part has a five-bayed carved wooden screen in the longitudinal direction, and a three-bayed wooden screen in the transverse direction. The upper portion has wooden brackets and a sloped wooden roof with clay tiles. The shrine was damaged in the 2015 earthquake. Extensive cracking was observed in the exterior masonry walls at the upper portion of the temple (Figure 8.17b).

Figure 8.17: Shiva and Parvati shrine before and after the earthquake: a) before the earthquake in 2008 (Travel 2008) and b) damaged temple after the earthquake (S. Brzev)

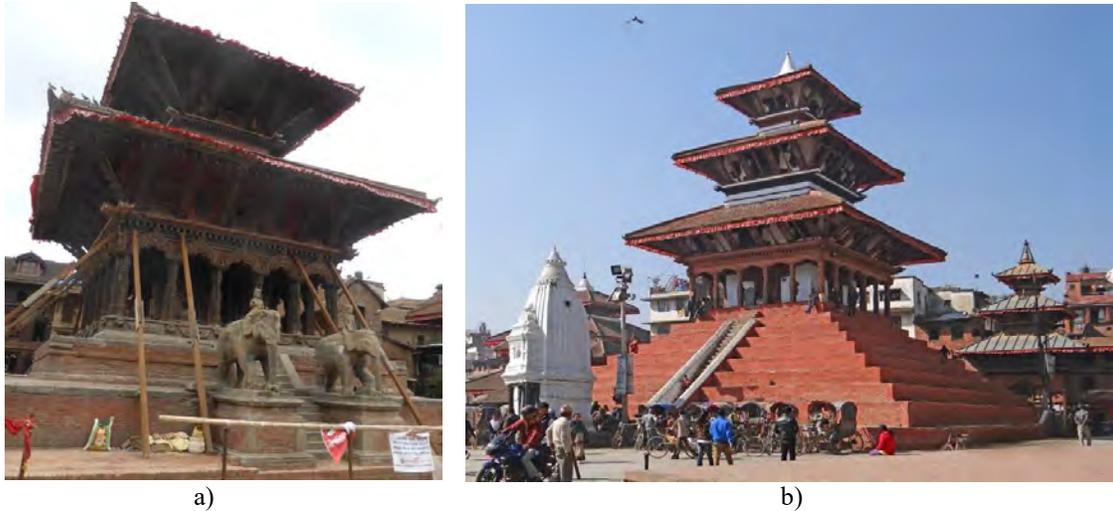
of a two-tiered temple. Figure 8.18b) shows a three-tiered Maju Deval temple in Kathmandu that collapsed in the 2015 earthquake.

Figure 8.18: Multi-tiered Hindu temples in Nepal: a) two-tiered Vishwanath temple, Patan after the 2015 earthquake (S. Brzev) and b) three-tiered Maju Deval Temple, Kathmandu in 2013--the temple collapsed in the 2015 earthquake (Wikimedia 2013).
