## Performance of structures during the September 19 2017 Puebla Morelos Earthquake in Mexico

A magnitude 7.1 earthquake occurred in central Mexico on September 19, 2017 in the states of Morelos and Puebla, including parts of Mexico City. The Canadian Association for Earthquake Engineering sent a team of geotechnical and structural engineers to the earthquake-stricken region to investigate the effects of the earthquake from Canadian seismic design perspectives. Structural damage was primarily observed in non-ductile reinforced concrete frames with and without masonry infills, confined masonry buildings, and traditional non-engineered unreinforced load bearing masonry and adobe buildings. The building inventory consisted of pre-1985 poorly designed reinforced concrete frames and post-1985 well-designed buildings with seismic force resisting systems consisting of reinforced concrete frames or frame-shear wall interactive systems. A great majority of buildings performed well. Unlike the interplate earthquake of 1985, which occurred off the coast along the Middle America Trench, 350 km west of Mexico city and caused widespread damage to long period structures in the central part of th

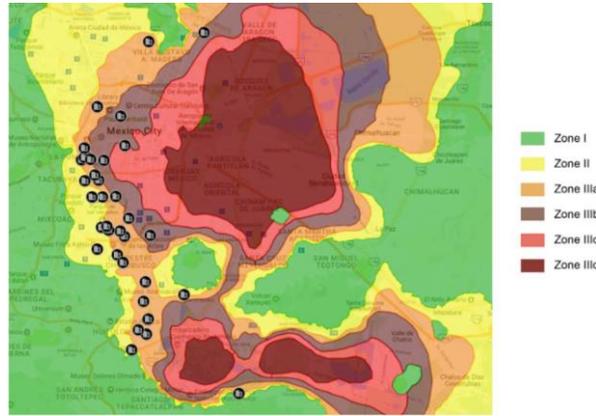
Figure 1. Map showing seismic zones and locations of collapsed buildings <https://www.sismosmexico.org/mapas>

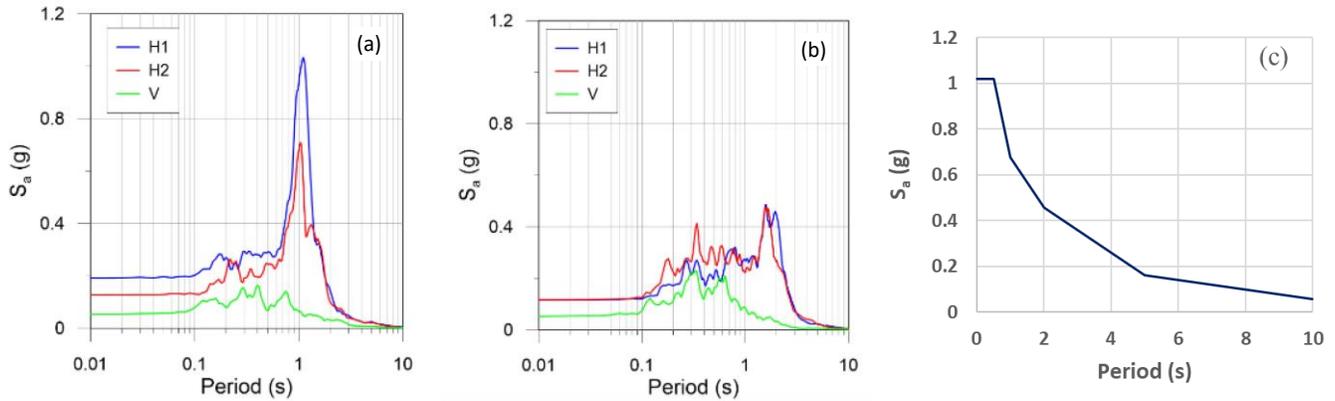
Typical response spectra of seismic records in two selected zones are illustrated in Fig. 2, demonstrating the significance of the effects of prevailing soil conditions [1]. Figure 2 also shows the design response spectra for Vancouver as the most populous city in Western Canada with similar seismicity as Mexico City, specified by the 2015 National Building Code of Canada (NBCC) [2]. The shear wave velocity in different zones of Mexico City varies between 117.4 m/s and 81.8 m/s for Zones I and Zone III(d) [3], which corresponds to Site Class E ( $V_s < 180$  m/s) in the NBCC site classification, indicating soft soil. Comparison of design spectral values with selected spectra of the recorded ground motions indicates that buildings having about 1.0 s period in Vancouver could be vulnerable to similar ground shaking if located on similarly soft soil without sufficient ductility. The average peak ground acceleration (PGA) recorded during the earthquake at an average epicentral distance of 115 km indicates a variation between 0.155g and 0.107g [3]. In comparison, the NBCC specified maximum PGA for Vancouver is 0.369g.

Figure 2. Acceleration response spectra, (a) at Station DX37 Transition Zone II, (b) at Station CI05 Lake Zone IIIa, (c) NBCC-2015 UHS for Vancouver, Site Class E (CAEE 2019)
