## Effectiveness of Surface Gravel Replacement for Liquefaction Damage Mitigation at Soma LNG Terminal during 2022 Fukushima Earthquake

### ABSTRACT

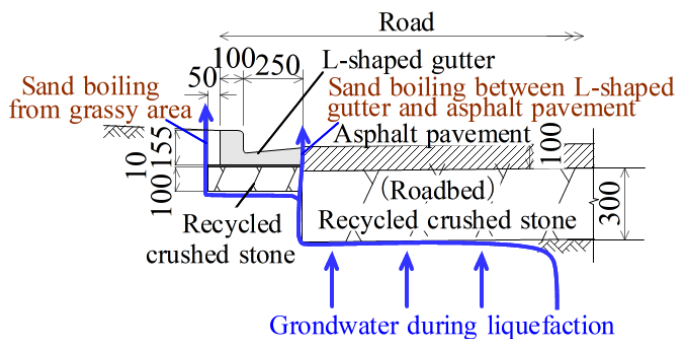
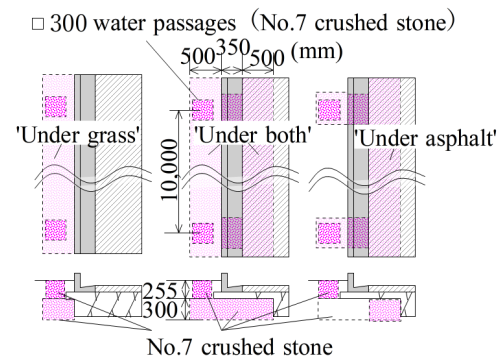
Figure 6. Mechanism of sand boiling and measures for the road

Figure 6(a) explains the assumed mechanism of sand boiling in this situation. In the post-liquefaction process, groundwater rises up and forces whole areas of road upward, spewing out at the edge of the road where the crushed-stone roadbed is thinner and avoiding the thicker roadbed under the asphalt pavement. This phenomenon was also observed in the 2011 Off the Pacific Coast of Tohoku Earthquake [4]. Based on this understanding, we assumed that countermeasures based on improvement with cement would simply induce sand boiling at other locations where countermeasures were not implemented. Instead, we implemented surface gravel replacement in three patterns as shown in Figure 6(b) depending on where the sand boiling occurred in the 2021 earthquake. The 'Under grass' pattern was to prevent sand boiling from grassy areas. 'Under asphalt' was to prevent sand boiling between L-shaped gutters and asphalt pavement. 'Under both' was to prevent both. In each case, a layer of No. 7 crushed stone (crushed stone with grain size adjusted from 2 to 5mm) with a thickness of 0.3m was laid along the axis of the road and water conduits leading to the ground surface in the grassy area were constructed at a pitch of 10m. By discharging the rising groundwater alone to the surface, these structures should prevent sand boiling.

(a) Assumed mechanism of sand boiling

(b) Three patterns of surface gravel replacement implementation

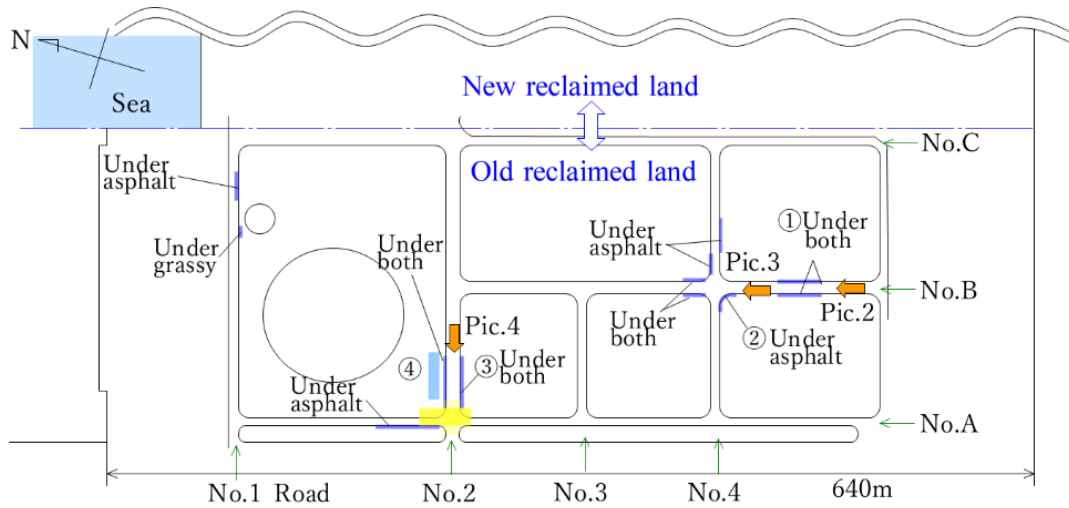
Figure 7. Locations of surface gravel replacement

The three patterns of surface gravel replacement were used at the positions shown in Figure 7. The effect of these liquefaction countermeasures is described in the following based on photographic observations.

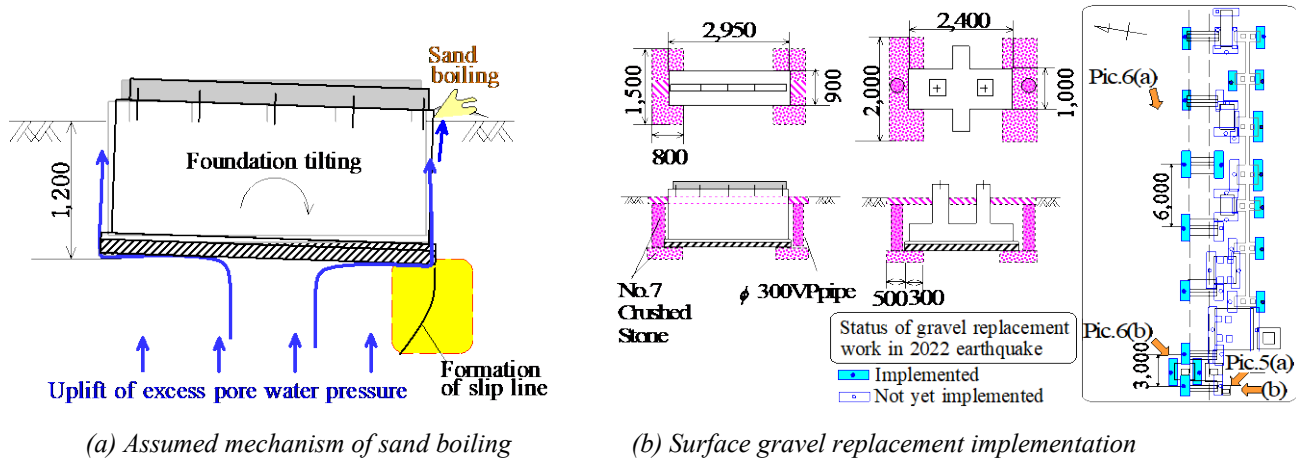
Figure 8. Mechanism of sand boiling and implementation of surface gravel replacement for pipework foundations

Figure 8(a) shows the mechanism by which sand boiling causes uneven foundation settlement. Gaps form around the foundation due to the difference in response between ground and foundation, allowing sand boiling to occur adjacent to the foundation. Uneven settlement leads to tilting of the foundation as the ground is progressively damaged. The tilting phenomenon progresses gradually as ground near the surface continues to liquefy. This gradual tilting occurs during liquefaction over a period of a few minutes to 10 minutes during and after shaking. Loosening of the soil under the edge of the foundation as a result of sand boiling increases the tilting of the foundation [1], [2]. This is what is thought to have occurred with these foundations. This understanding leads to the conclusion that liquefaction damage may be reduced by ensuring the ground remains strong by quickly draining only water and not sand from immediately below the foundation. Based on this conclusion, surface gravel replacement was implemented as shown in Figure 8(b) to achieve this. A 300mm-thick layer of No. 7 crushed stone was laid with a width of 300mm under the foundation and 500mm outside both sides of the foundation. Groundwater is drained to the surface through  $\phi 300$  pipes filled with No. 7 crushed stone.

At the time of the 2022 earthquake, gravel replacement work had already been implemented for some of the foundations. The blue colored areas in Figure 8(b) are the locations where the work had been completed. Picture 6 shows the situation around the foundations after the 2022 earthquake. The sand boiling that occurred around the foundations in the 2021
