Seismic Retrofit and Structural Assessment of a Modern Timber Building Re-Commissioned for Exterior Conditions as a Giant Gazebo

Francis Vandal^{1*}, Félix Bouffard² and Jean-François Martel³

ABSTRACT

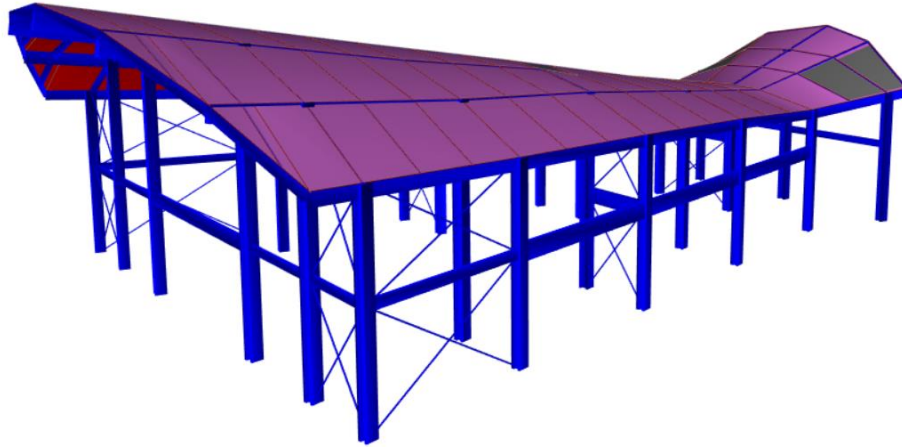
Figure 3. Numerical model of the wood building.

From the detailed analysis of the deconstructed building, the design's team assessed that the 5% in 50 years seismic event should result in:

- Yielding of the diaphragm connections or crushing due to concentrated stresses at support points. These damages are estimated to occur only in localized areas of the diaphragm.
- Disconnection of the diaphragm from the collector beam in the long direction due to high shear flow stress and deficient assembly design.
- Loss of stability and potential collapse of the structure due to the removal of the two side wings providing lateral resistance.

These damage levels did not allow the structure to meet the mandatory performance criteria described previously, therefore demonstrating the importance of the thorough seismic assessment. Consequently, the seismic retrofit was required.
