PERFORMANCE OF A SIX-STORY REINFORCED CONCRETE STRUCTURES IN POST-EARTHQUAKE FIRE

H. Mostafaei¹ and T. Kabeyasawa²

ABSTRACT

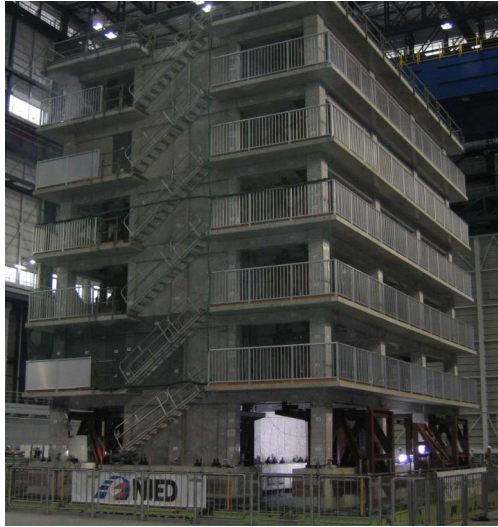
a) the building specimen

b) the 3D analytical model

Figure 1. The six-story reinforced concrete wall-frame building

most damage during the test compared to other elements of the building. Therefore, the short columns of Y1 axis in the ground floor were selected to be exposed to the standard fire after the earthquake. It is important to note that there are many possible post-earthquake fire scenarios that could be considered for this study. However, the above fire scenario is assumed to be one the worse case fire scenarios. The analysis was simulated for the building in two fire scenarios: first exposing the short columns to fire and simulate the performance of the building before any earthquake damage and then exposing the same columns to fire but by considering the damages caused to the building columns due to the Kobe Earthquake 1995. Fig. 1 shows the 3D analytical model of the building simulated for this study.

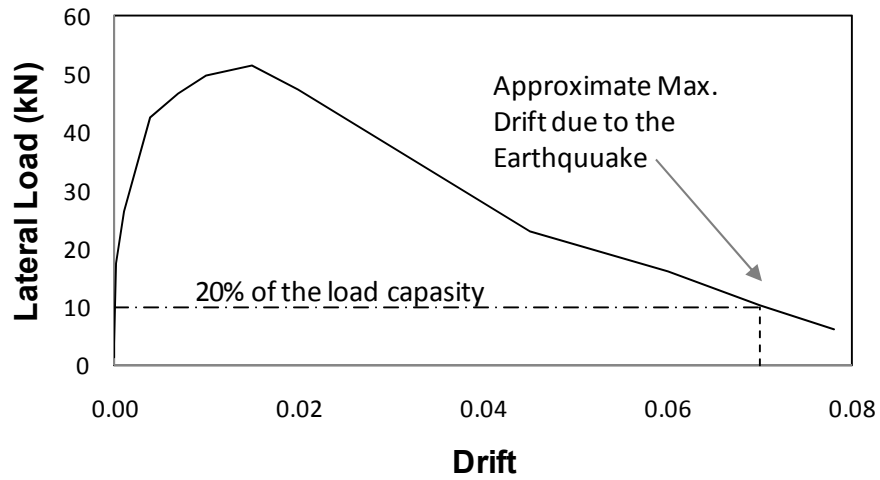
Figure 5 Lateral load-drift response of the two columns, X1-Y1 and X1-Y4, in the ground floor, obtained by the ASFI method, and the residual load capacity

Concrete compression strength was the main mechanical property that its degradation was calculated for the damaged columns. For this purpose, a pushover analysis using the Axial-Shear-Flexure Interaction (ASFI) approach developed by Mostafaei and Kabeyasawa (2007) was implemented to determine the lateral load degradation of the columns when the elements were subjected to a maximum drift experienced during the test. Then the same degradation ratio was assumed approximately to be the concrete compression strength degradation of the damaged columns for use in the fire response analysis. Fig. 5 shows the results of analysis for lateral loading of the short columns and the load capacity degradation ratio. The result shows 20% residual lateral load capacity for the damaged columns after the test. Hence, for fire response of the building structure, concrete compressive strength for the damaged short columns is degraded to 20% of the original compressive strength or 4.8MPa. The same analysis was implemented for the long columns in the ground floor axis X3 also damaged during the earthquake. The result showed 50% residual lateral load capacity after the earthquake. Therefore, for these columns 50% of the original concrete compressive strength or 12MPa was assigned as the residual concrete compressive strength in the fire response analysis.
