## Steel Jacket Retrofit For Bridge Columns With Structural Flares

### ABSTRACT

Four 0.4-scale flared reinforced concrete bridge columns were tested to examine the as-built seismic behavior of the columns in a 16-span bridge in Reno, Nevada, and to determine the effectiveness of steel jacket retrofit. Because the bridge was built well after the 1971 San Fernando earthquake, a relatively large amount of lateral steel was used in the columns. However, analysis showed that some of the columns may be susceptible to shear failure under strong earthquakes. A steel jacket retrofit with a predetermined gap location to force the plastic hinge at that location was found to be effective in reducing shear distress in the columns.

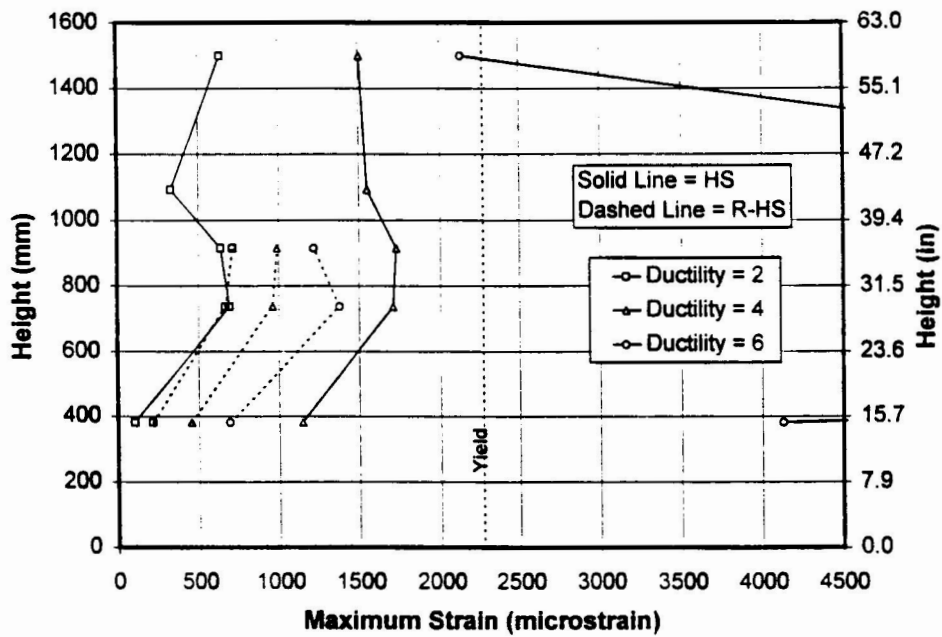
Fig. 4 -Perimeter tie bar strains at different displacement ductilities in HS and R-HS

Results of the tests on the as-built specimens indicated that flexure dominated the mode of failure in both. The displacement ductility at failure was 8 for LS and 6 for HS. Both specimens exhibited good energy dissipation capacity, and strength degradation was small. However, the ties yielded in both specimens, and there was extensive shear cracks at 45 to 60 degrees relative to the column axis. Figure 3 shows specimen HS at the end of the test. The failure load was controlled by the buckling of the longitudinal bars and low-cycle fatigue failure of these bars. Note the extensive shear cracking and the relatively large plastic hinge length. The extent of tie bar yielding was limited in LS but was substantial in HS. Figure 4 shows the maximum perimeter tie bars strains at different displacement ductilities in HS.
