## Behavior of Diaphragms Sheathed with FRP Panels

This paper summarizes the results from the first phase of an ongoing research project to determine the suitability of using Fiber Reinforced Polymer (FRP) panels as sheathing material for roof diaphragms and to develop schemes using advanced composite materials to retrofit seismically damaged roof diaphragms. This was accomplished by constructing a typical plywood diaphragm and testing it under fully reversed, cyclic lateral loads. Following the diaphragm testing, damaged plywood panels were removed and replaced with FRP panels. The repaired diaphragm, sheathed with FRP panels and lightly damaged plywood panels, was then retested by again applying fully reversed, cyclic lateral loads. Observations and results obtained from the two sets of tests are briefly described in this paper.

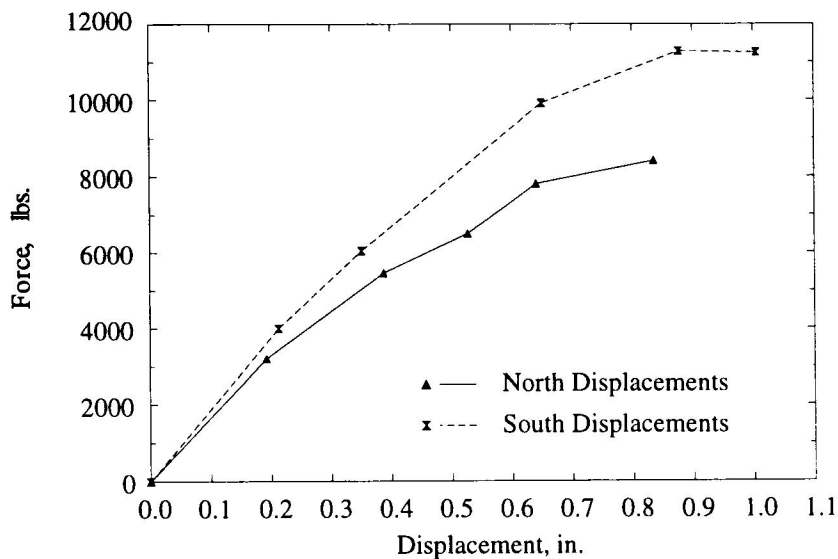
Fig. 4 Measured Response of Composite Diaphragm

The measured response of the composite diaphragm is shown in Figure 4. In the composite diaphragm test, the maximum measured loads for the diaphragm were 8400 lbs. per hydraulic ram with the rams pushing on the diaphragm (north displacements) and 11200 lbs. per hydraulic ram with the rams pulling on the diaphragm (south displacements). The maximum measured deflections associated with these forces were approximately 0.85 in. with the rams pushing on the diaphragm and about 0.9 in. with the rams pulling on the diaphragm. Figure 4 shows the points corresponding to maximum force at each displacement level connected to each other with straight line segments simply to make visualization easier.

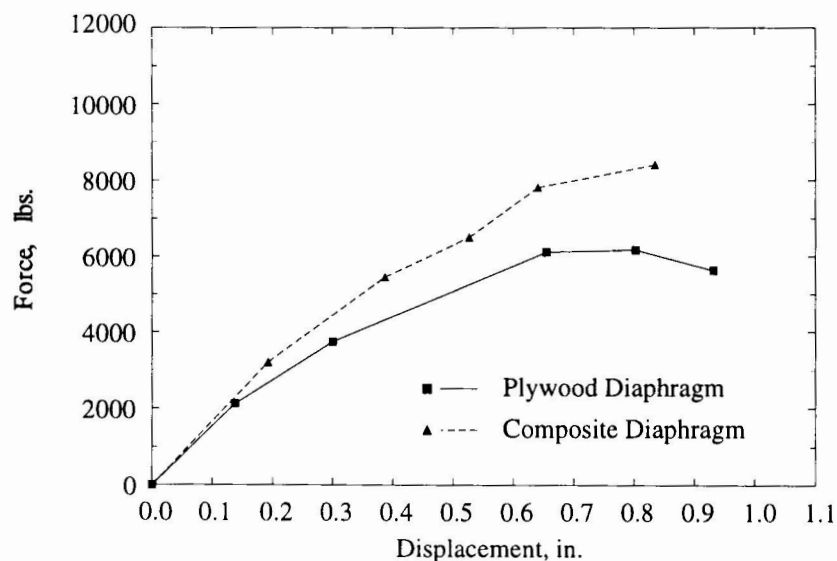
Fig. 5 North Displacements

The load-displacement curves for the plywood and the composite diaphragms are shown in Fig. 5 for north displacements and in Fig. 6 for south displacements. Straight line segments connect the points corresponding to maximum force at each displacement level simply to make the comparison easier. The data show that the composite diaphragm is capable of carrying higher lateral loads than the plywood diaphragm. The maximum measured load on the composite diaphragm was about 35 percent higher than that for the plywood diaphragm.

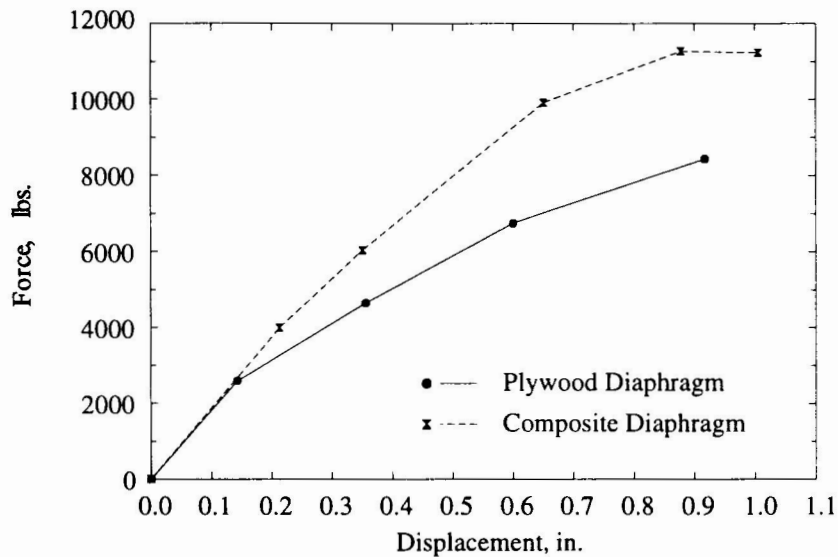
Fig. 6 South Displacements
