USING HISTORICAL DATA TO AID IN THE EVALUATION OF STRUCTURAL PERFORMANCE OF BUILDINGS

S. A. Freeman¹, T. F. Paret², G. R. Searer³, M. Hachem⁴ and U. Gilmartin⁴

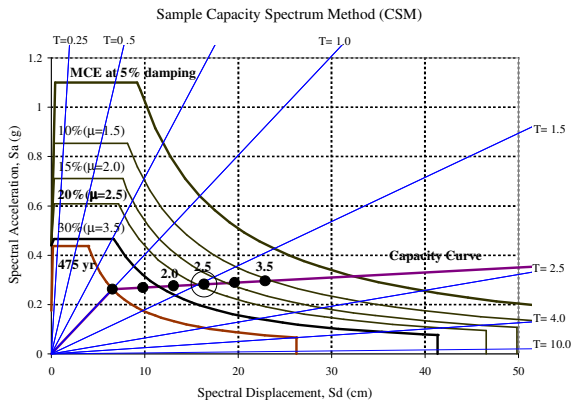
Figure 1. Sample Capacity Spectrum Method.

Contrary to a number of recent publications that describe the utility of pushover analysis negatively, representation of the capacity of a structure to resist lateral forces by a pushover curve can predict with reasonable accuracy and significantly aid understanding how a structure will perform under limit state conditions. First, a realistic linear estimate of first yielding is made. Then elements are allowed to yield until a reasonably acceptable maximum nonlinear displacement is estimated. The response spectrum at five percent damping generally represents linear-elastic response of the structure. Increased damping can be used to approximate an inelastic response spectrum that accounts for reduction in demand due to energy absorption from inelastic hysteretic behavior (Freeman 2006). An example shown in Figure 1 indicates that the response of the structure to an MCE design earthquake will be at a ductility of 2.5, which equates to a demand at 20 percent effective damping.

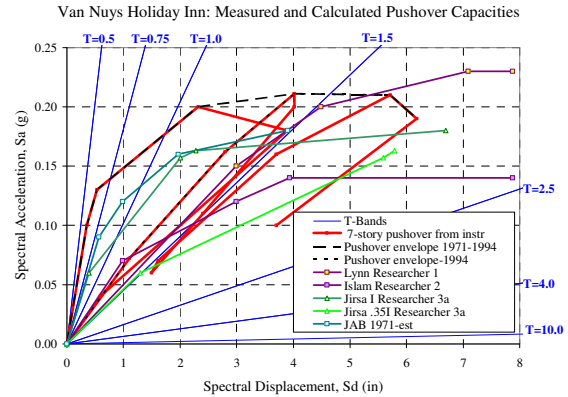
Figure 2. Van Nuys Holiday Inn Pushovers.

In the authors' study, the strong motion records were analyzed by a process of deconstruction that measured cycles of the fundamental mode of vibration at the roof such that a pushover curve could be approximated directly from the response records (Freeman *et al.* 1997a). The results are summarized in Figure 2. The February 1971 response data is consistent with a spectral displacement (S_d) demand of about 4 inches. The balance of points on the pushover represent the first ten seconds of the 1994 earthquake, and reaches a peak S_d of about 6 inches. The upper bound envelope of the plot represents an equivalent pushover curve of the capacity of the building. Shown for comparison, analytically developed pushover data from other researchers were converted into S_a and S_d coordinates. Although there is a large degree of variance, the results do fit into a broad band that can be compared to the measured pushover. Additional analysis indicated that north side infill brick panels at the first story caused torsion in the building that contributed to the damage to the south side columns. Figure 3 shows 10 and 20 percent damped response spectra that represent the 1971 and 1994 earthquakes, superimposed on the pushover to illustrate the CSM procedure.

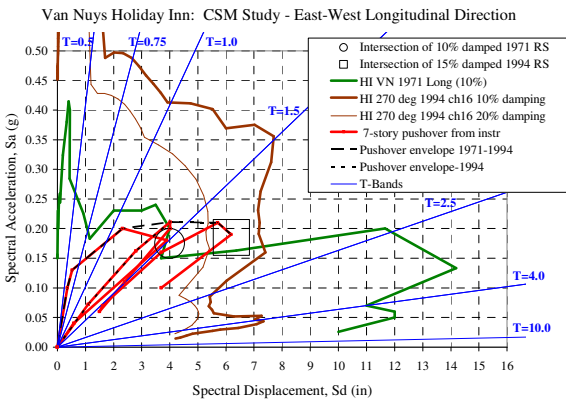
Figure 3. Van Nuys Holiday Inn CSM Study, EW.

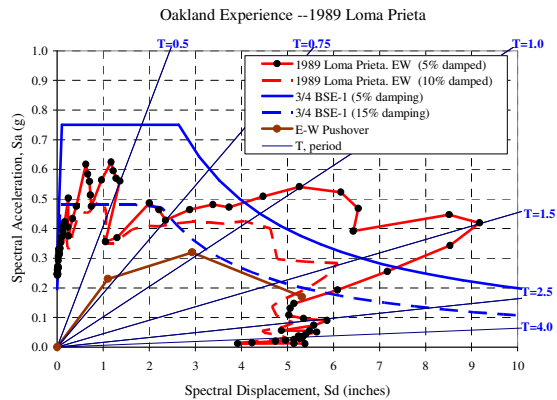
Figure 4. Oakland Experience, 1989 Loma Prieta.

In reality, the structure rode out the 1989 Loma Prieta earthquake with very little damage, and although the downtown ground motion data described above was available to provide a calibration/reality check of the engineer's conclusions, no comparison was made. By simply converting the engineer's results from the nonlinear pushover to a capacity spectrum and plotting this best-estimate capacity against the demand from the Loma Prieta earthquake, a significant inconsistency was revealed. Use of the CSM procedure indicates that the structure should have experienced major damage as a result of the 1989 Loma Prieta earthquake; but it actually did not experience any significant damage. This demonstrates that the Phase III FEMA 356/ASCE-41 evaluation significantly underestimated the capacity of the structure (Figure 4). While some in the profession might argue on the accuracy of the CSM procedure, although time after time it has been shown to be consistent with reality, at the very least it indicates that a significant rethinking of the evaluation of this structure would be warranted prior to recommending an expensive upgrade.
