## FEMA P-58 Seismic Building Performance Assessment of the New St. Paul's Hospital

Behrad Keshavarz<sup>1\*</sup> and John Sherstobitoff<sup>2</sup>

The new St. Paul's Hospital, currently under construction in Vancouver's False Creek Flats, is designed as a post-disaster facility in accordance with the 2019 Vancouver Building By-law. As it will play an essential role in the post-disaster response of the community, additional assessments beyond the requirements of the building code were conducted to better predict the post-earthquake performance of the facility. The assessment methodology as outlined in the FEMA P-58: Seismic Performance Assessment of Buildings was utilized to assess the facility's performance based on its specific site characteristics, structural and non-structural components, medical equipment, and occupancy. This paper presents an overview of two methods that were used to present and summarize the FEMA P-58 assessment's outputs to various stakeholders: 1) floor-by-floor breakdown of repair costs and repair times for various component groups with emphasis on equipment crucial to post-earthquake functionality of the facility 2) component-by-component damage stat

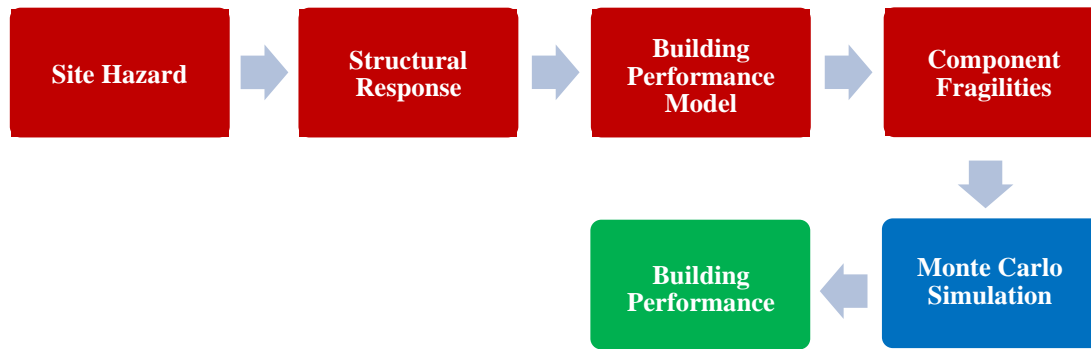
The seismic performance assessment methodology as outlined in FEMA P-58 Vol. 1 [1] evaluates the likelihood of a building, including structural and non-structural components, being damaged by earthquake ground shaking and estimates the potential consequences of such damage. There are four main parameters that comprise the methodology: site hazard characteristic, structural responses, assembling building model including structural and non-structural components, and developing consequence fragilities. The information acquired through these four parameters will then go through Monte Carlo simulation to generate building specific performance measures. Figure 1 is a flowchart of this process.

Figure 1: FEMA P-58 Assessment Methodology Flowchart

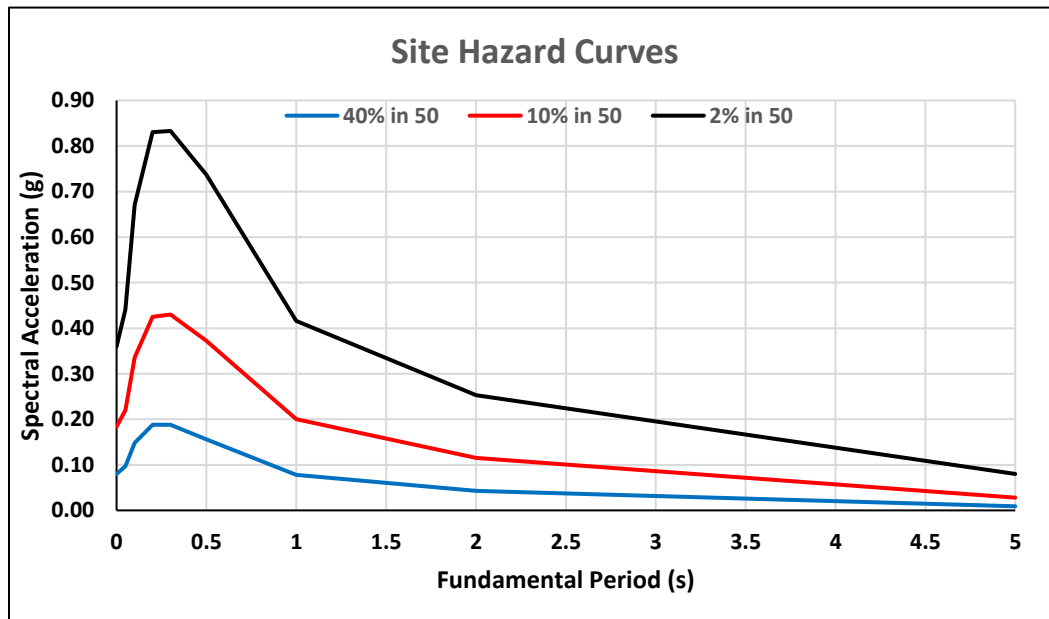
Three ground shaking intensities were considered in the assessment as related to probabilities of exceedance of 2% in 50 years, 10% in 50 years, and 40% in 50 years in accordance with VBBL 2019 seismic loading. Figure 2 illustrates the uniform hazard curves for the site.

Figure 2: Uniform Hazard Curves for the Site
