Highway 1 Burnside Bridges Widening and Seismic Retrofit

ABSTRACT

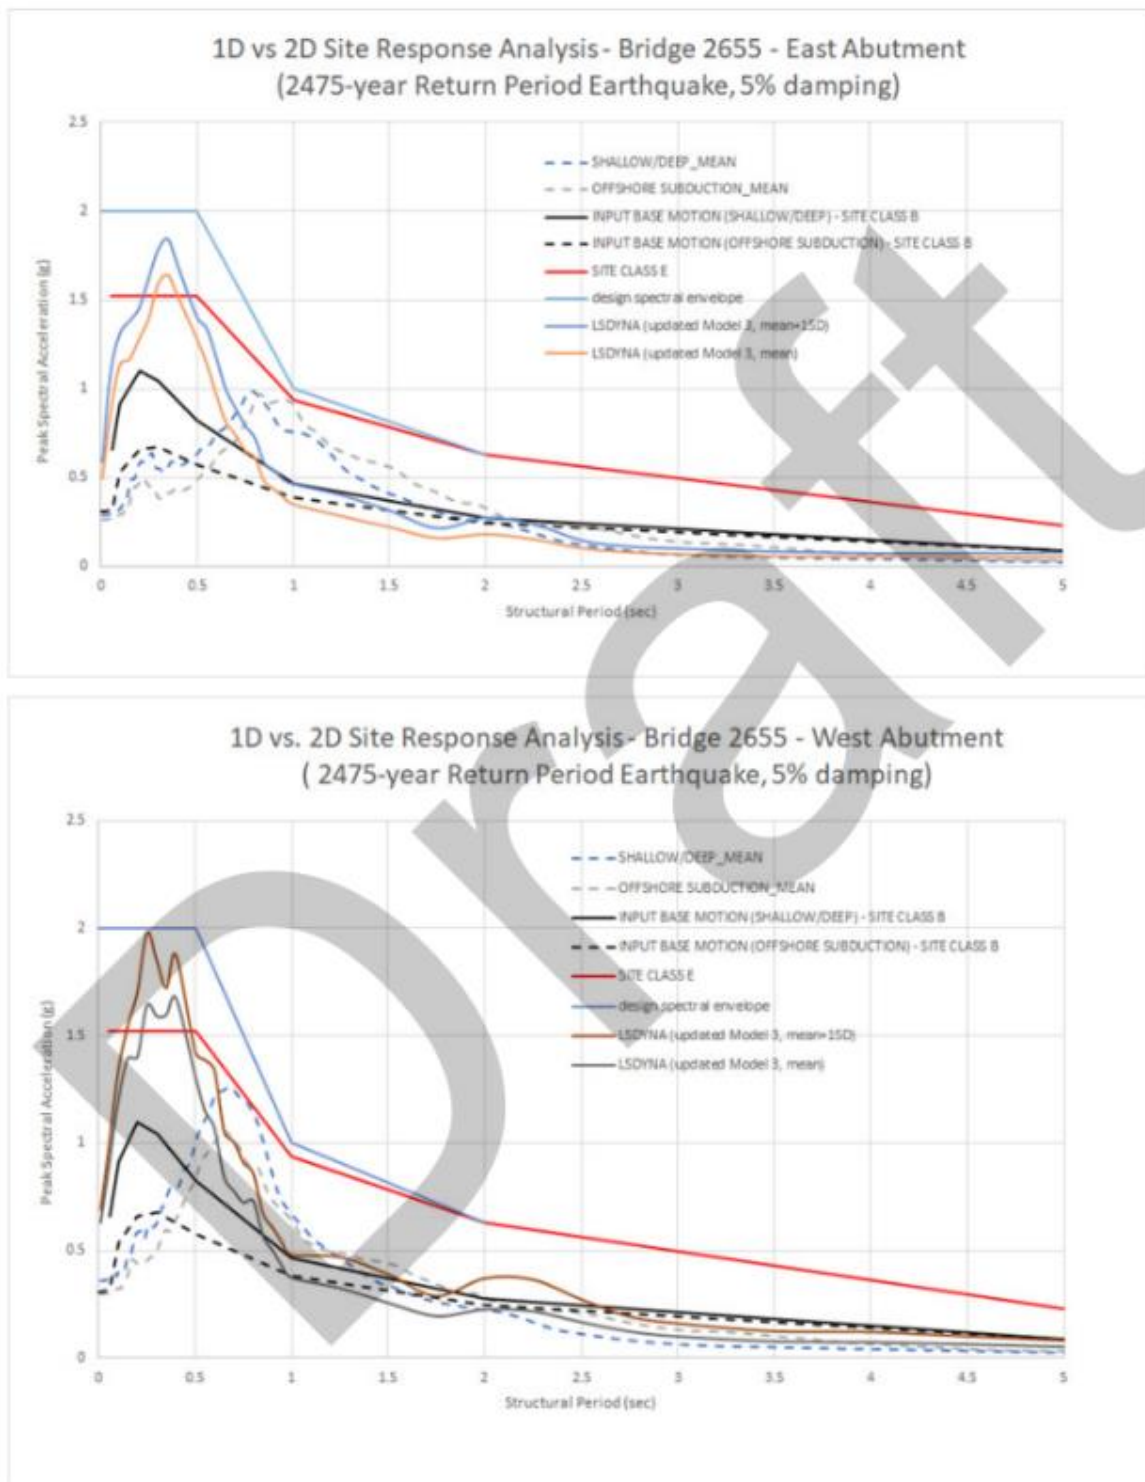
Figure 5. Design Spectrum for 02655 (01378 Similar)

The structures were assessed for Site Class E at Functional Design stage based on a desktop study of existing geotechnical information for the site. In Detailed Design the design spectra were revised based on ground investigations which exceed Site Class E acceleration as per 5th Generation earthquake model. Figure 5 outlines the design spectrum for the 2,475-year return period for 02655 Colquitz River Bridge No. 2.
