## Resilient Homes for Pacific Rim Communities: Financial, Environmental and Health Impacts of Earthquake Damage and Improved Resilience

Ben Exton<sup>1\*</sup> and Geoff Banks<sup>2</sup>

<sup>1</sup>CEO, Seismic Shift Limited, Christchurch, New Zealand

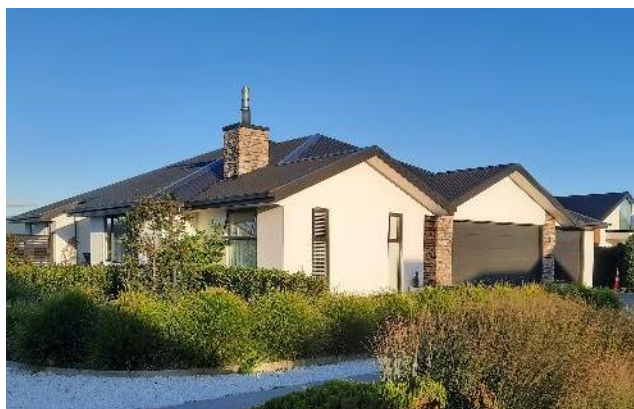
*Figure 1. A typical detached home in Lincoln, New Zealand.*

One exception is the home pictured earlier in this paper (refer Figure 1), constructed in Canterbury after the CES. Whilst in all other respects very conventional in its design and construction, this home was protected by a slip layer under the concrete floorslab and seismic dissipation devices, designed to dissipate seismic energy while limiting movement to a low level in order to accommodate the building services crossing the slip surface. To-date, there have been no formal retrofitting or low-damage incentive schemes for residential homes in NZ.
