## RETROFITTING R/C BRIDGE PIER TYPE CROSS-SECTIONS WITH PARTIAL CONFINEMENT EMPLOYING CARBON FIBER REINFORCING PLASTICS

### ABSTRACT

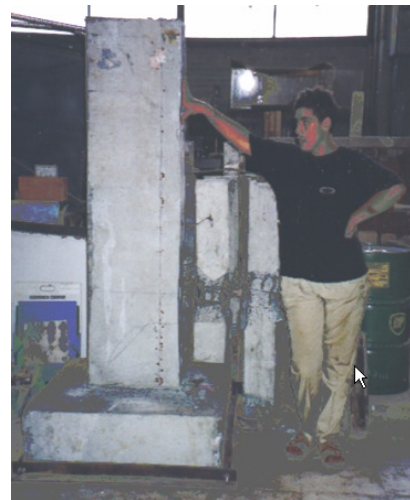
Figure 2b. Bridge pier model specimen tested at the laboratory.

The initial cross-section, which formed the basis of the tested specimens, is depicted in Fig. 3a with an aspect ratio  $h/b$  equal to 2.5. This is a rectangular cross section of a bridge pier model structure, which was tested both at the laboratory (Fig. 2b) and at the Volvi-Greece European Test Site in the framework of the European project Euro-Risk (Manos et.al. 2004 and 2005). This cross section was intentionally

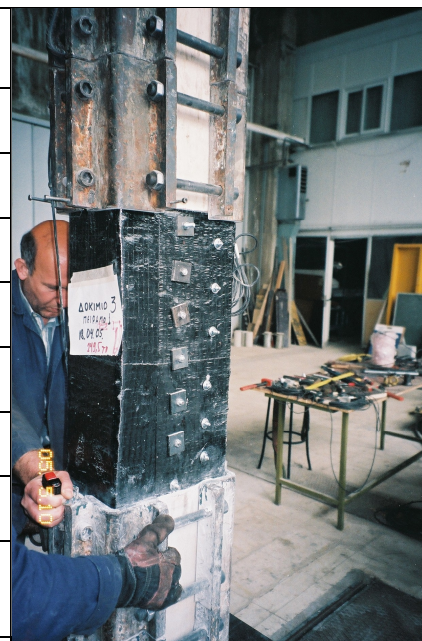
Figure 5. Confining steel brackets and partial CFRP confinement at the mid-part.

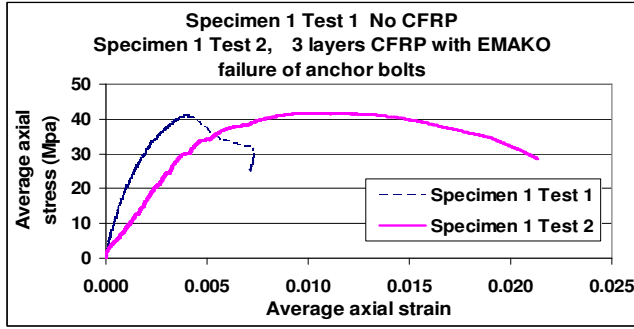
Figure 6a. Partial confinement of low effectiveness.

In Figs. 6a and 6b the obtained behavior of specimen1 (Test 2) with 3 CFRP layers and specimen 3a (Test 1) with 5 CFRP layers is compared with specimen 1 test 1 (no partial confinement). Specimen 1 test 2 was formed from specimen 1 test 1 by repairing the failed specimen 1 test 1 with special (low shrinkage) concrete as well as with 3 layers of CFRP forming the partial confinement. This repaired specimen failed

in compression with almost the same capacity as the previously-tested virgin test with no partial confinement, but with larger deformability. The effectiveness of the partial confinement is low and it is due to the failure of the anchor bolts of the applied confinement. In Fig. 6b the observed behavior of specimen 3a Test 1 is also included. This is a virgin specimen that had a 5-CFRP layer partial confinement. Despite the increase in the CFRP layers, the observed effectiveness of the partial confinement is low as was for specimen 1 test 2, again because of the failure of the anchor bolts (Fig. 7b).

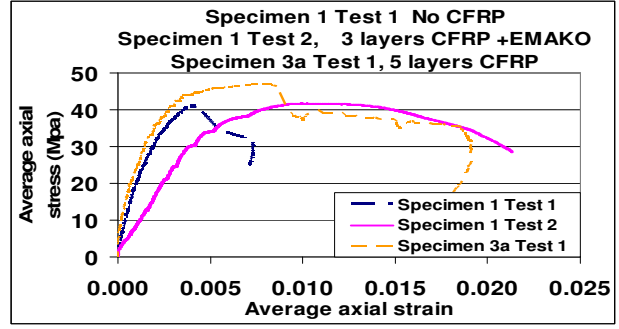
Figure 6b. Partial confinement of low effectiveness.

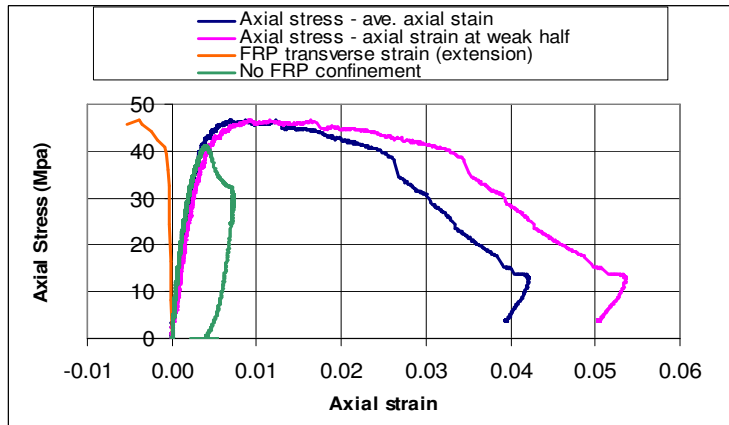
Figure 7a. Specimen 4, Test 1 (5 layers CFRP) Comparison with Specimen 1 Test 1 (no confinement).

In Fig. 7a the observed behavior of specimen 4 test 1 is depicted. This was a virgin specimen with 5 CFRP layers partial confinement. In this case, a certain alteration was applied in the anchor bolts, by increasing their length. However, this was not sufficient to improve accordingly the effectiveness of the partial confinement, which was again linked to the failure of the anchor bolts. The failed virgin specimen without the partial confinement is shown in Fig. 8a whereas Fig. 8b depicts the failure of the anchor bolts for the “low effectiveness” partial confinement.

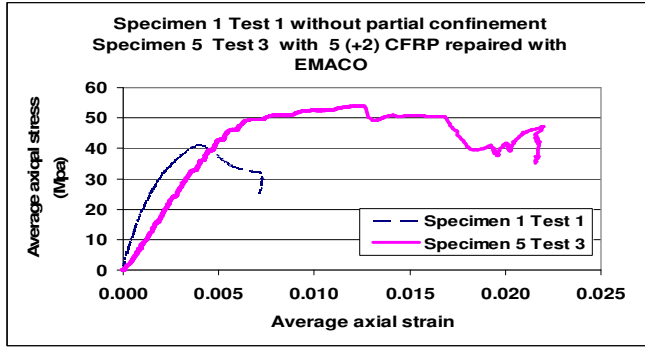
Figure 9a. Partial confinement of considerable effectiveness.

In Figs. 9a and 9b the obtained behavior of specimen 5 (Test 3) with 5 (+2) CFRP layers is compared to specimen 1 test 1 (no partial confinement). Specimen 5, test 3 was formed by repairing a previously failed virgin specimen with special (low shrinkage) concrete as well as with 5 layers of CFRP forming the partial confinement. An additional two (+2) CFRP layers were applied at the part of the section where the anchor bolts were placed. This repaired specimen failed in compression with a modest increase (31%) in its capacity when compared with the capacity of the virgin unconfined specimen. The effectiveness of the partial confinement in this case was classified as considerable. This was due to an alteration in the anchoring of the partial confinement which proved to be relatively successful. The limit state for this specimen commenced with the tensile failure of the CFRP layers at the central zone and was accompanied, as expected, by a consequent compressive failure of the neighboring weak part of the section. This is depicted in Fig. 8c where the anchor bolts, which were left intact, are also shown. In Fig. 9b, the comparison is extended to include specimen 4 (Test 1), in which the partial confinement exhibited low effectiveness due to the failure of the anchor bolts (section 6.1).

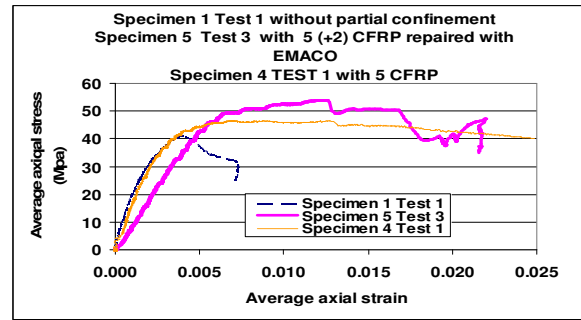
Figure 9b. Partial confinement of considerable effectiveness.

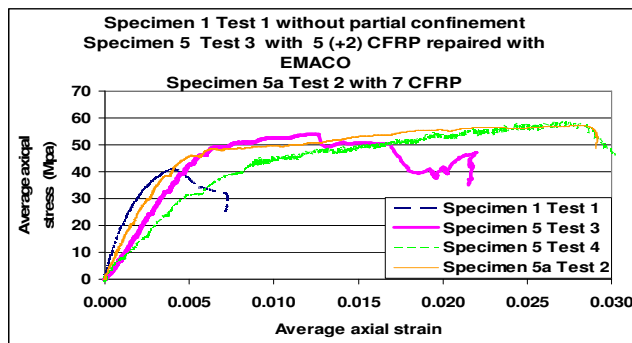
Figure 10a. Very effective partial confinement.

In Fig. 10a, the behavior of specimens 5 (Test 4) and 5a (Test 2) is compared with the behavior of specimens 1 test 1 (with no partial confinement) and 5 (Test 3) discussed in section 2. Specimens 5 (Test 4) and 5a (Test 2) were formed by repairing previously failed specimens with partial confinement of 7 layers of CFRP. Moreover, all the anchoring of their partial confinement was made with bolts going through the whole width of the strong part of the repaired section (see Table 3 and Fig. 3b). As can be seen in Fig. 10a, a substantial increase (40%), in the bearing capacity as well as in the deformability, resulted from the described partial confinement for these two specimens. Their behavior was in this way better than the behavior of specimen 4 (Test 1) which was classified before as one of considerable effectiveness of the partial confinement (section 6.2).

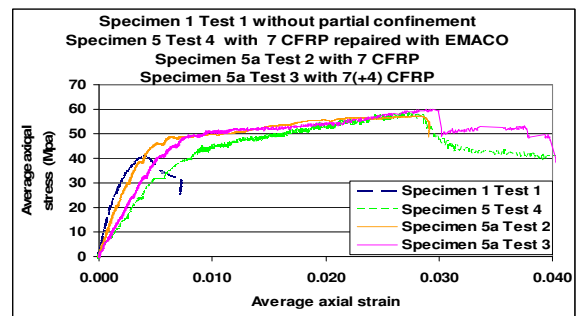
Figure 10b. Very effective partial confinement.

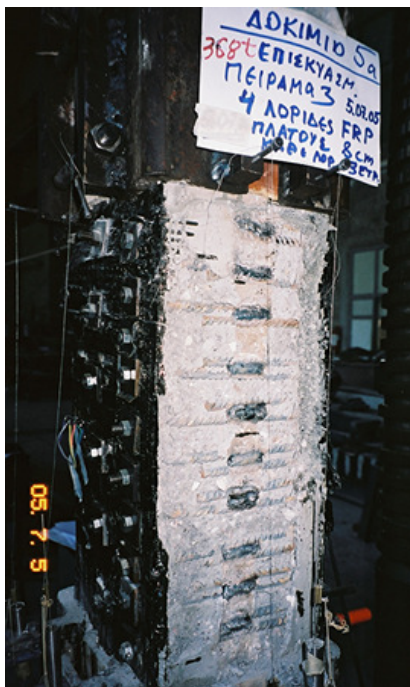
Figure 11a. Strengthening of the stirrups for the strong part.

Based in this increased capacity and deformability of specimens 5 (Test 4) and 5a (Test 2) they were classified as specimens with very effective partial confinement. The limit state of specimen 5 (Test 4) was accompanied with the failure of the stirrups of the strong part whereas the limit state of specimen 5a (Test 2) was accompanied with the tensile failure of the CFRP layers at the central zone. In Fig. 10b the observed behavior of specimen 5a (Test 3) is compared with that of specimens 5 (Test 4) and 5a (Test 2) previously discussed. Specimen 5a Test 3 had a partial confinement formed by 7 layers of CFRP. Moreover, the area sustaining the anchor bolts was strengthened by additional four (+4) layers of CFRP. Apart from the anchor bolts going through the whole width of the strong part of its section, the stirrups of this strong part were also strengthened (Fig. 11a). This time the increase in the bearing capacity was 46%; the increase in the deformability was also quite substantial. Thus, the behavior of this specimen is also one with very effective partial confinement. The observed limit state was accompanied with the compressive failure of the CFRP layers at the mid-part near the steel brackets (Fig. 11b).

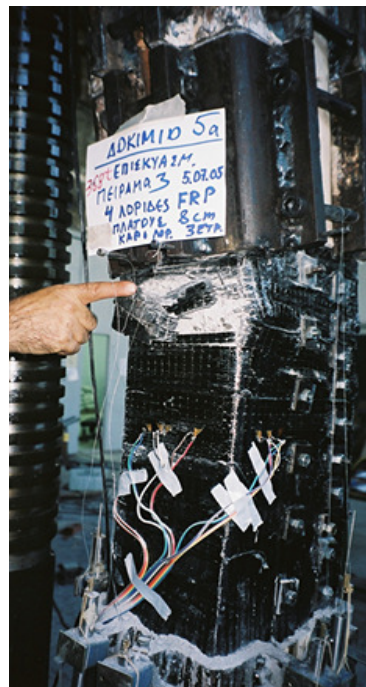
Figure 11b. Failure of the CFRP layers of the mid-part.
